STANDARDS & SPECIFICATIONS SITE INSPECTION REPORT LEVEL 1 (FIELD REPORT)

Project Name:	Mountain Valley Pipeline	S&S Program:	Mountain Valley Pipeline (SS027)
Inspector:	Matthew Grant	Inspection Date:	Monday, August 26, 2024
Project Contact:	Cory Chalmers Brian Clauto	Project Contact Email:	cchalmers@equitransmidstream.com bclauto@equitransmidstream.com
Spread G: Giles County	STA 10750-10675 ATWS 1391, 1390	Site Conditions:	Dry

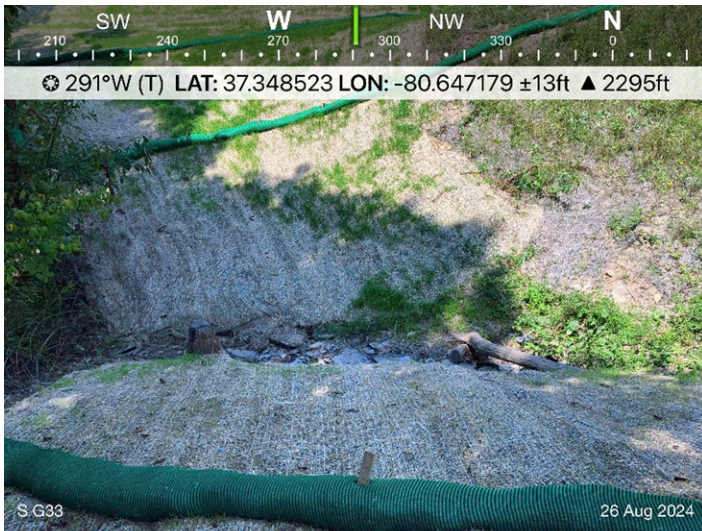
Fig. 1

Description: Designated Crossing S-G33, ESC is in place.

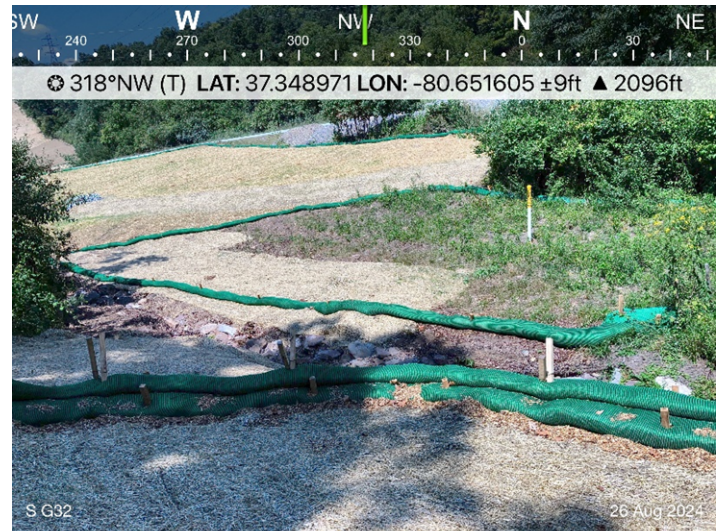
Fig. 2

Description: Designated Crossing S-G32, ESC is in place.

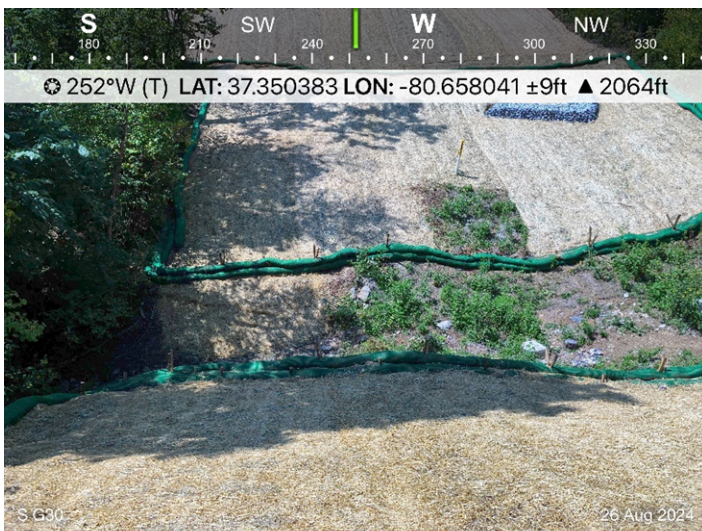
Fig. 3

Description: Designated crossing S-G30, ESC is in place.

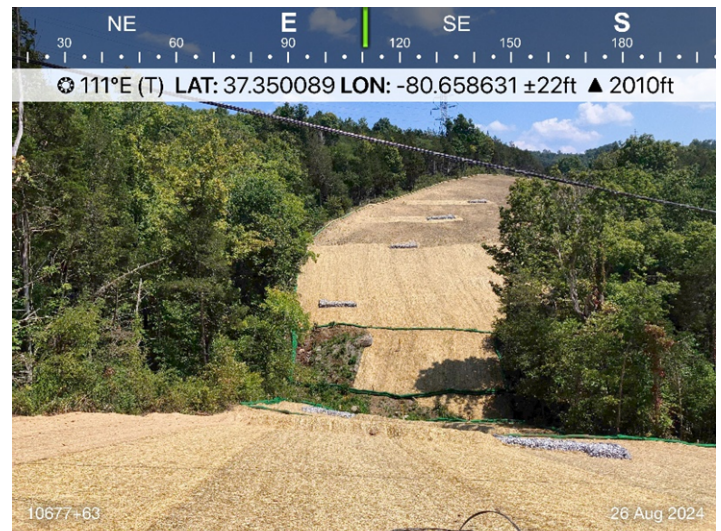
Fig. 4

Description: Permanent stabilization seed mix has been applied; mature growth has not been established.
