## STANDARDS & SPECIFICATIONS SITE INSPECTION REPORT LEVEL 1 (FIELD REPORT)

Project Name:	Mountain Valley Pipeline	S&S Program:	Mountain Valley Pipeline (SS027)
Inspector:	Matthew Grant	Inspection Date:	Monday, October 28, 2024
Project Contact:	Cory Chalmers Brian Clauto	Project Contact Email:	brian.clauto@eqt.com cory.chalmers@eqt.com
Spread G: Giles County	Sta 11158, 10890-10880, 10698+15-10711 ATWS 1391, 464, 1056, 1360, 1333, 471 GI 241, 241.04, 241.02	Site Conditions:	Dry

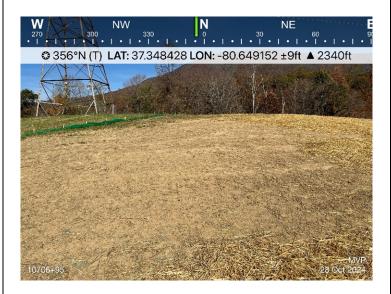
Fig. 1
Description: Sta 10706+95 denuded area requires restabilization.

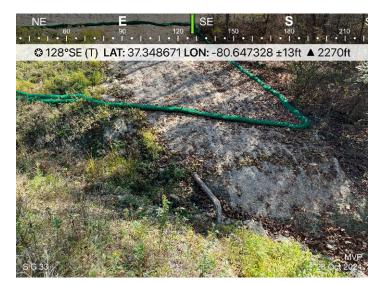
Fig. 2 Description: Designated Stream S-G33, ECD's remain in place.

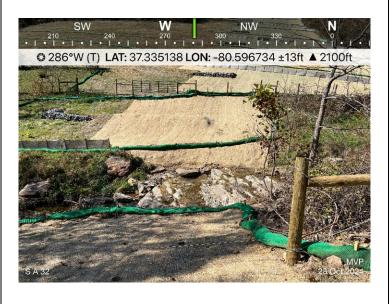
Fig. 3
Description: Designated stream S-A32, ESC remains in place.

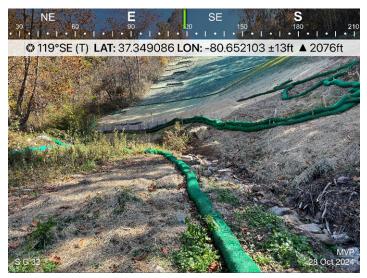
Fig. 4
Description: Designated stream S-G32, ESC remains in place.
