STANDARDS & SPECIFICATIONS SITE INSPECTION REPORT LEVEL 1 (FIELD REPORT)

Project Name:	Mountain Valley Pipeline	S&S Program:	Mountain Valley Pipeline (SS027)
Inspector:	Matthew Grant	Inspection Date:	Wednesday, October 16, 2024
Project Contact:	Cory Chalmers Brian Clauto	Project Contact Email:	cchalmers@equitransmidstream.com bclauto@equitransmidstream.com
Spread G: Giles County	Sta11227-11254 MLV 25, AR 253.03 ATWS1347, 1370, 1370A	Site Conditions:	Dry

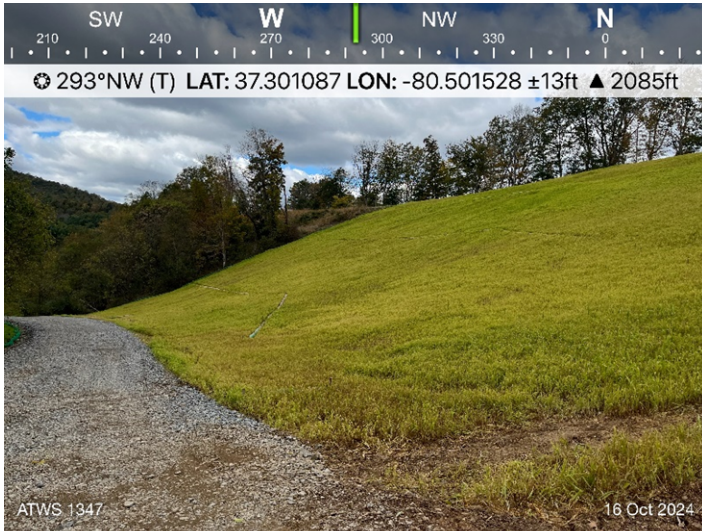
Fig. 1
Description: ATWS 1347, area is stabilized and ESC is in place.

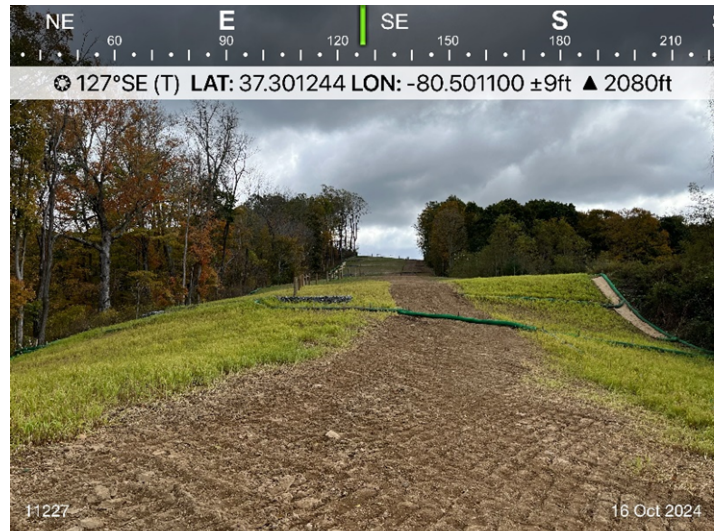
Fig. 2
Description: Sta 11227, ESC is in place.

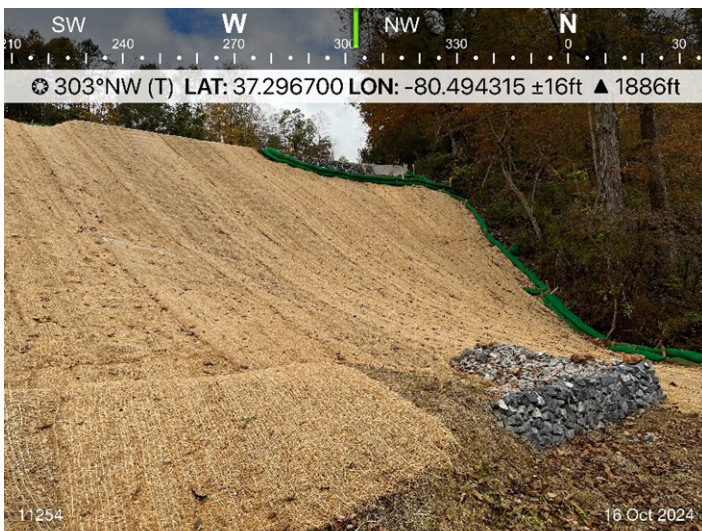
Fig. 3
Description: Sta 11524, ESC is in place.

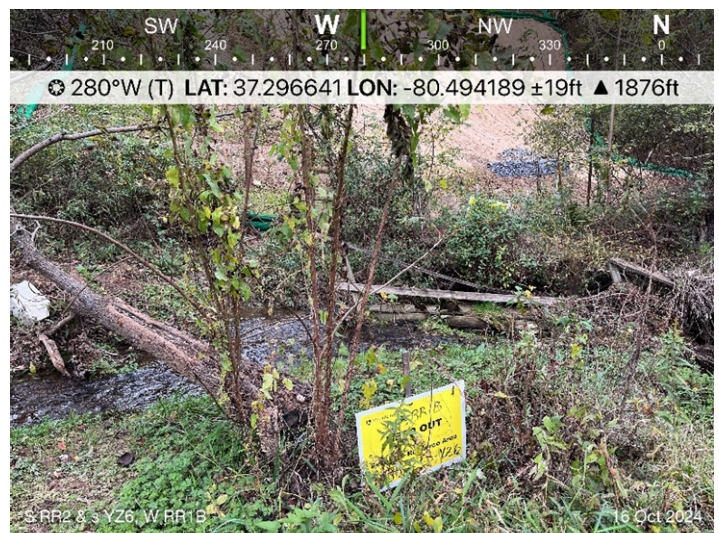
Fig. 4
Description: Designated crossing S-YZ6, SRR2, & W-RR1B ESC is in place.
