# STANDARDS & SPECIFICATIONS SITE INSPECTION REPORT LEVEL 1 (FIELD REPORT)

<b>Project Name:</b>	Mountain Valley Pipeline	<b>S&amp;S Program:</b>	Mountain Valley Pipeline (SS027)
<b>Inspector:</b>	Matthew Grant	<b>Inspection Date:</b>	Wednesday, October 16, 2024
<b>Project Contact:</b>	Cory Chalmers Brian Clauto	<b>Project Contact Email:</b>	cchalmers@equitransmidstream.com bclauto@equitransmidstream.com
<b>Spread G: Giles County</b>	AR GI 234	<b>Site Conditions:</b>	Dry

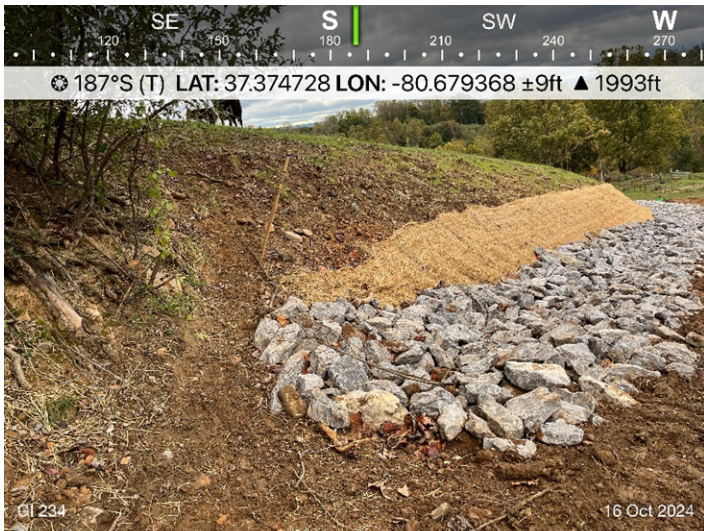
Fig. 1  
Description: Cattle crossing area, ESC is in place.

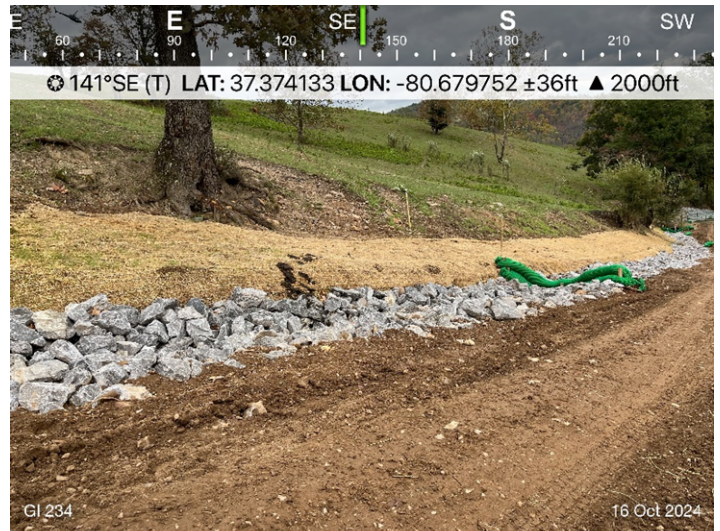
Fig. 2  
Description: Past cattle trail/ crossing location, ESC is in place.

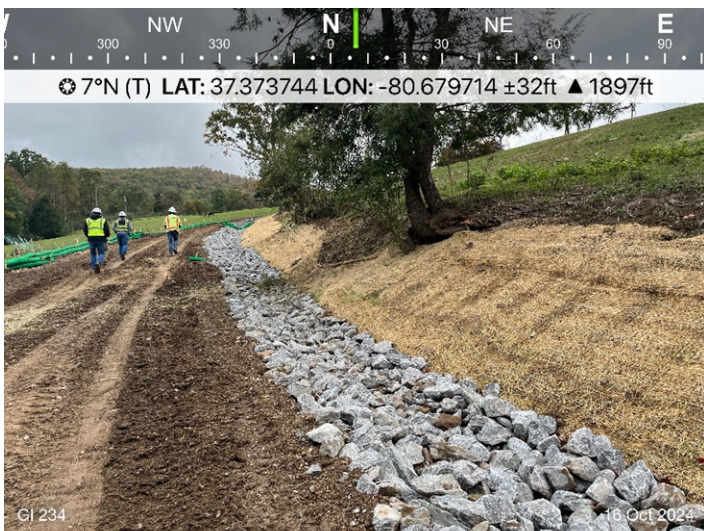
Fig. 3  
Description: GI 234, ESC is in place.

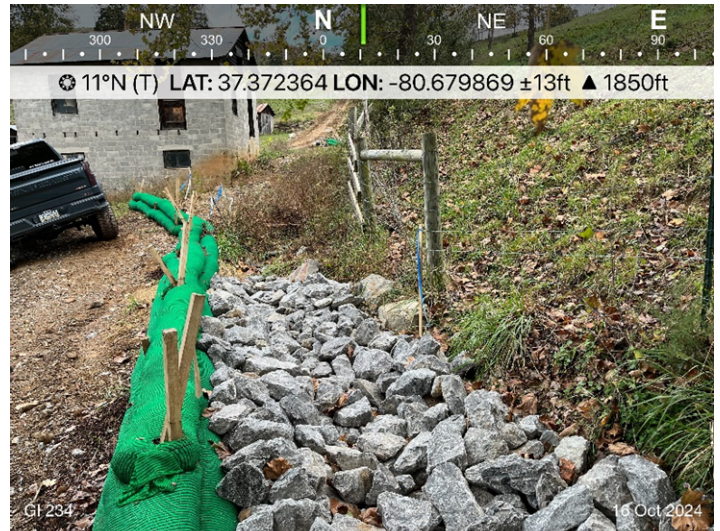
Fig. 4  
Description: GI 234, ESC is in place.
