## FIELD INSPECTION REPORT

<b>Project Name:</b>	Mountain Valley Pipeline	<b>Inspector:</b>	Marshall Willis
<b>Inspection Date:</b>	Thursday, August 13, 2020	<b>Project Contact:</b>	Brian Clauto, Cory Chalmers
<b>Spread G: Giles County Montgomery County</b>	STA 11765+00 – 11788+00 STA 11976+00 – 11988+00 MVP-GI-241.01/.04 MVP-MN-266	<b>Weather:</b>	Wet

## FIELD INSPECTION PHOTO LOG

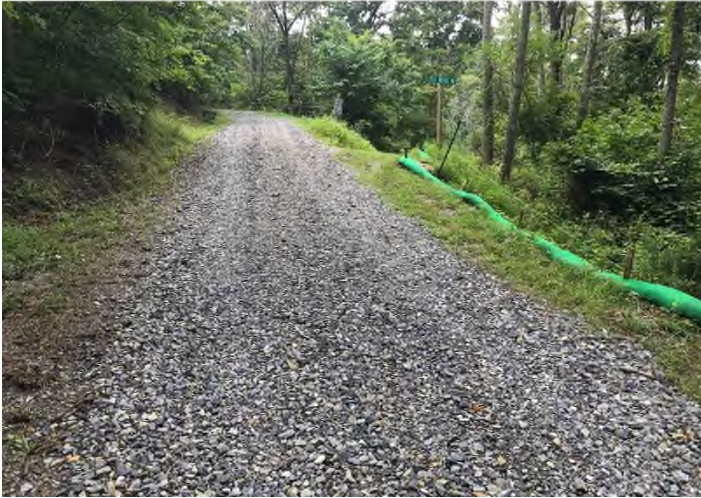
**Figure 1: MVP-GI-241.04** – Controls in place and functioning properly.

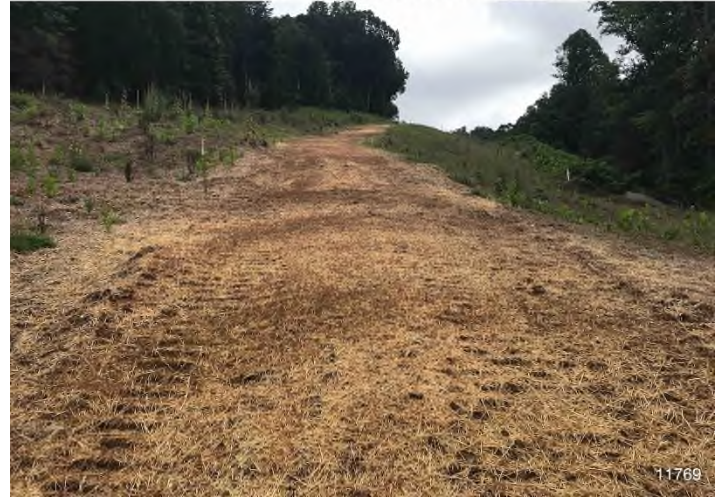
**Figure 2: STA 11769+00** – Controls in place and functioning properly. Area stabilized with straw.

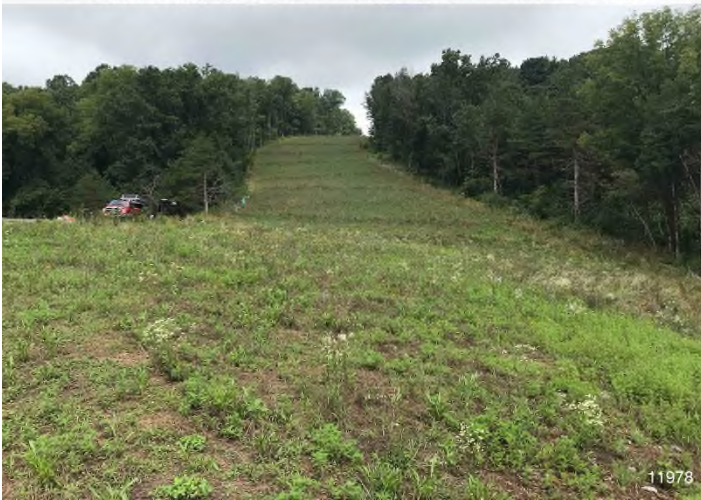
**Figure 3: STA 11978+00** – Controls in place and functioning properly.

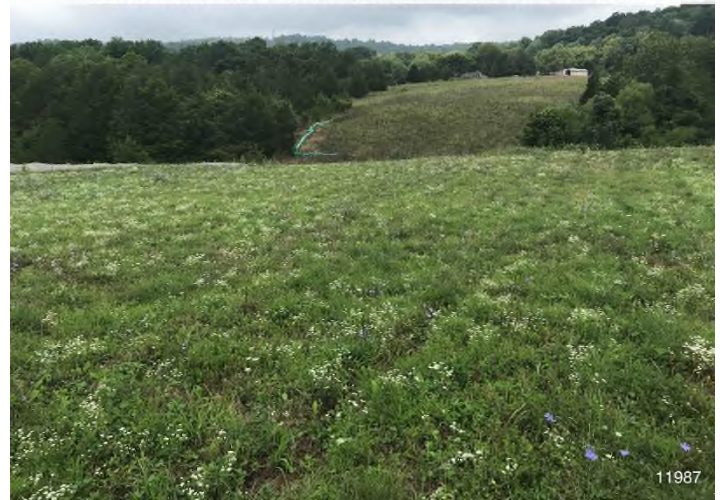
**Figure 4: STA 11987+00** – Controls in place and functioning properly.
