FIELD INSPECTION REPORT

Project Name:	Mountain Valley Pipeline	Inspector:	Marshall Willis
Inspection Date:	Monday, August 10, 2020	Project Contact:	Brian Clauto, Cory Chalmers
Spread G: Giles County	STA 10929+71 – 11011+87 MVP-GI-243.01 ATWS 974/974A/1137/1138/467	Weather:	Dry

FIELD INSPECTION PHOTO LOG

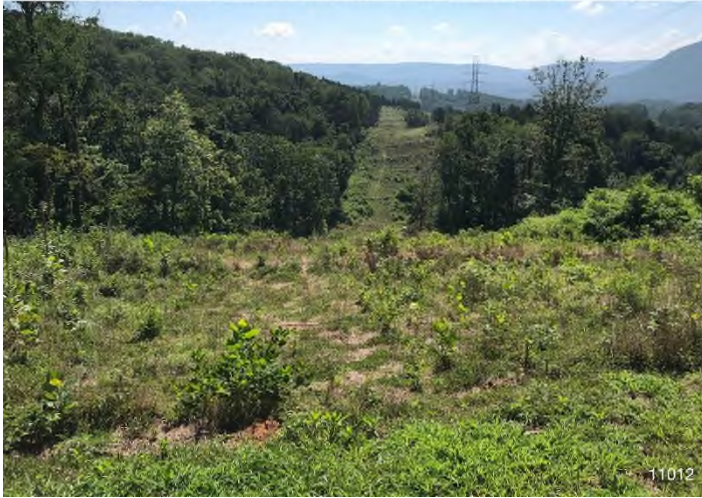
Figure 1: STA 11012+00 – Controls in place and functioning properly.

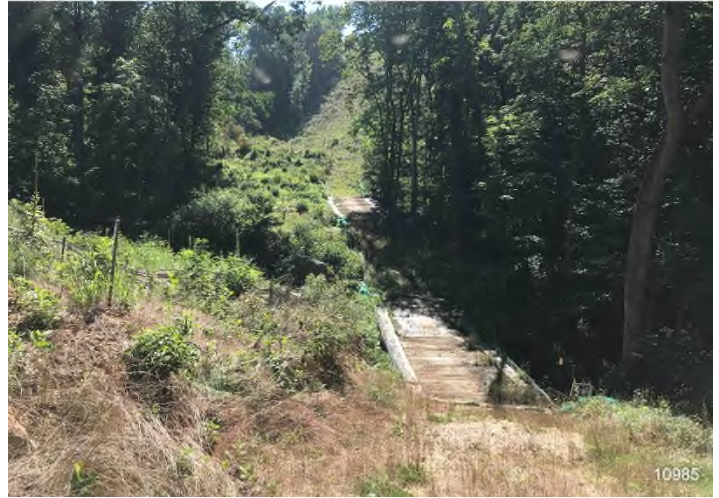
Figure 2: STA 10985+00 – Controls in place and functioning properly.

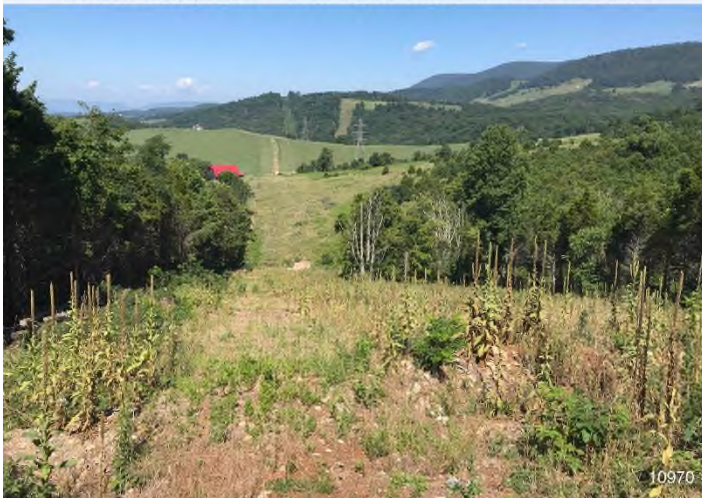
Figure 3: STA 10970+00 – Controls in place and functioning properly.

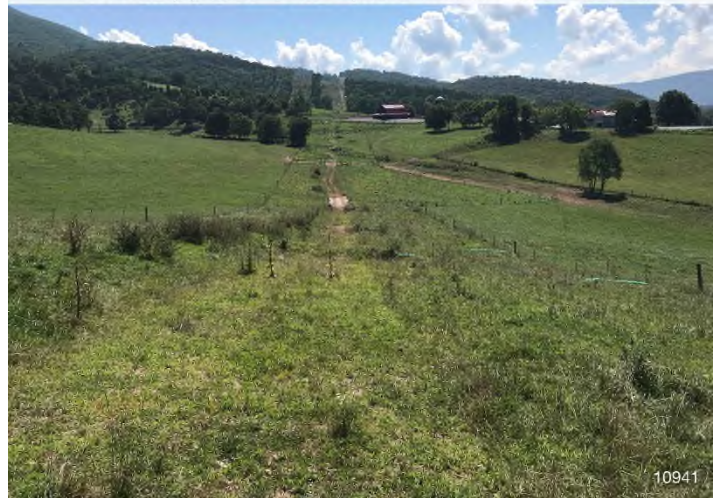
Figure 4: STA 10941+00 – Controls in place and functioning properly.
