FIELD INSPECTION REPORT

Project Name:	Mountain Valley Pipeline	Inspector:	Matthew Grant		
Inspection Date:	Tuesday, August 4, 2020	Project Contact:	Brian Clauto		
Spread G: Giles Montgomery	AR-GI-244 MP208.6- 206.7 ATWS 1138, 1137, 1487 MP 223.1, 223	Weather:	Dry

FIELD INSPECTION PHOTO LOG

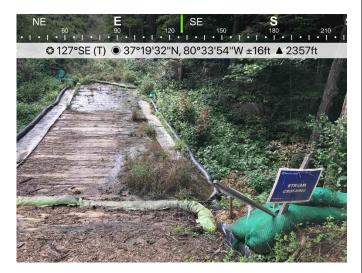
Figure 2: Designated crossing S-E25, controls in place.

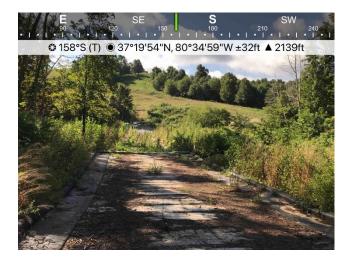
Figure 3: Designated stream S-Y3, controls in place.
