## FIELD INSPECTION REPORT

| <b>Project Name:</b> | Mountain Valley Pipeline | <b>Inspector:</b> | Marshall Willis |
| <b>Spread G:<br/>Montgomery County</b> | STA 11596+94 – 11618+91<br>ATWS 1373/1057<br>MVP-MN-258.04/.03<br>Laydown Yard 028 | <b>Weather:</b> | Dry |

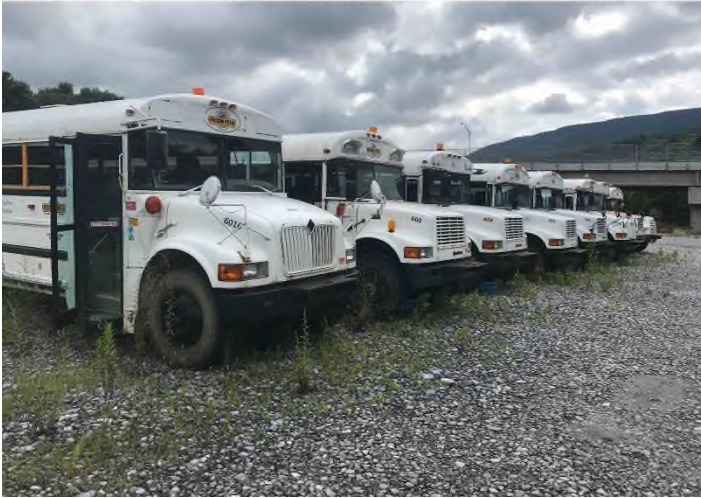
**Figure 1: Laydown Yard 028** – Leak protection in place and functioning properly.

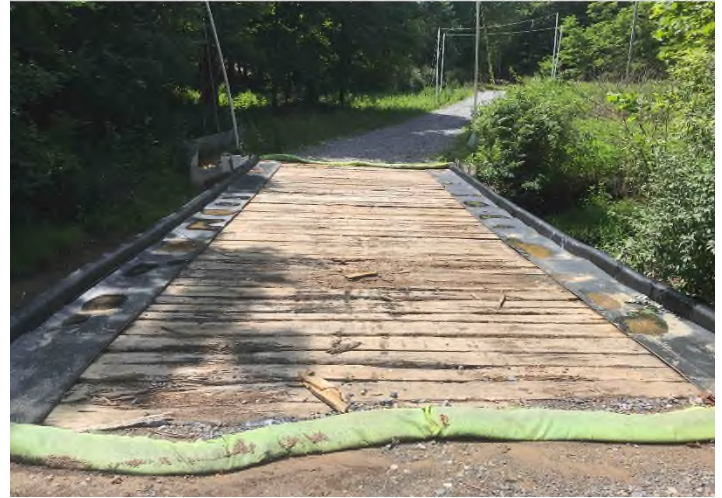
**Figure 2: Stream S-RR13** – Controls in place and functioning properly around Craig Creek crossing of MVP-MN-258.04.

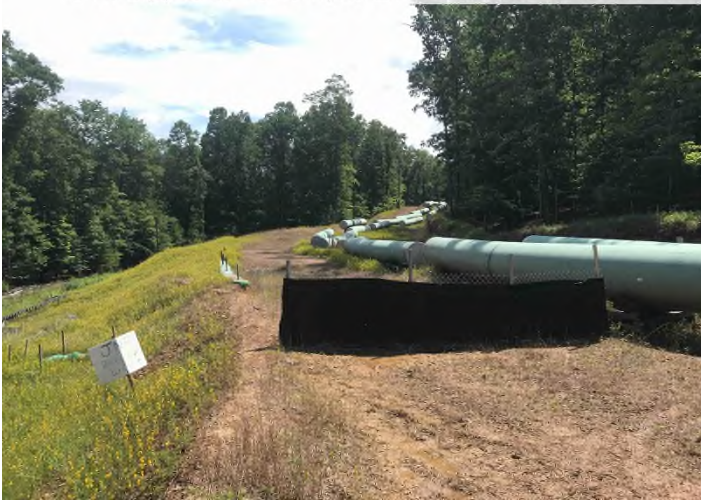
**Figure 3: STA 11618+00** – Controls in place and functioning properly.

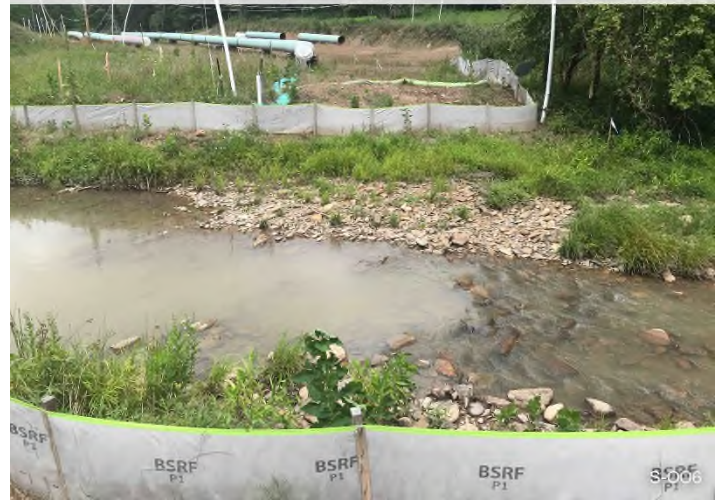
**Figure 4: Stream S-006** – Controls in place and functioning properly around Craig Creek crossing.
