FIELD INSPECTION REPORT

| Project Name: | Mountain Valley Pipeline | Inspector: | Matthew Grant |
| Inspection Date: | Tuesday, September 15, 2020 | Project Contact: | Brian Clauto |

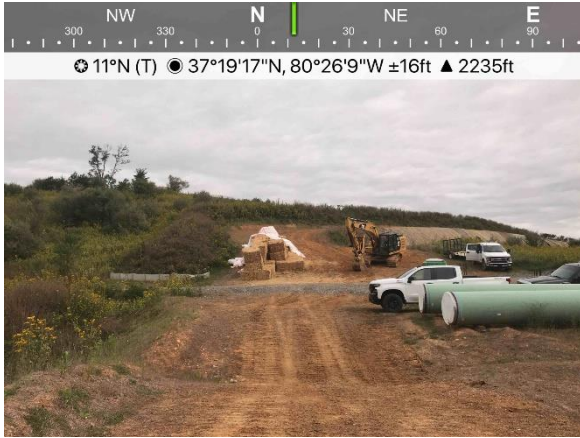
Figure 1: MVP E&S crews working near MP217.1

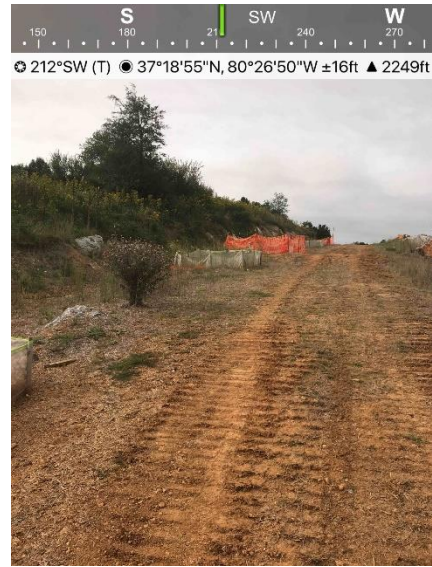
Figure 2: Holes identified by DCR continue to be protected near MP 216.3

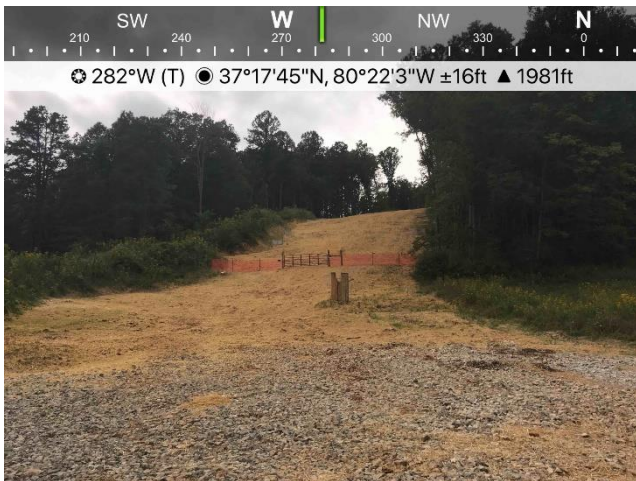
Figure 3: Gate installed near MLV 26 and area has been recently re stabilized.

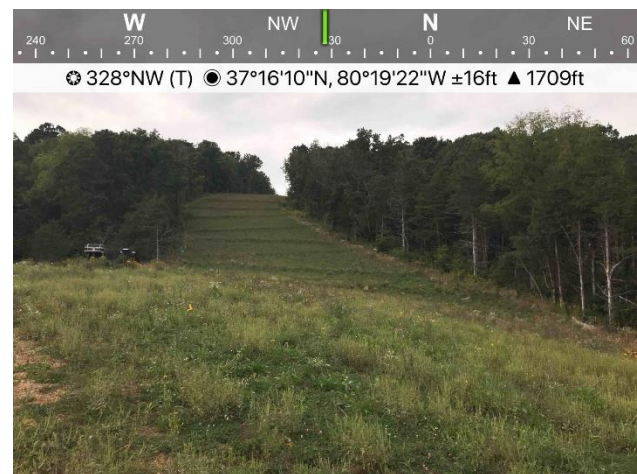
Figure 4: Stabilized slope near Catawba Road near MP 226.7
