FIELD INSPECTION REPORT

Project Name:	Mountain Valley Pipeline	Inspector:	Marshall Willis
Inspection Date:	Wednesday, August 26, 2020	Project Contact:	Brian Clauto, Cory Chalmers
Spread G: Montgomery County	STA 11669+08 – 11788+43	Weather:	Dry

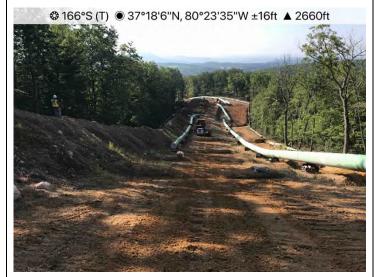
<u>Figure 1</u>: **STA 11675+00** – Crews actively re-stabilizing with seed and straw.

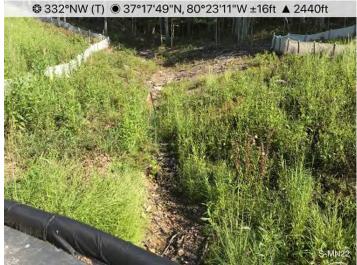
<u>Figure 2</u>: **Stream S-MN22** – Controls in place and functioning properly around S-MN22 crossing.

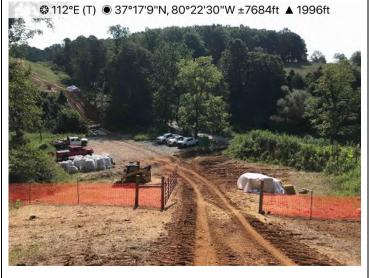
Figure 3: **STA 11765+00** – Fencing and gate installed. Crews actively stabilizing with seed and straw.

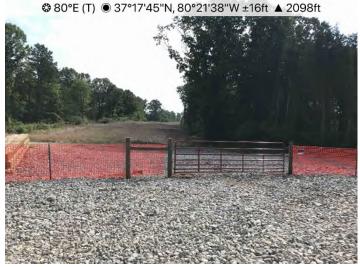
Figure 4: STA 11792+00 – Fencing and gate installed.
