FIELD INSPECTION REPORT

Project Name:	Mountain Valley Pipeline	Inspector:	Marshall Willis
Inspection Date:	Thursday, October 15, 2020	Project Contact:	Brian Clauto, Cory Chalmers
Spread G: Montgomery County	STA 11788+43 – 11815+00	Weather:	Dry

FIELD INSPECTION PHOTO LOG

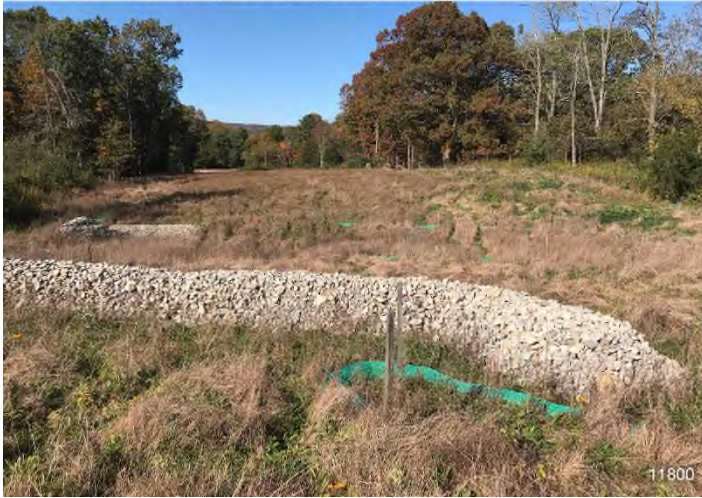
11800

Figure 1: STA 11800+00 – Controls in place and functioning properly.

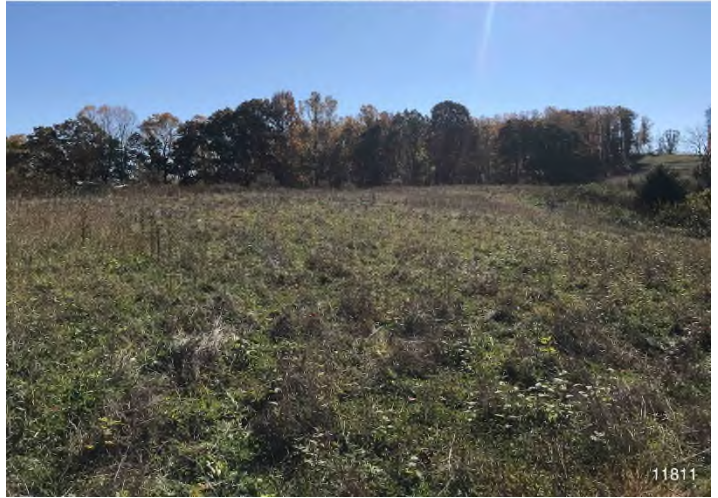
11811

Figure 2: STA 11811+00 – Controls in place and functioning properly.
