## FIELD INSPECTION REPORT

<b>Project Name:</b>	Mountain Valley Pipeline	<b>Inspector:</b>	Marshall Willis
<b>Inspection Date:</b>	Thursday, October 1, 2020	<b>Project Contact:</b>	Brian Clauto, Cory Chalmers
<b>Spread G: Giles County</b>	Laydown Yard 026	<b>Weather:</b>	Dry

## FIELD INSPECTION PHOTO LOG

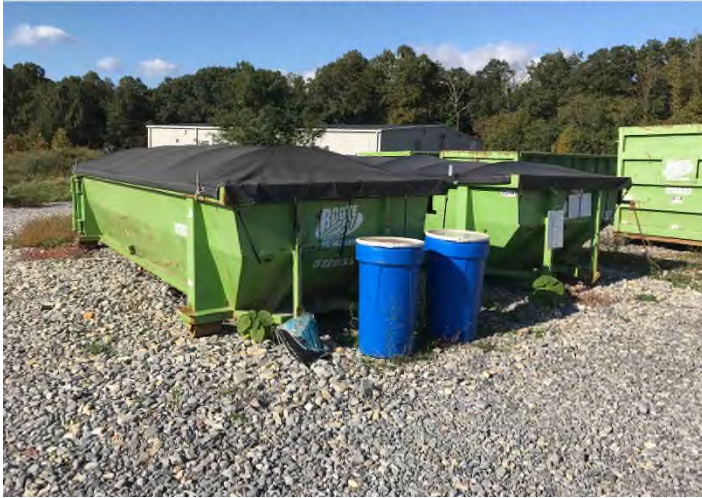
**Figure 1: Laydown Yard 026** – Controls in place and functioning properly.

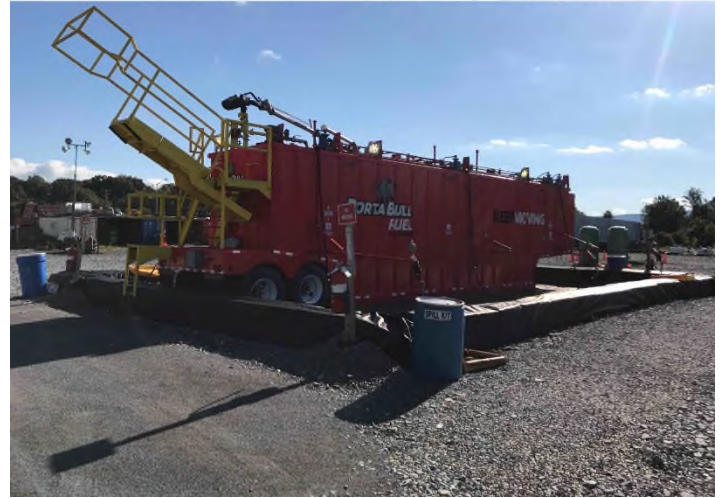
**Figure 2: Laydown Yard 026** – Secondary containment in place and functioning properly.

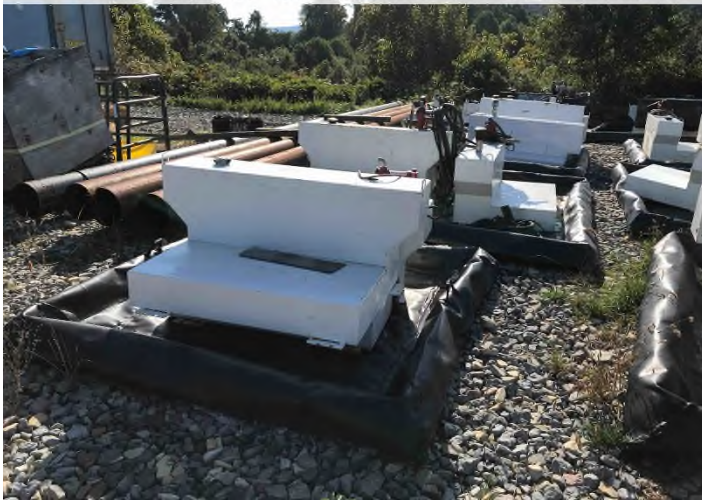
**Figure 3: Laydown Yard 026** – Secondary containment in place and functioning properly.

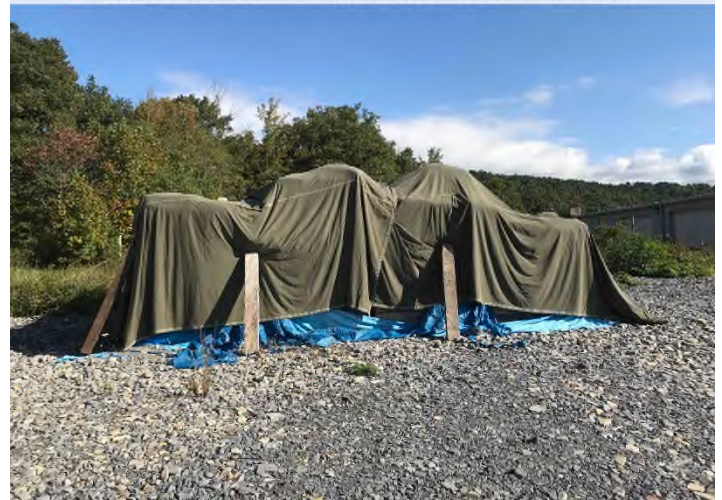
**Figure 4: Laydown Yard 026** – Controls in place and functioning properly.
