## FIELD INSPECTION REPORT

<b>Project Name:</b>	Mountain Valley Pipeline	<b>Inspector:</b>	Marshall Willis
<b>Inspection Date:</b>	Tuesday, September 29, 2020	<b>Project Contact:</b>	Brian Clauto, Cory Chalmers
<b>Spread G: Giles County Montgomery County</b>	STA 11163+00 – 11177+00 STA 11020+00 – 11030+00 STA 11762+54 – 11770+00	<b>Weather:</b>	Rainy

## FIELD INSPECTION PHOTO LOG

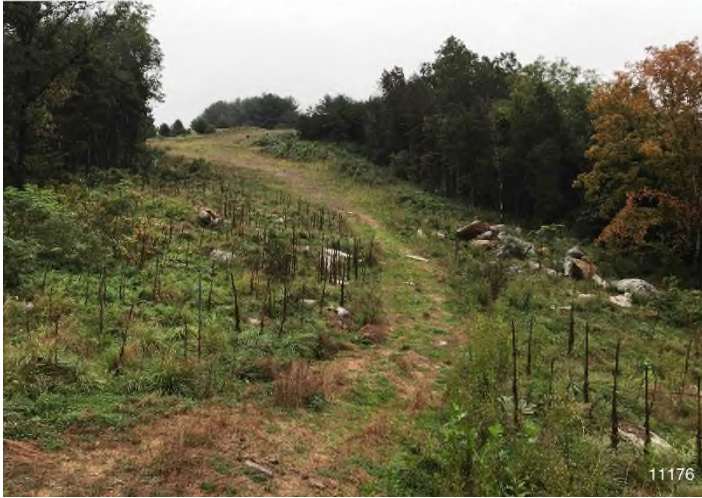
11176

**Figure 1: STA 11176+00** – Controls in place and functioning properly.

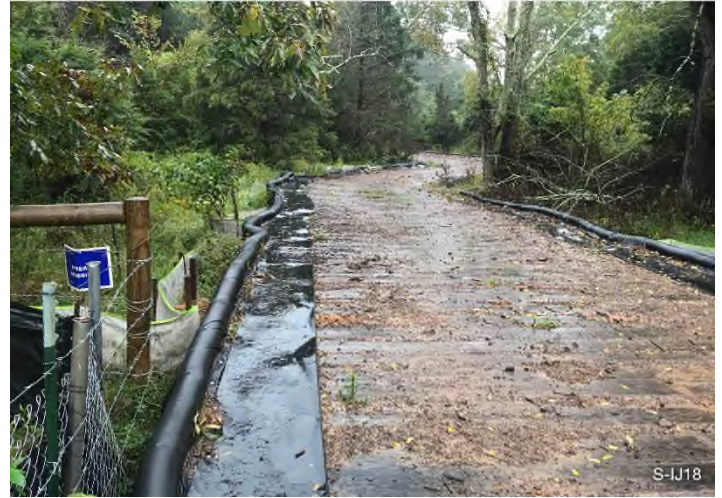
**Figure 2: Stream S-IJ18** – Controls in place and functioning properly around stream S-IJ18 crossing.

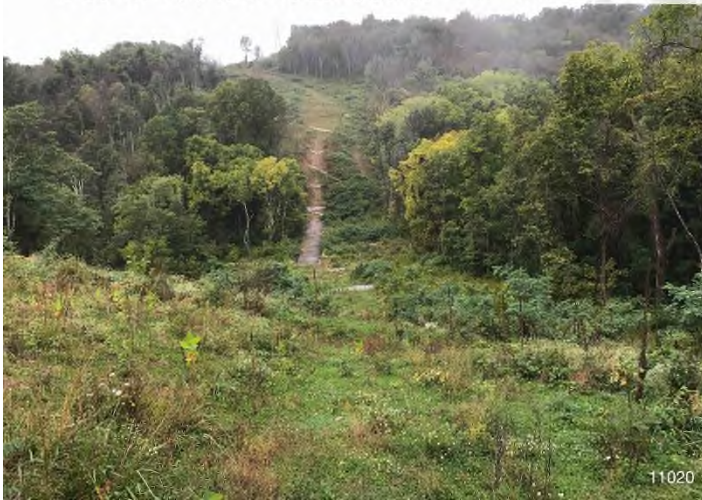
11020

**Figure 3: STA 11020+00** – Controls in place and functioning properly.

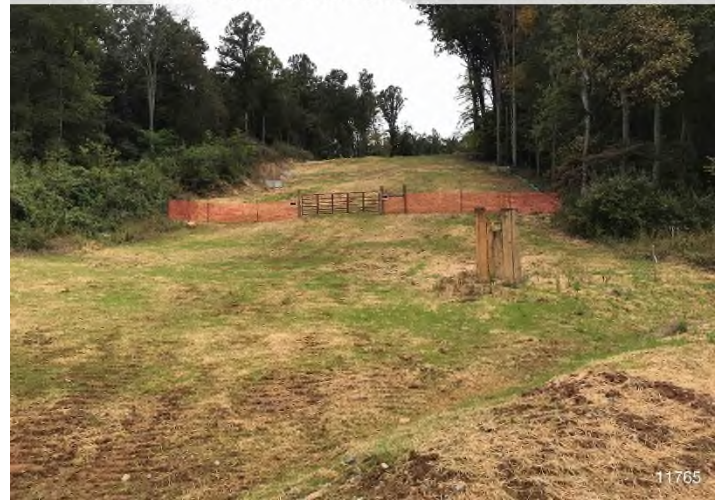
11765

**Figure 4: STA 11765+00** – Controls in place and functioning properly. Area stabilized with straw.
