## FIELD INSPECTION REPORT

<b>Project Name:</b>	Mountain Valley Pipeline	<b>Inspector:</b>	Marshall Willis
<b>Inspection Date:</b>	Friday, November 6, 2020	<b>Project Contact:</b>	Brian Clauto, Cory Chalmers
<b>Spread G: Montgomery County</b>	STA 11929+42 – 12008+53 MVP-MN-266	<b>Weather:</b>	Dry

## FIELD INSPECTION PHOTO LOG

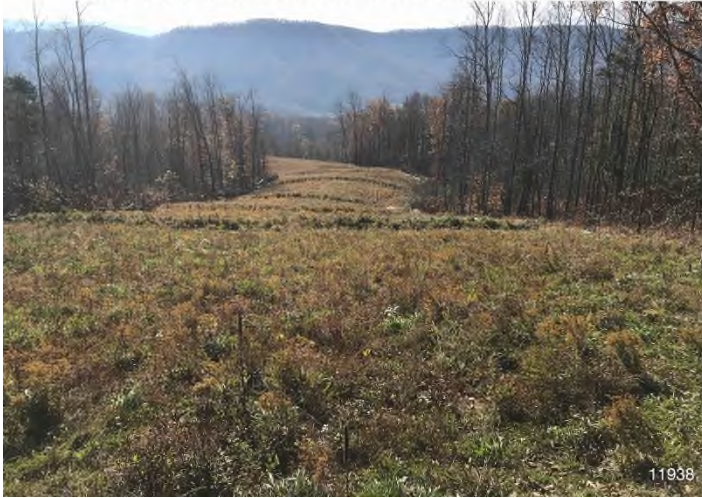
**Figure 1: STA 11938+00** – Controls in place and functioning properly.

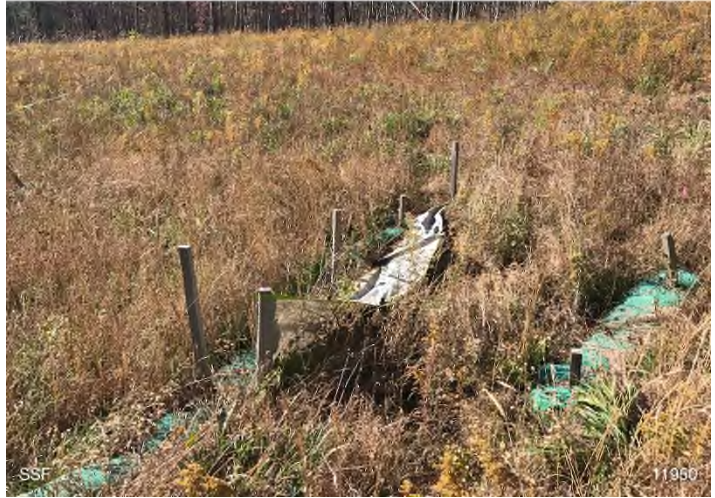
- STA 11950+00: P1 maintenance needed.
- STA 11962+50: P1 maintenance needed.

**Figure 2: STA 11950+00** – P1 maintenance needed.

**Recommended Corrective Action:** Maintain and install all controls per the approved PSS&S.

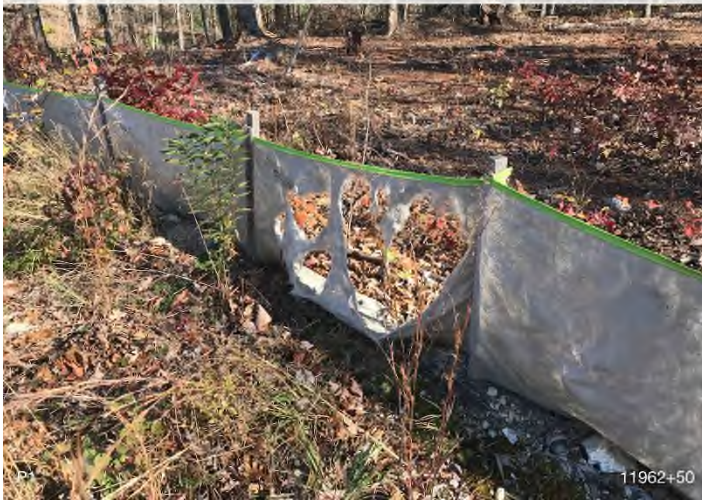
**Figure 3: STA 11962+50** – P1 maintenance needed.

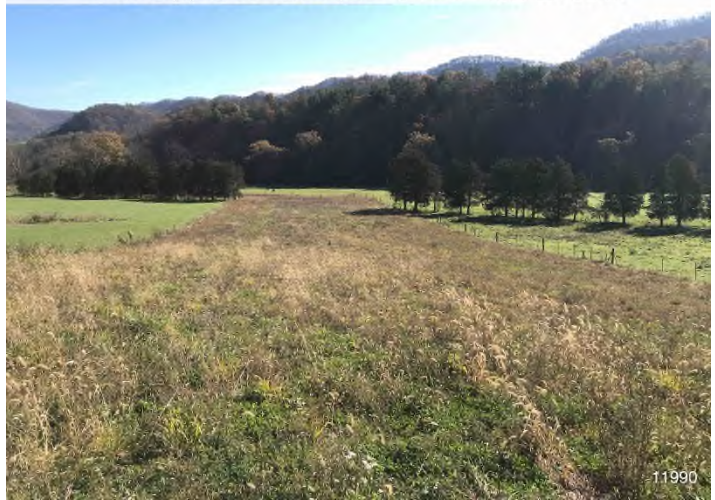
**Figure 4: STA 11990+00** – Controls in place and functioning properly.
