COMPLAINT INVESTIGATION REPORT

Project Name:	Mountain Valley Pipeline	Inspector:	Marshall Willis
Inspection Date:	Friday, October 30, 2020	Project Contact:	Brian Clauto, Cory Chalmers
Spread I: Franklin County	STA 14062+17 – 14171+36 ATWS 1472/1473/1478/1479/1480	Weather:	Wet

Background: This investigation was conducted in response to a complaint (IR#: 297171) received on October 29, 2020 for the Jonesmill Lane area near MP 267 at stream S-KL41 (~STA 14105+32).

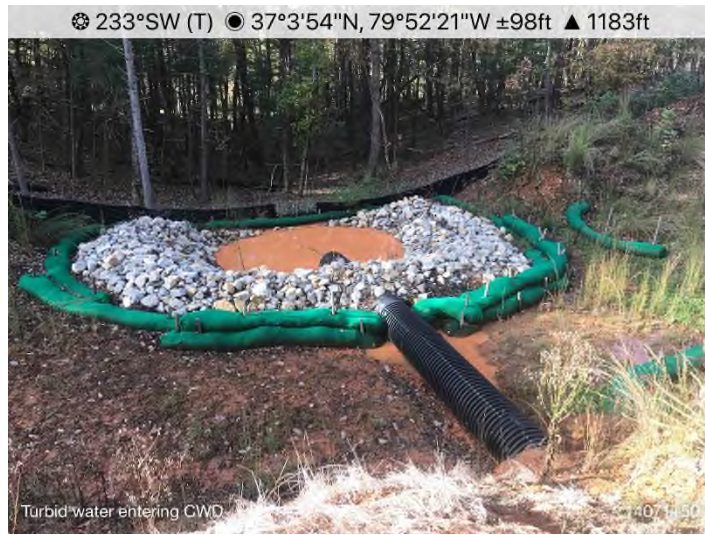
- STA 14071+50: Onsite runoff entering CWD plunge pool.
- STA 14156+00: Waterbar overtopped. Repair needed.

Figure 1: STA 14071+50 – Onsite discharge entering CWD plunge pool, repair needed.

Recommended Corrective Action: Maintain and install all controls per the approved PSS&S.

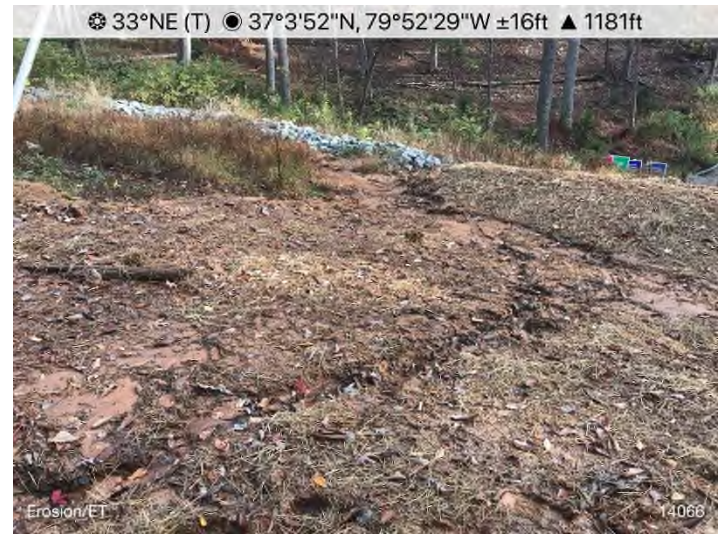
- STA 14066+00: Erosion in travel lane depositing sediment into stone permanent waterbar end-treatment.
- STA 14083+00: CFS maintenance needed.

Figure 2: STA 14068+00 – Erosion depositing sediment into permanent waterbar rock end-treatment. Repair/stabilize erosion and remove sediment.

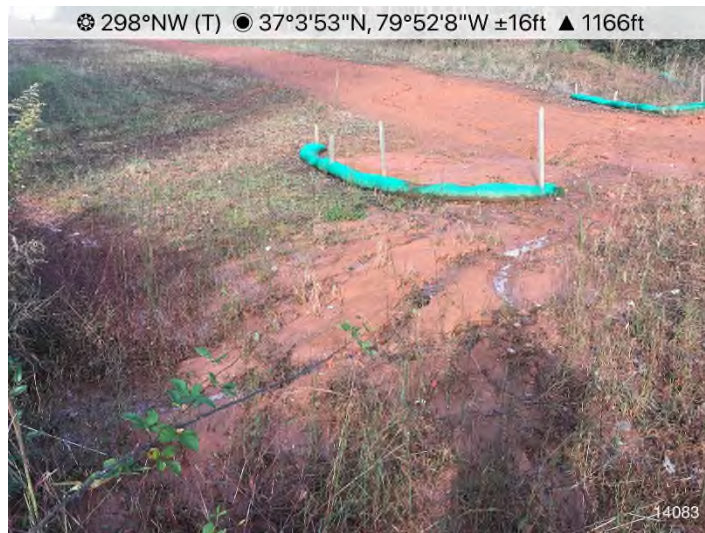
Figure 3: STA 14083+00 – CFS maintenance needed.

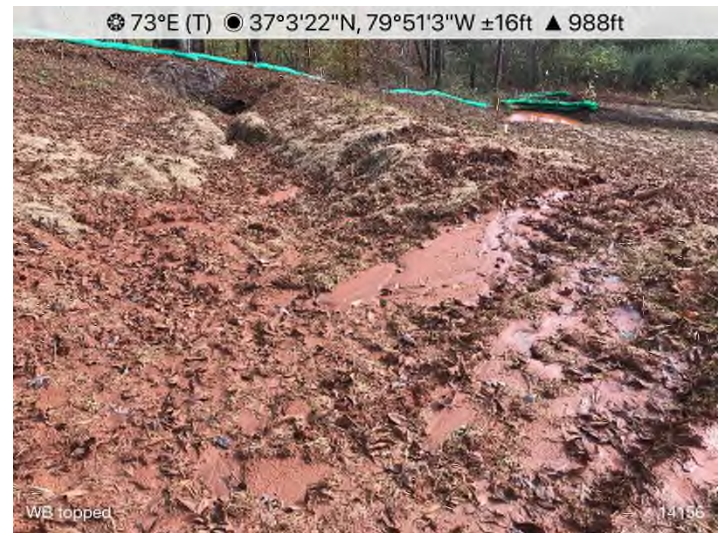
Figure 4: STA 14156+00 – Waterbar overtopped, repair needed.

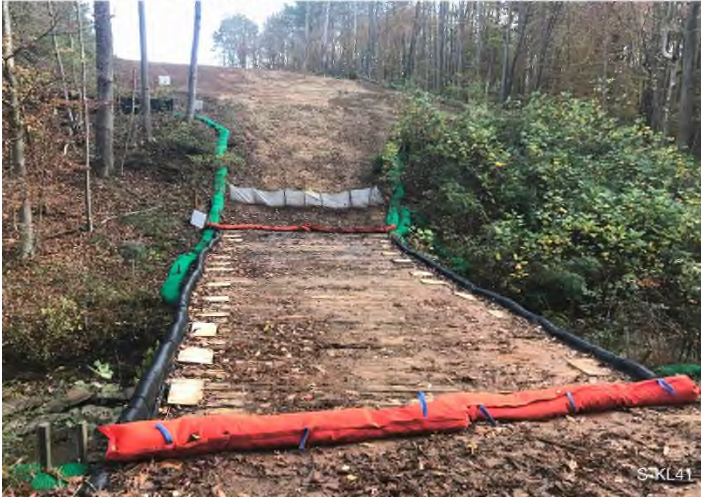
Figure 5: Stream S-KL41 – Unnamed trib. to Blackwater River crossing looking east at crossing. Controls in place and area stabilized with straw.

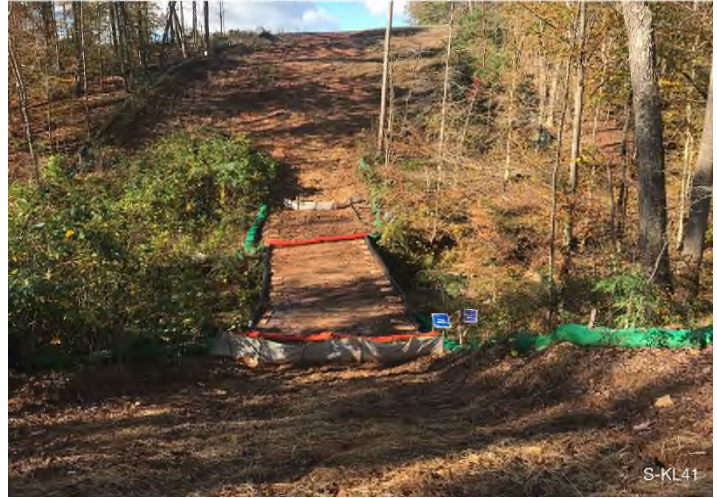
Figure 6: Stream S-KL41 – Unnamed trib. to Blackwater River crossing looking west at crossing. Controls in place and area stabilized with straw.

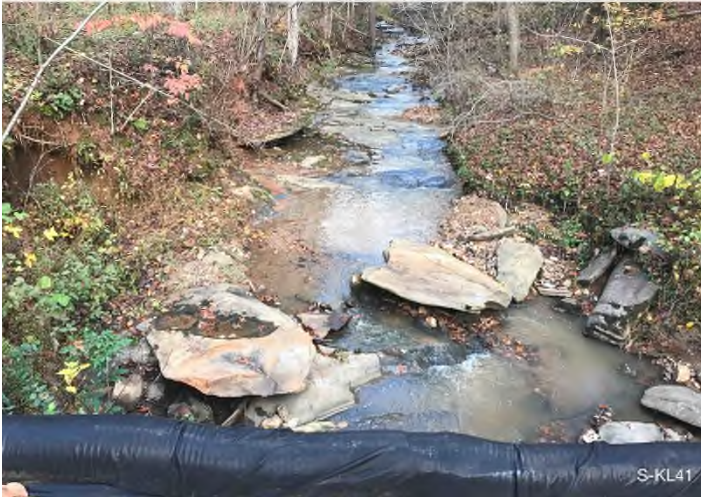
Figure 7: Stream S-KL41 – Unnamed trib. to Blackwater River crossing looking upstream from crossing.
