## FIELD INSPECTION REPORT

Project Name:	Mountain Valley Pipeline	Inspector:	Matthew Grant		
Inspection Date:	Wednesday, October 28, 2020	Project Contact:	Brian Clauto		
Spread G: Montgomery	AR 258.02 MP 219.59 ATWS 1057, 1373	Weather:	Rainy

## FIELD INSPECTION PHOTO LOG

**Project Name:** Mountain Valley Pipeline

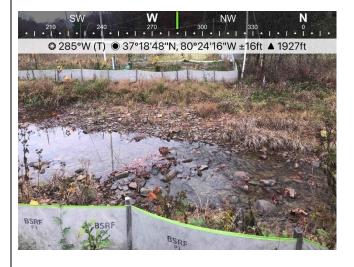
Figure 3: Designated stream crossing S-006, ECD's are in place.

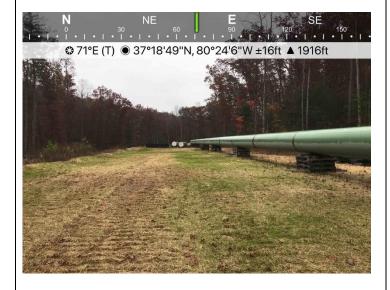
- <u>Figure 4</u>: Near MP 219.5 area is stabilized and ECD's are in place.
