FIELD INSPECTION REPORT

Project Name:	Mountain Valley Pipeline	Inspector:	Marshall Willis
Inspection Date:	Wednesday, October 21, 2020	Project Contact:	Brian Clauto, Cory Chalmers
Spread G: Montgomery County	STA 11669+00 – 11788+43	Weather:	Dry

FIELD INSPECTION PHOTO LOG

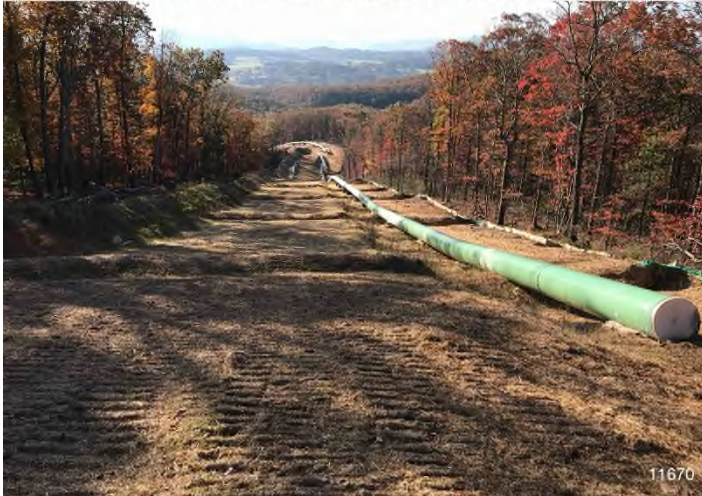
11670

Figure 1: STA 11670+00 – Controls in place and functioning properly. Area stabilized with straw.

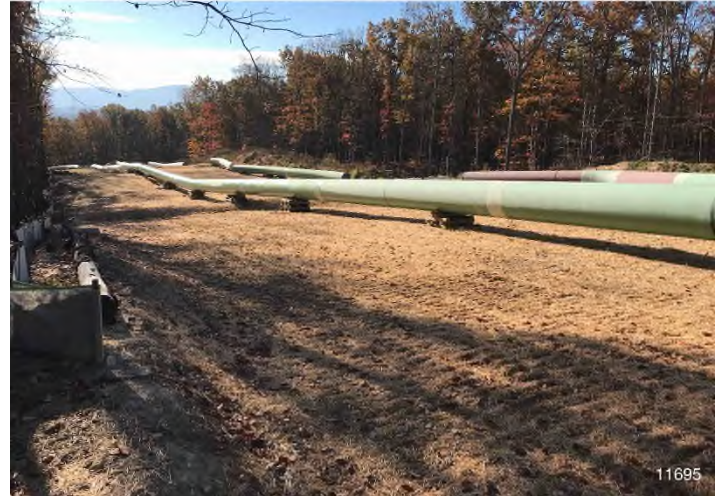
11695

Figure 2: STA 11695+00 – Controls in place and functioning properly. Area stabilized with straw.

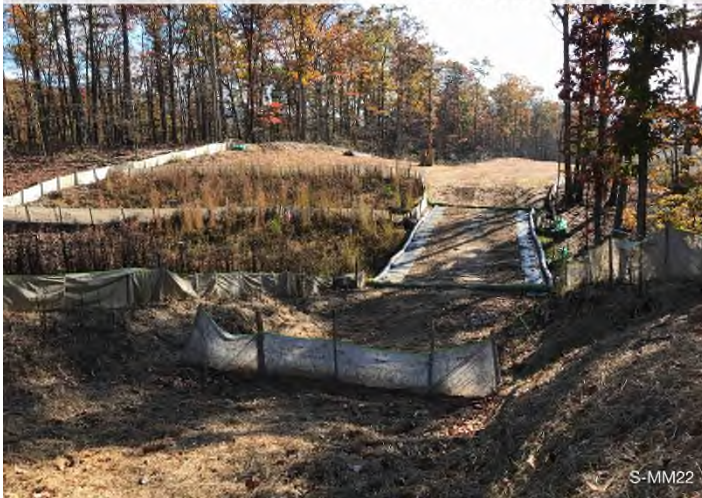
Figure 1: Stream S-MN22 – Controls in place and functioning properly around stream S-MN22 crossing.

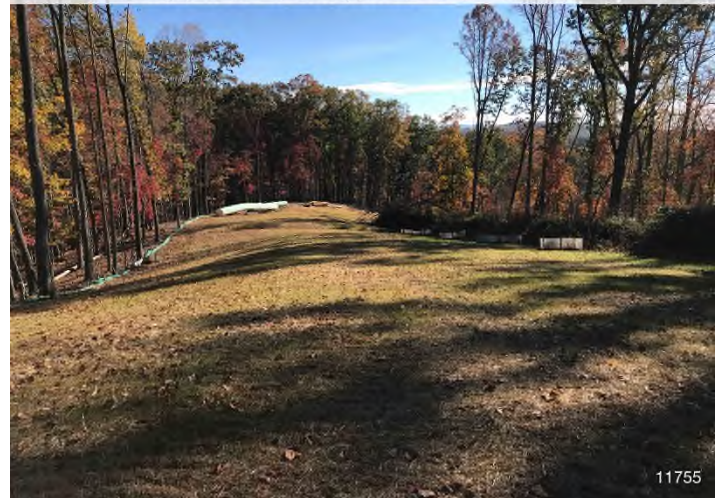
11755

Figure 1: STA 11755+00 – Controls in place and functioning properly.
