## FIELD INSPECTION REPORT

<b>Project Name:</b>	Mountain Valley Pipeline	<b>Inspector:</b>	Marshall Willis
<b>Inspection Date:</b>	Tuesday, December 8, 2020	<b>Project Contact:</b>	Brian Clauto, Cory Chalmers
<b>Spread G: Giles County</b>	STA 10929+38 – 11023+80 ATWS 1145/1146/974/467/1331 MVP-GI-244	<b>Weather:</b>	Dry

# FIELD INSPECTION PHOTO LOG

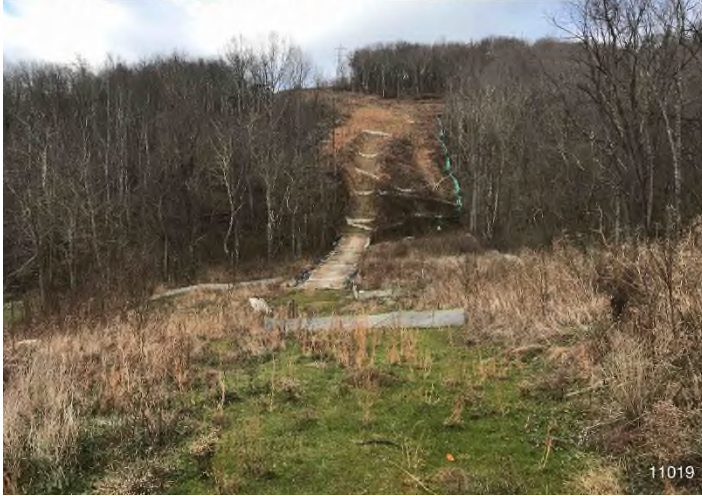
**Figure 1: STA 11019+00** – Controls in place functioning properly.

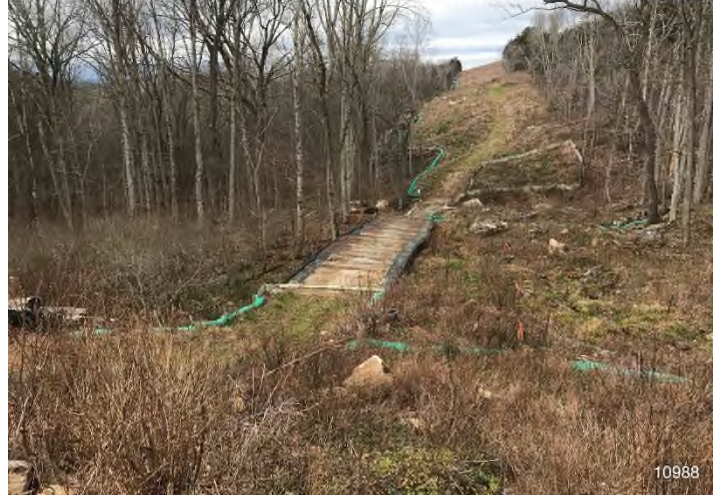
**Figure 2: STA 10988+00** – Controls in place functioning properly.

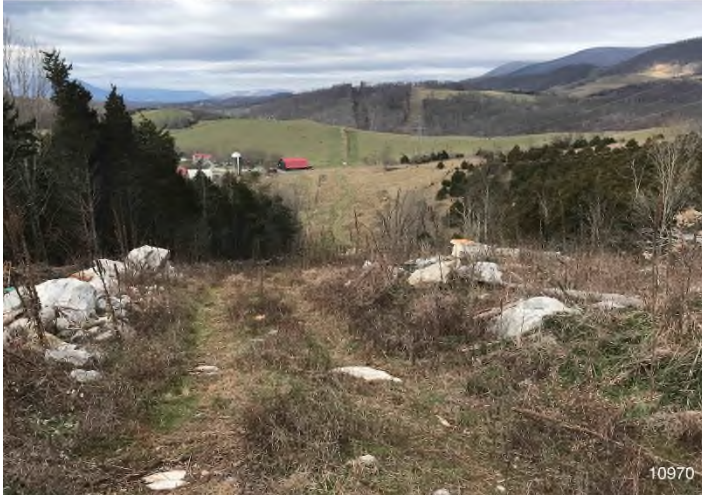
**Figure 3: STA 10970+00** – Controls in place functioning properly.

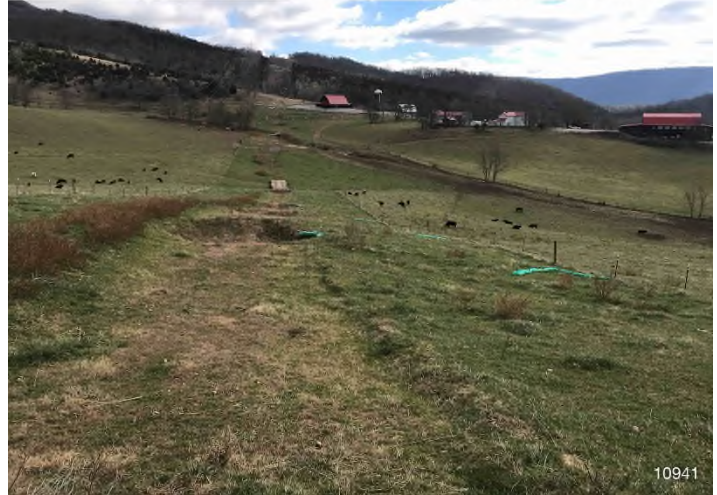
**Figure 4: STA 10941+00** – Controls in place functioning properly.
