# FIELD INSPECTION REPORT

| <b>Project Name:</b> | Mountain Valley Pipeline | <b>Inspector:</b> | Matthew Grant |
| <b>Inspection Date:</b> | Tuesday, December 8, 2020 | <b>Project Contact:</b> | Brian Clauto |
| <b>Spread G:<br/>Giles</b> | ST10990-10929+70<br>ATWS 467, 1137 | <b>Weather:</b> | Dry |

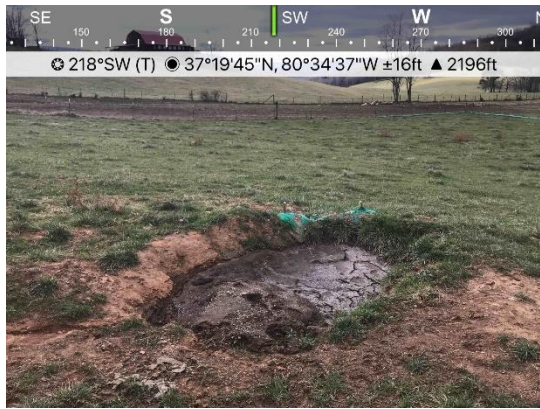
- ST 10947+00 bridge underlay fabric requires repair
- ST 10947+50 sump requires CFS repair
- ST 10948+50 sump requires sediment removal and CFS repair

Figure 1: St 10948+50 sump requires sediment removal and CFS repair.

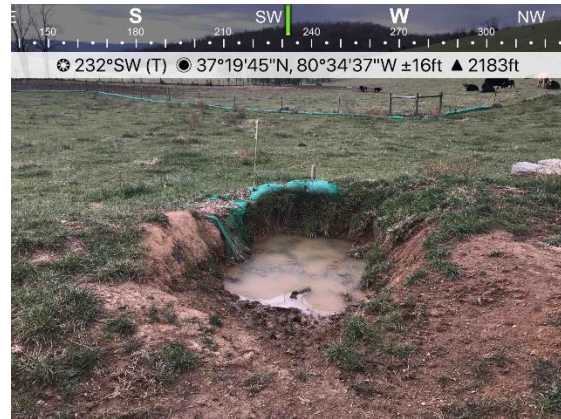
Figure 2: St 10947+50 sump requires CFS repair.

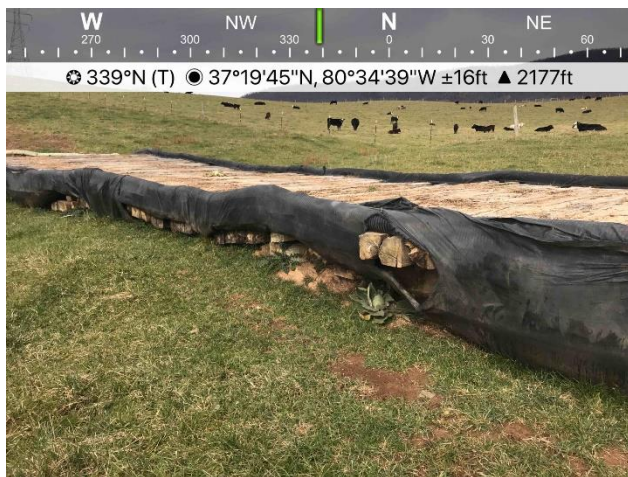
Figure 3: St 10947+00 bridge underlay fabric requires repair.

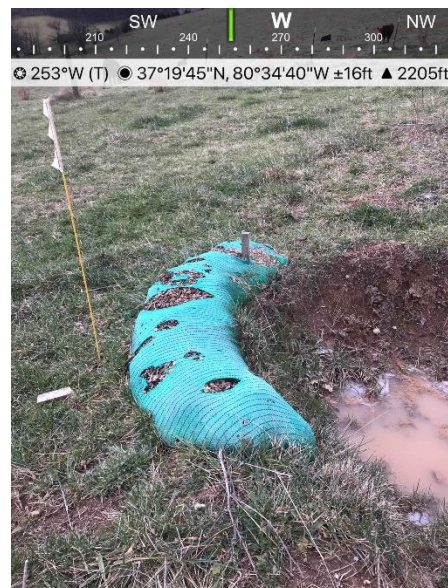
- ST10946+00 sump requires CFS repair
- ST 10942+22 sump requires CFS repair
- ST 10941+00 sump requires CFS repair

Figure 4: St 10946/10946+00 sump requires CFS repair.

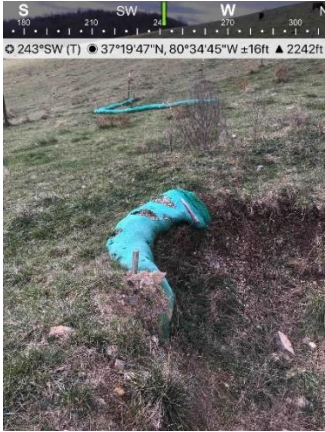
**Figure 5:** St 10942+22 sump requires CFS repair.

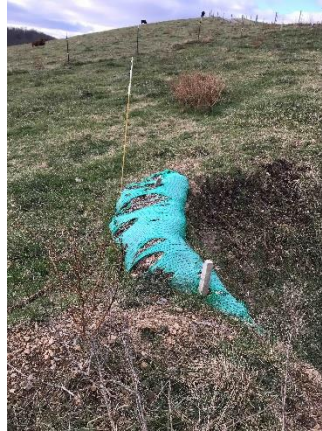
**Figure 6:** St 10941+00 sump requires CFS repair.

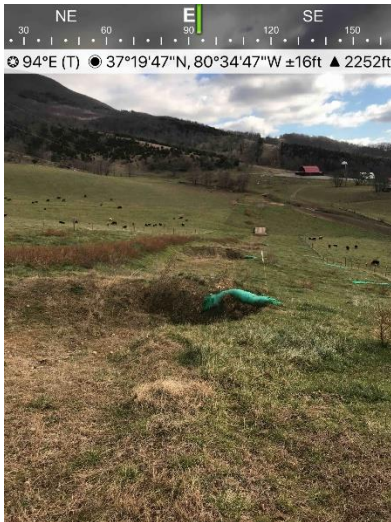
**Figure 7:** Looking from St 10941+20 toward 10948+50, area is stabilized.

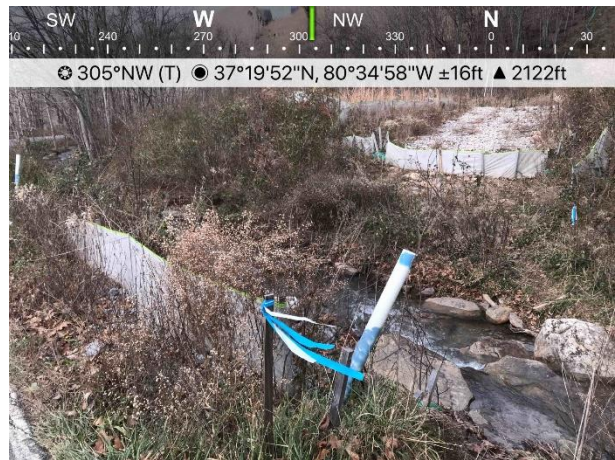
- Comments: Inspected the following resources: S-Y2, S-E24, S-E25
- ECD's were in place and functioning at the designated crossings.

**Figure 8:** Designated crossing S-Y2. ECD's are in place.
