FIELD INSPECTION REPORT

| Project Name: | Mountain Valley Pipeline | Inspector: | Marshall Willis |
| Spread G: Montgomery County | STA 11788+43 – 11900+00 MVP-MN-266.03 | Weather: | Dry |

FIELD INSPECTION PHOTO LOG

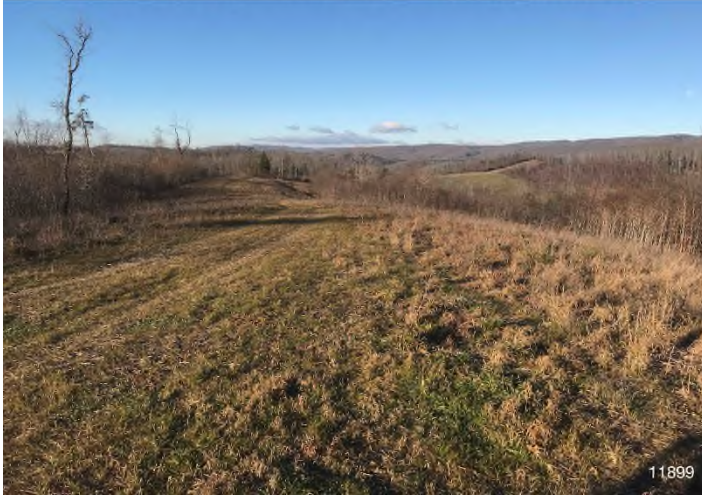
Figure 1: STA 11899+00 – Controls in place functioning properly.

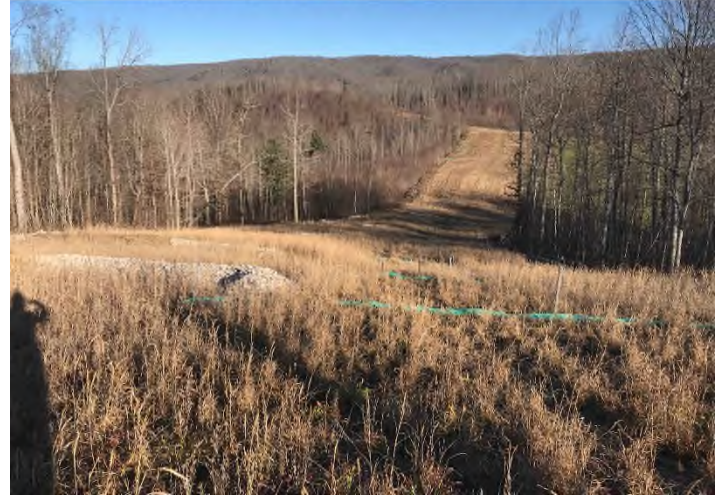
Figure 2: STA 11856+00 – Controls in place functioning properly.

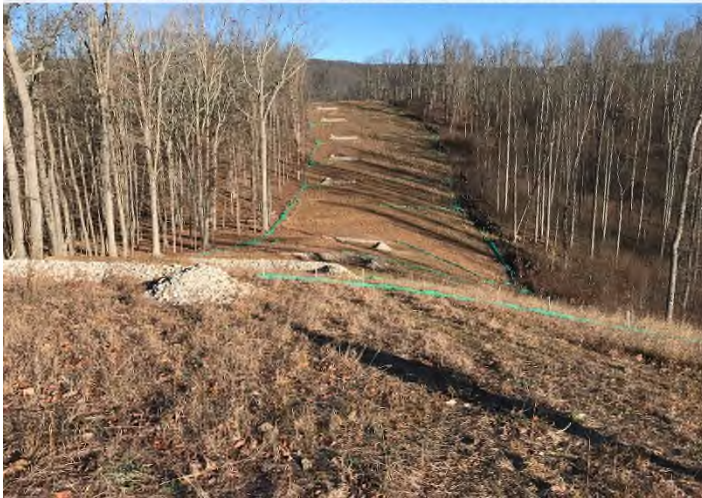
Figure 3: STA 11835+00 – Controls in place functioning properly.

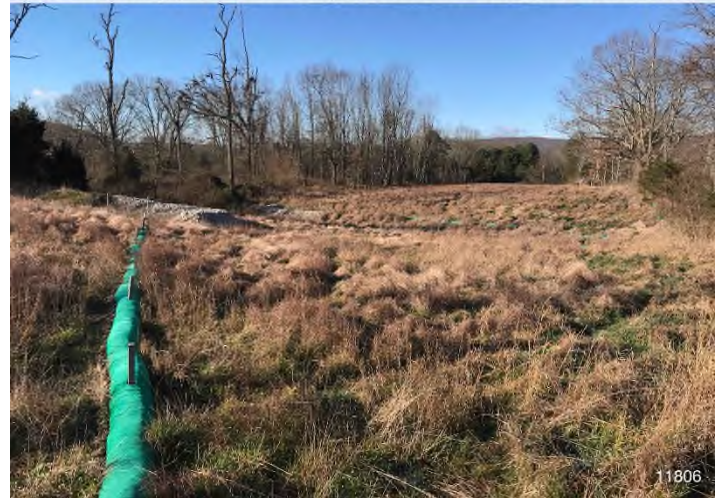
Figure 4: STA 11806+00 – Controls in place functioning properly.
