# FIELD INSPECTION REPORT

<b>Project Name:</b>	Mountain Valley Pipeline	<b>Inspector:</b>	Matthew Grant
<b>Inspection Date:</b>	Wednesday, February 24, 2021	<b>Project Contact:</b>	Brian Clauto
<b>Spread G: Giles</b>	ST11470-11353+94 AR-GI 256	<b>Weather:</b>	Dry

# FIELD INSPECTION PHOTO LOG

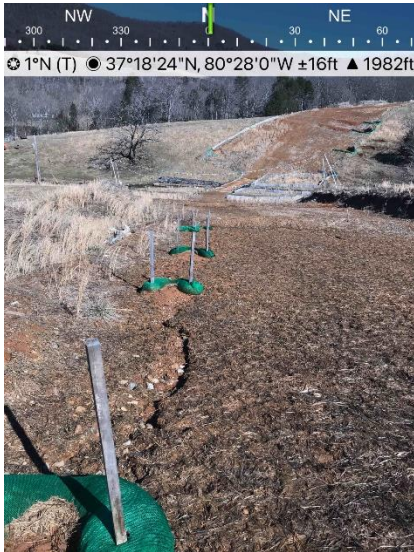
- St11426 sump is at clean out level and requires maintenance
- St11358 multiple CFS's require cleanout and rill repair

**Figure 1:** Near St11358 multiple CFS and rill erosion require repair.

**Recommended Corrective Action:** Maintain and install all controls per the approved PSS&S.

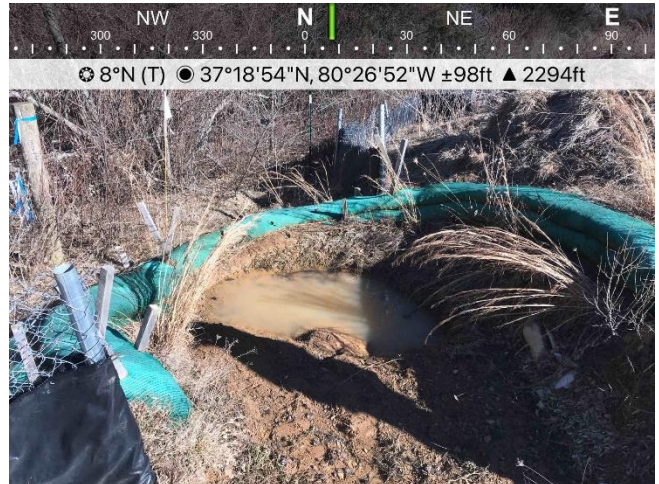
**Figure 2:** St11426 sump is at clean out level and requires maintenance.

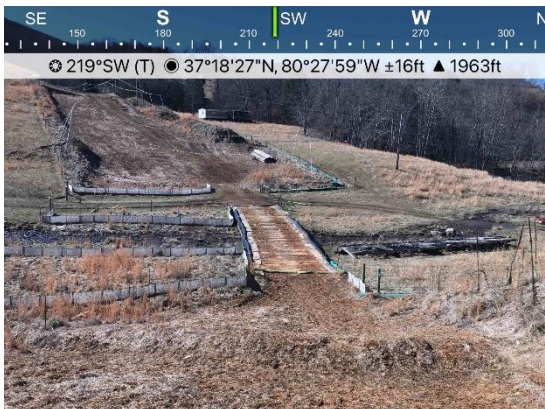
- Comments: Inspected the following resources: S-0013, S-0014, S-KL43
- ECD's were in place and functioning at the designated crossings.

**Figure 3:** Designated stream S-KL43, ECD's are in place.

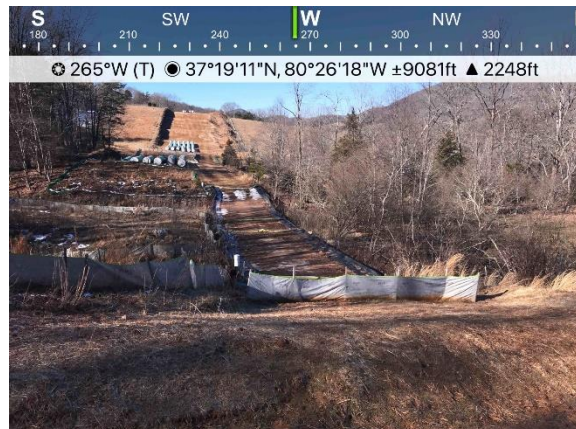
**Figure 4:** Designated stream S-0013, ECD's are in place.
