## FIELD INSPECTION REPORT

<b>Project Name:</b>	Mountain Valley Pipeline	<b>Inspector:</b>	Marshall Willis
<b>Inspection Date:</b>	Tuesday, January 5, 2021	<b>Project Contact:</b>	Brian Clauto, Cory Chalmers
<b>Spread G: Giles County Montgomery County</b>	STA 11216+00 – 11246+69 STA 11596+94 – 11620+00 MVP-MN-258.03/.04/.05	<b>Weather:</b>	Wet

## FIELD INSPECTION PHOTO LOG

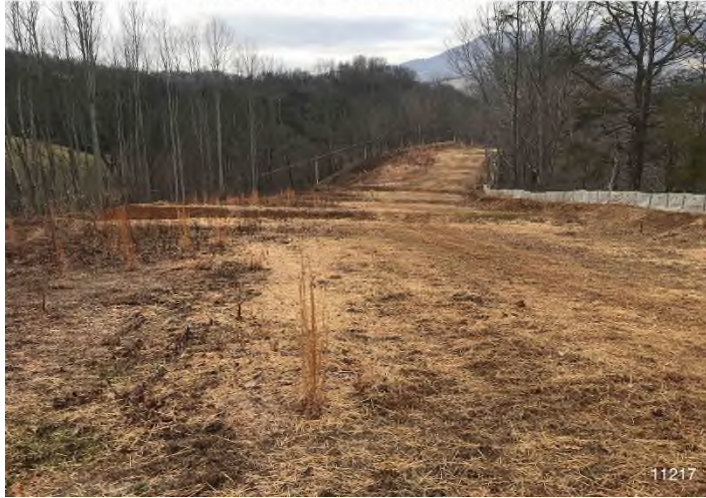
11217

**Figure 1: STA 11217+00** – Controls in place functioning properly. Area stabilized with straw.

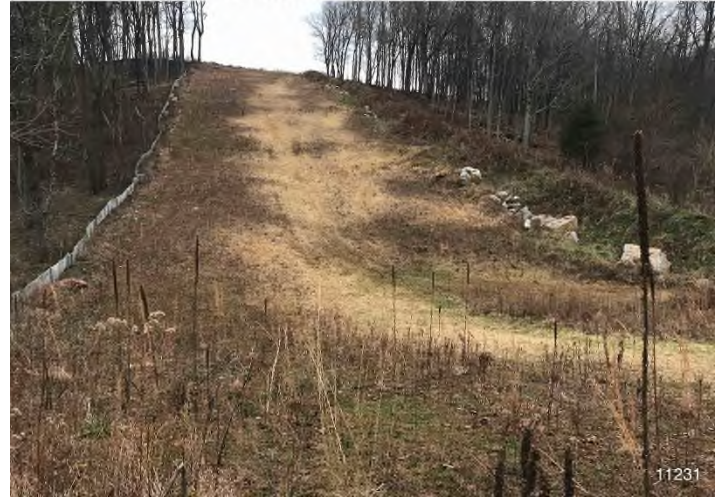
11231

**Figure 2: STA 11231+00** – Controls in place functioning properly. Area stabilized with straw.

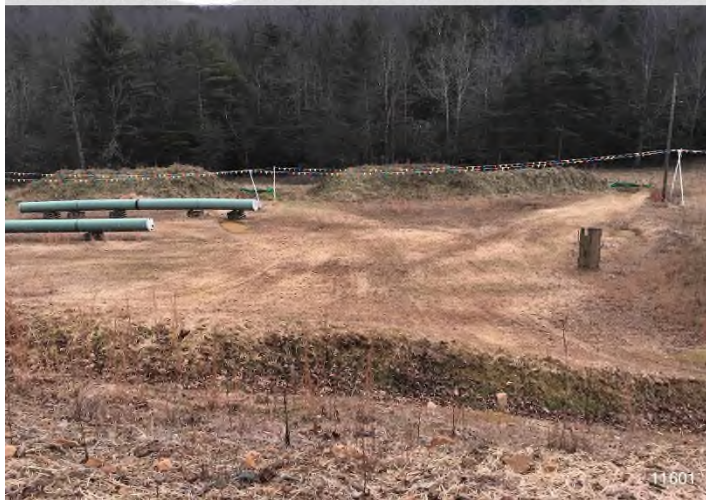
11601

**Figure 3: STA 11601+00** – Controls in place functioning properly. Area stabilized with straw.

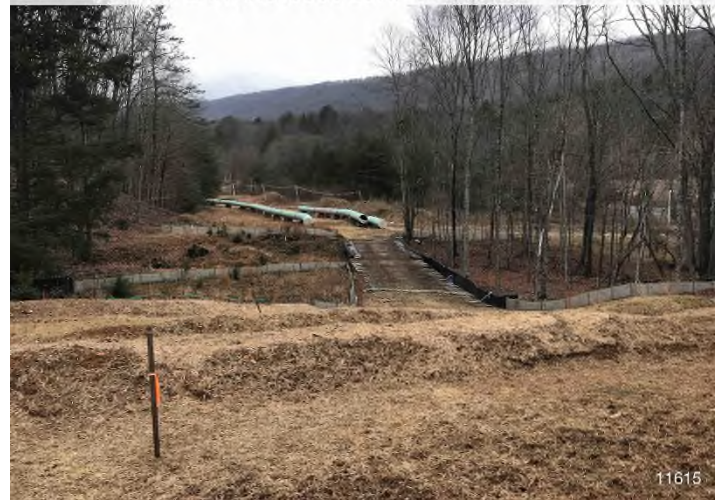
11615

**Figure 4: STA 11615+00** – Controls in place functioning properly. Area stabilized with straw.
