FIELD INSPECTION REPORT

Project Name:	Mountain Valley Pipeline	Inspector:	Marshall Willis
Inspection Date:	Wednesday, February 24, 2021	Project Contact:	Brian Clauto, Cory Chalmers
Spread G: Giles County Craig County	MVP-GI-256 STA 11353+21 – 11525+00 MVP-CR-258.01/258.02	Weather:	Dry

FIELD INSPECTION PHOTO LOG

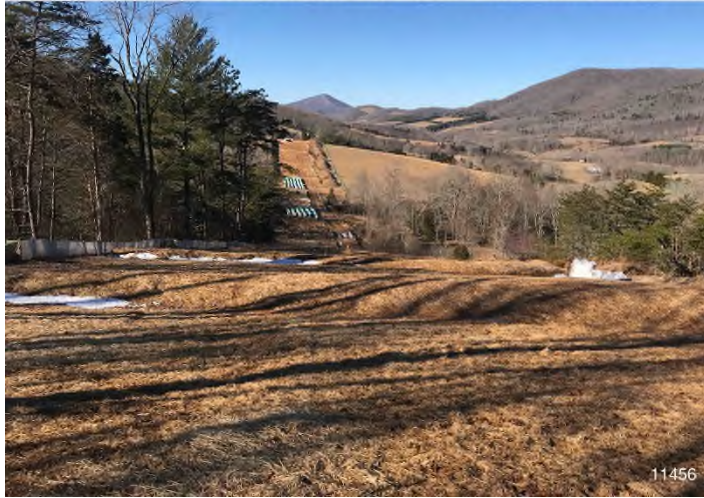
Figure 1: STA 11456+00 – Controls in place and functioning properly. Area stabilized with straw.

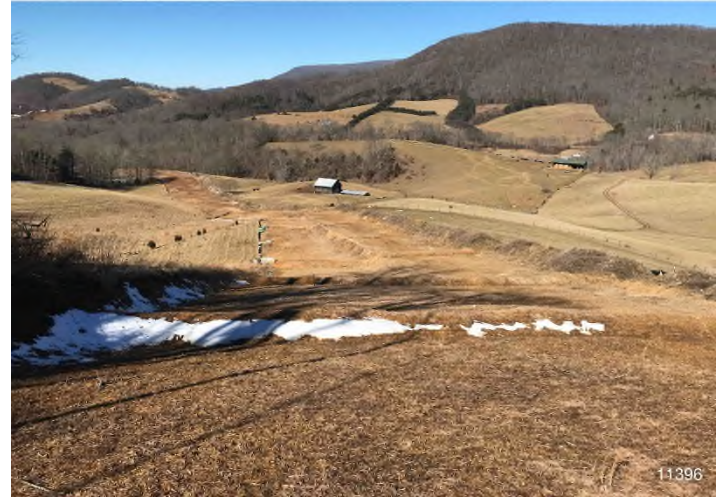
Figure 2: STA 11396+00 – Controls in place and functioning properly. Area stabilized with straw.

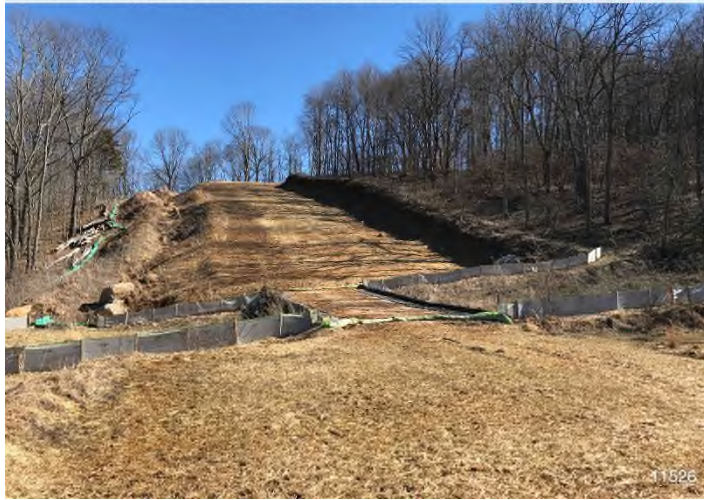
Figure 3: STA 11526+00 – Controls in place and functioning properly. Area stabilized with straw.

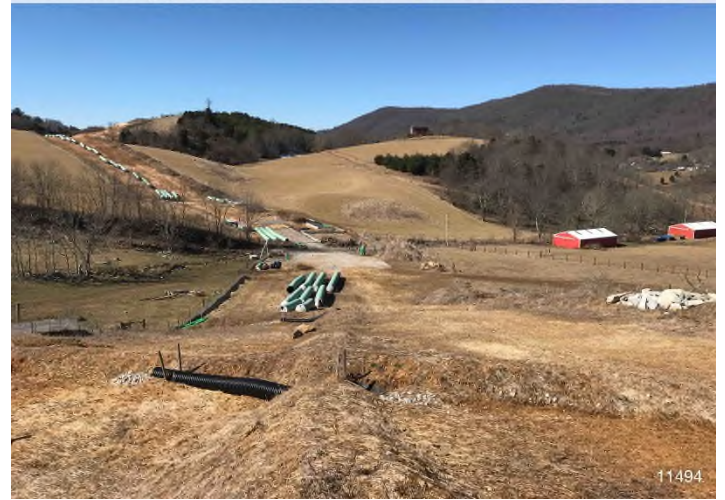
Figure 4: STA 11494+00 – Controls in place and functioning properly. Area stabilized with straw.
