## FIELD INSPECTION REPORT

<b>Project Name:</b>	Mountain Valley Pipeline	<b>Inspector:</b>	Marshall Willis
<b>Inspection Date:</b>	Friday, February 5, 2021	<b>Project Contact:</b>	Brian Clauto, Cory Chalmers
<b>Spread G: Giles County</b>	Laydown Yard 026 Laydown Yard 028 Laydown Yard 029	<b>Weather:</b>	Snow

## FIELD INSPECTION PHOTO LOG

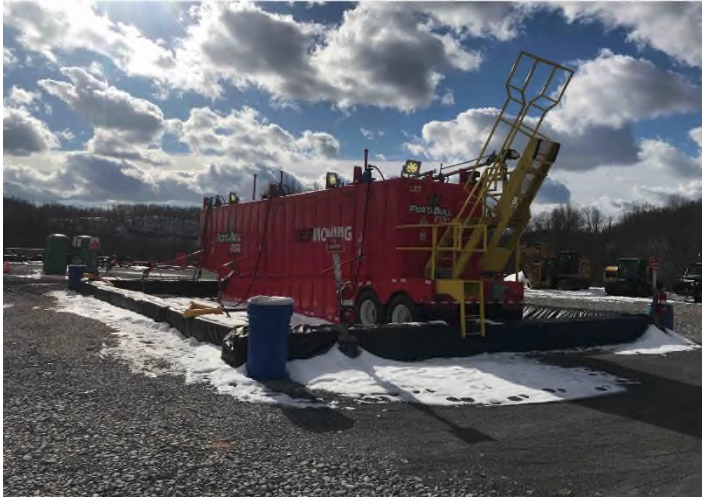
**Figure 1: Laydown Yard 026** – Controls in place and functioning properly around fueling station.

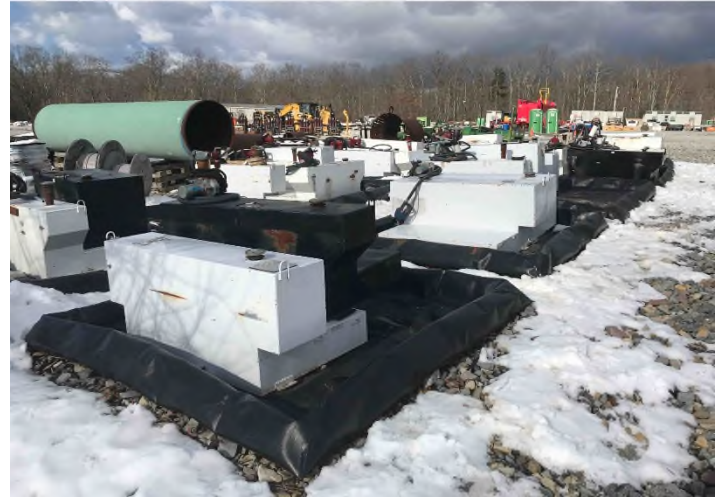
**Figure 2: Laydown Yard 026** – Secondary containment in place and functioning properly.

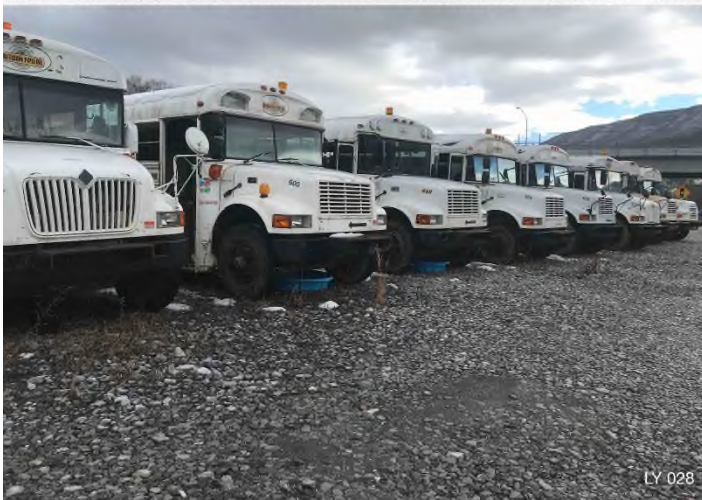
**Figure 3: Laydown Yard 028** – Controls in place and functioning properly.

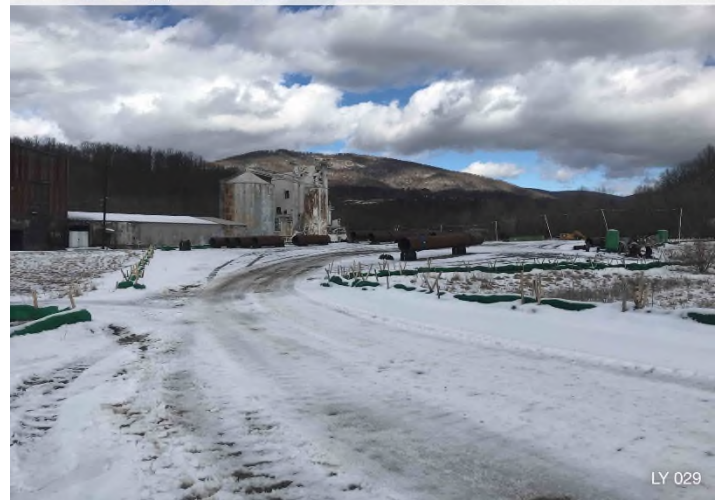
**Figure 4: Laydown Yard 029** – Controls in place and functioning properly.
