## FIELD INSPECTION REPORT

<b>Project Name:</b>	Mountain Valley Pipeline	<b>Inspector:</b>	Matthew Grant
<b>Inspection Date:</b>	Wednesday, July 8, 2020	<b>Project Contact:</b>	Brian Clauto
<b>Spread G: Giles Montgomery</b>	AR GI-234 AR GI 241.01 MP 202 MP 205-206 ATWS 1333, 1332, 1360	<b>Weather:</b>	Dry

## FIELD INSPECTION PHOTO LOG

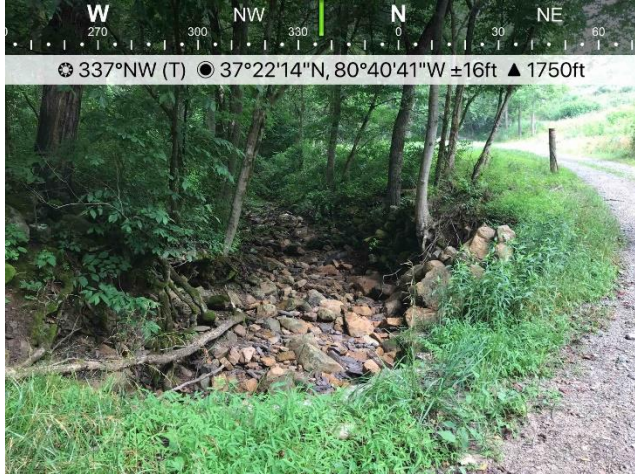
Figure 1: Designated stream S-Q14 along GI 234.

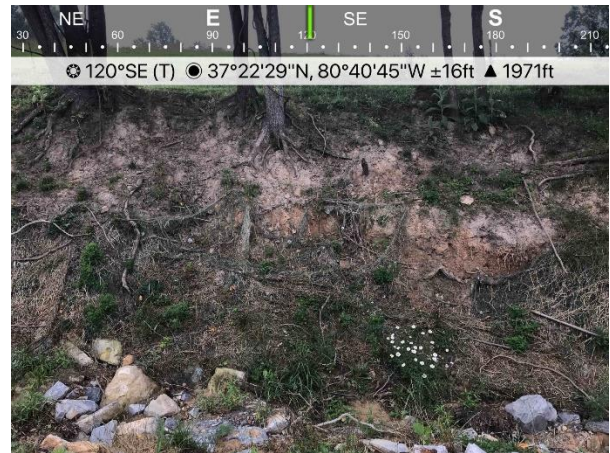
- Ditch line of GI-234 requires repair of matting.

Figure 2: On access rd. GI-234, the ditch line blanket matting requires repair.

**Recommended Corrective Action:** Maintain and install all controls per the approved PSS&S.

**Deadline:** Within 72-Hour of Notification

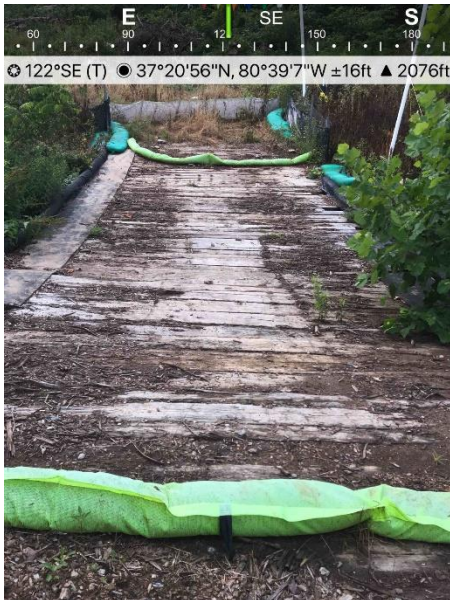
Figure 3: Designated crossing S-G32, ECDs are in place and functioning.

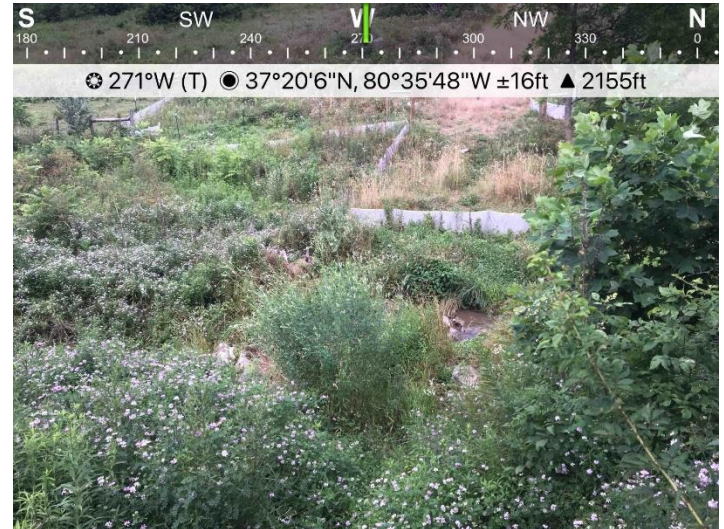
Figure 4: Designated stream S-A32, ECDs are in place and functioning.
