COMPLAINT INVESTIGATION REPORT

Project Name:	Mountain Valley Pipeline	Inspector:	Matthew Grant
Inspection Date:	Wednesday, July 8, 2020	Project Contact:	Brian Clauto
Spread G: Giles County	AR MN-278.01 MP 237.4-237.2	Weather:	Dry

FIELD INSPECTION PHOTO LOG

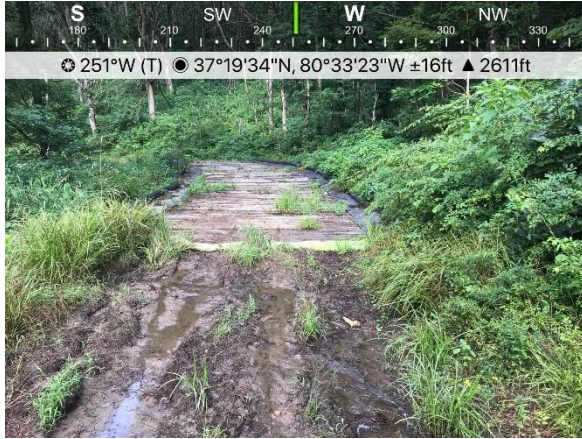
1. At the time of inspection, there was no evidence of a crushed culvert pipe under the steel plate.
2. At the time of the inspection, a section of the access road was flowing with water toward S-RR4.
3. ECDs within the MVP access road and the LOD were installed per the approved plans and appeared to be functioning as designed.
4. At this time access road GI 243.01 is not being used by heavy machinery and the use is limited for passenger vehicles and trucks

Figure 5: Near designated stream S-RR04, flowing water was evident on the access road.

- Conduct additional delineation near S-RR04.

Recommended Corrective Action: Conduct an additional delineation on access rd GI 243.01 specifically near S-RR04 where active water flow is evident and wetland plants were observed. No additional vehicles should be driven over this section until delineation is completed and if needed additional controls are installed.
