## FIELD INSPECTION REPORT

<b>Project Name:</b>	Mountain Valley Pipeline	<b>Inspector:</b>	Marshall Willis
<b>Inspection Date:</b>	Wednesday, June 24, 2020	<b>Project Contact:</b>	Brian Clauto, Cory Chalmers
<b>Spread G: Giles County</b>	STA 11064+53 – 11151+27 MVP-GI-245.01/249 ATWS 1366/1367/1465	<b>Weather:</b>	Dry

## FIELD INSPECTION PHOTO LOG

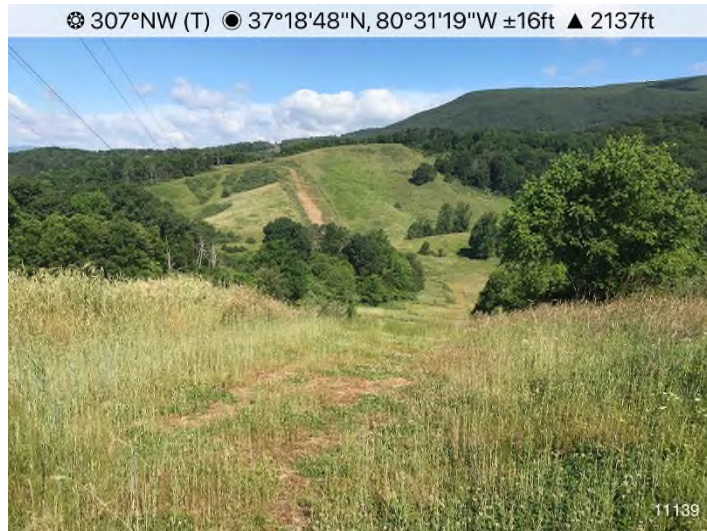
**Figure 1: STA 11139+00** – Controls in place and functioning properly. Area stabilized with straw.

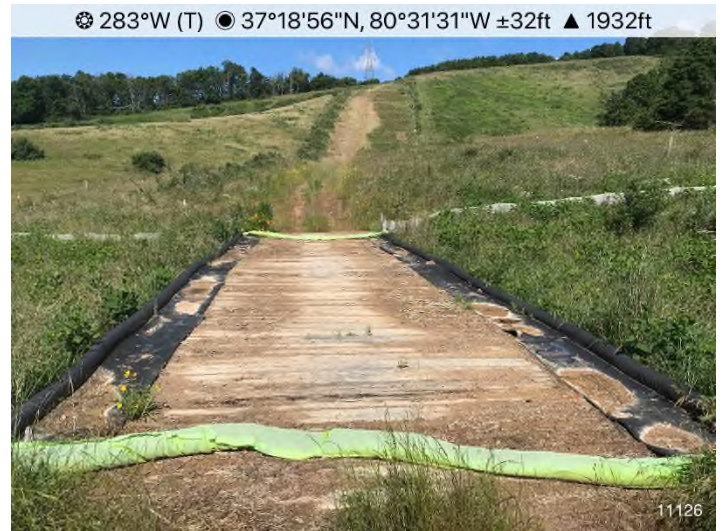
**Figure 2: STA 11126+00** – Controls in place and functioning properly. Area stabilized.

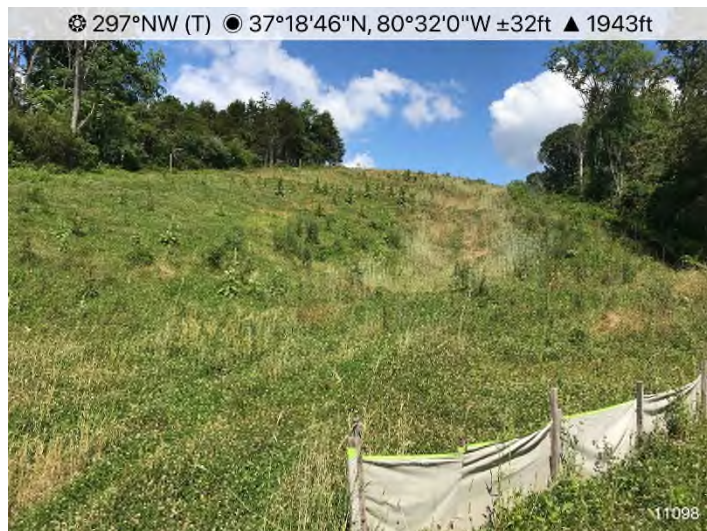
**Figure 3: STA 11098+00** – Controls in place and functioning properly. Area stabilized.

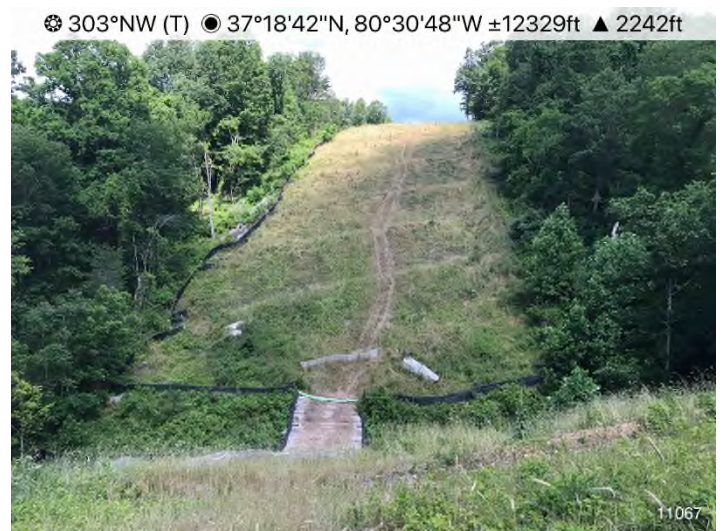
**Figure 4: STA 11067+00** – Controls in place and functioning properly. Area stabilized.
