FIELD INSPECTION REPORT

Project Name:	Mountain Valley Pipeline	Inspector:	Marshall Willis
Inspection Date:	Thursday, July 23, 2020	Project Contact:	Brian Clauto, Cory Chalmers
Spread G: Giles County	Laydown Yard 029 MVP-GI-238/241.01/241.04 ATWS 339A/340/1390/1391	Weather:	Rainy

FIELD INSPECTION PHOTO LOG

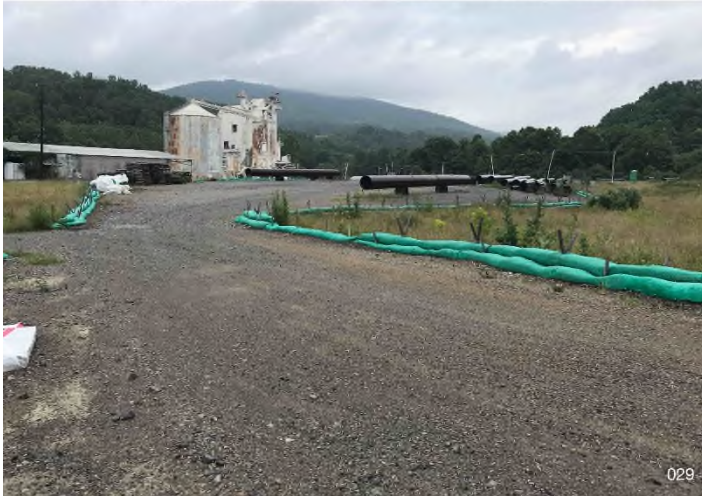
Figure 1: LY 029 – Controls in place and functioning properly.

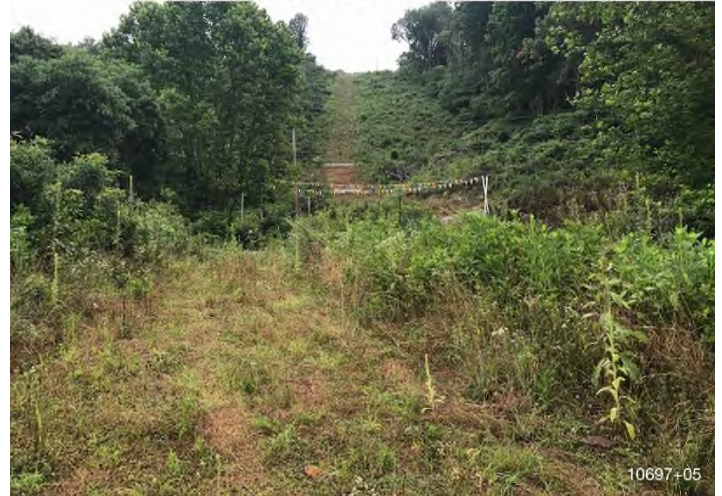
10697+05

Figure 2: STA 10697+00 – Controls in place and functioning properly.

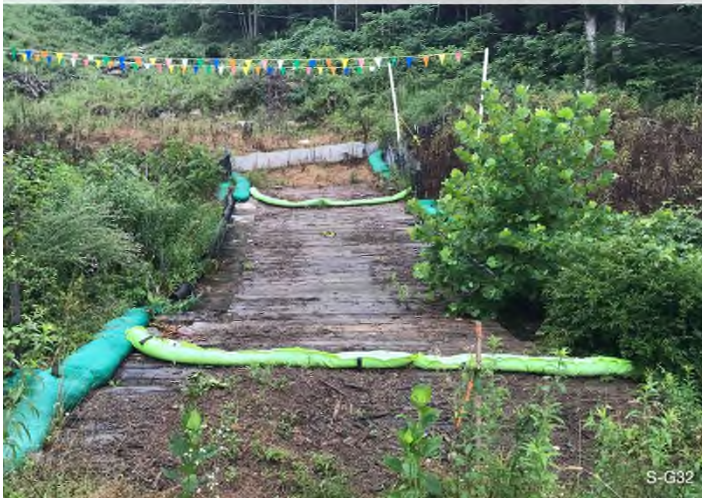
Figure 3: Stream S-G32 – Controls in place and functioning properly around S-G32 stream crossing.

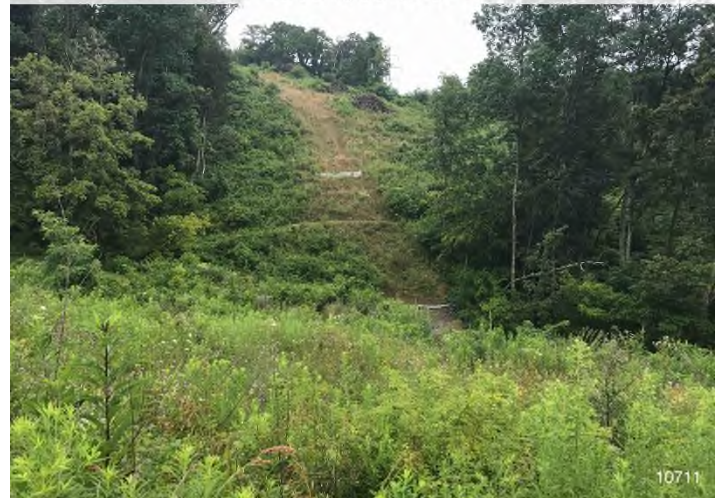
10711

Figure 4: STA 10711+00 – Controls in place and functioning properly.
