FIELD INSPECTION REPORT

| Project Name: | Mountain Valley Pipeline | Inspector: | Marshall Willis |
| Spread G: Giles County | STA 11353+67 – 11471+52 MVP-GI-256 MVP-CR-258.01 | Weather: | Dry |

FIELD INSPECTION PHOTO LOG

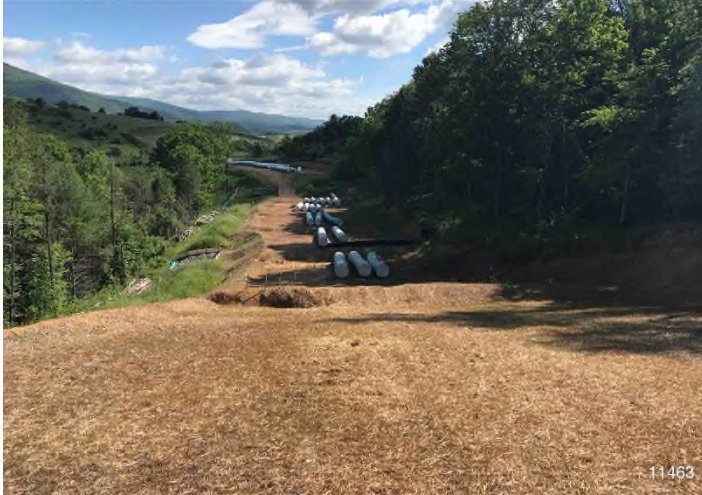
Figure 1: STA 11463+00 – Controls in place and functioning properly. Area stabilized with straw.

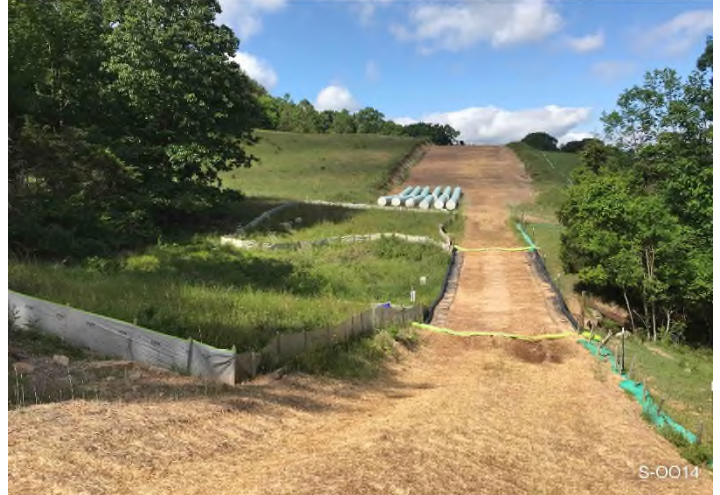
Figure 2: Stream S-0014 – Controls in place and functioning properly. Area stabilized with straw.

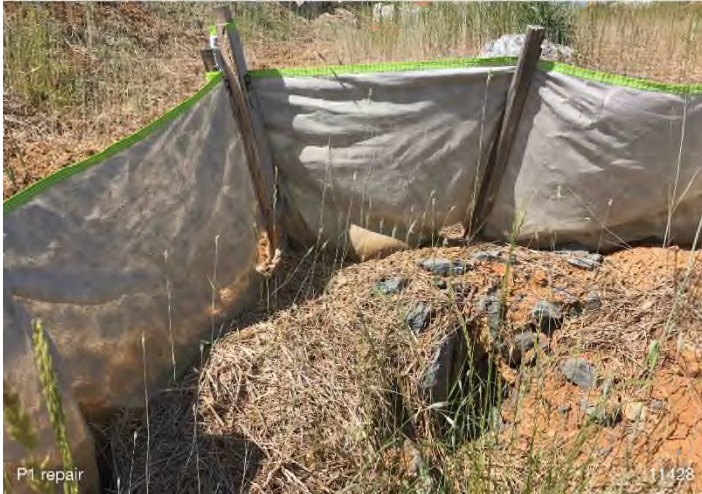
- STA 11428+00: P1 repair needed.

Figure 3: STA 11428+00 – P1 repair needed.

Recommended Corrective Action: Maintain and install all controls per the approved PSS&S.

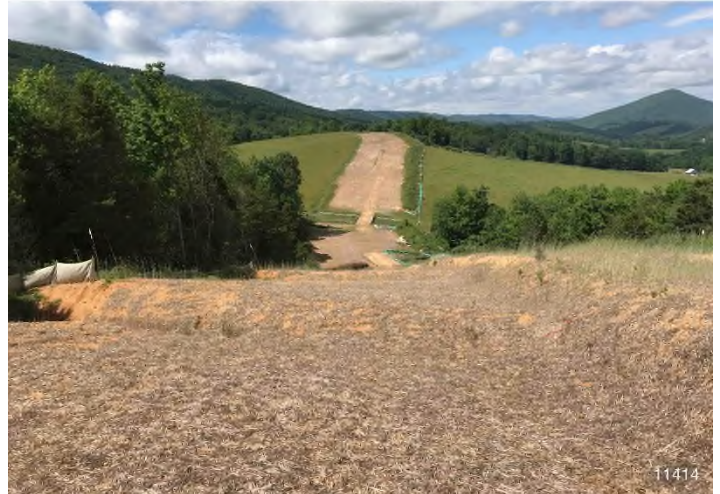
Figure 4: STA 11414+00 – Controls in place and functioning properly. Area stabilized with straw.
