FIELD INSPECTION

Project Name:	Mountain Valley Pipeline	Inspector:	Marshall Willis
Inspection Date:	Monday, January 6, 2020	Project Contact:	Brian Clauto, Cory Chalmers
Spread G: Montgomery County Giles County	STA 11596+94 - 11618+91 STA 11204+61 - 11246+69 MVP-MN-258.03/258.04/MLV-AR-25 ATWS 1373/1057/1370/1370A/1347	Weather (Wet/Dry/Rain):	Dry

Project Name: Mountain Valley Pipeline

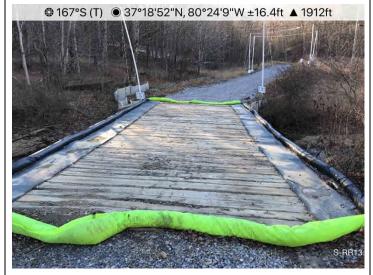
Fig. 1: **Stream S-RR13** – Controls in place and functioning properly.

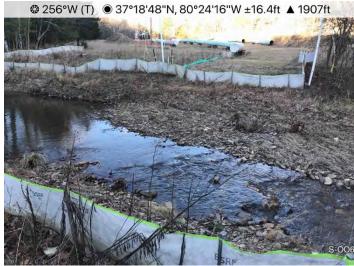
Fig. 2: **Stream S-OO6** – Controls in place and functioning properly.

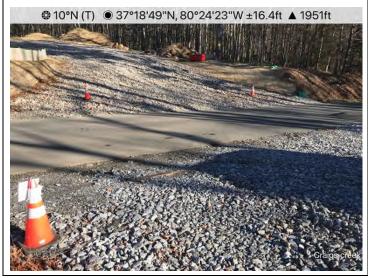
Fig. 3: **STA 11600+00** – Craig's Creek Road crossing controls in place and functioning properly.

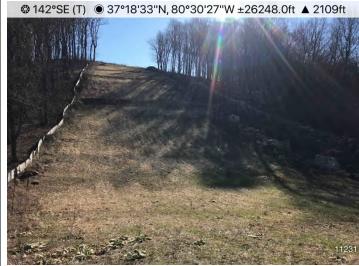
Fig. 4: **STA 11231+00** – Controls in place and functioning properly. Area stabilized with straw and vegetation.
