Field Inspection

Project Name:	Mountain Valley Pipeline	Inspector:	Matthew Grant
Inspection Date:	Wednesday, January 22, 2020	Project Contact:	Brian Clauto
Spread: Giles Co. AR GI 234 AR GI 241.01 AR GI 256.02 ATWS1331,1333,1332 ,1360 MP 202.4, 205.9, 206.7-207.3, 214.2- 214.8	Spread G	Weather (Wet/Dry/Rain):	Dry
STAGE OF CONSTRUCT	ION: (Check all that apply)		
Clearing	Rough Grading	Trench Excavation	Pipe Assembly, Testing & Installation
Backfilling and Grade Restoration Final Grading & Stabilization			Other: Dormant

FIELD INSPECTION PHOTO LOG

Project Name: Mountain Valley Pipeline Date: Wednesday, January 22, 2020

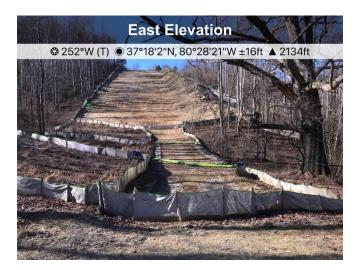
Fig. 3 At designated crossing S-NN12, ECD's are in place.

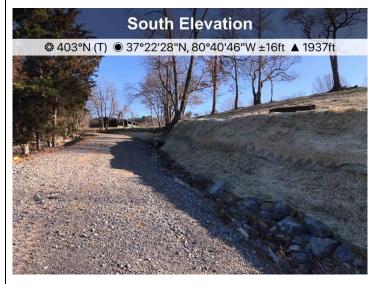
Fig. 4. At AR GI-234, additional matting has been installed.
