FIELD INSPECTION

Project Name:	Mountain Valley Pipeline	Inspector:	Marshall Willis
Inspection Date:	Wednesday, January 15, 2020	Project Contact:	Brian Clauto, Cory Chalmers
Spread G: Montgomery County	STA 11669+00 – 11767+50 MVP-MLV-AR-26	Weather (Wet/Dry/Rain):	Wet

FIELD INSPECTION PHOTO LOG

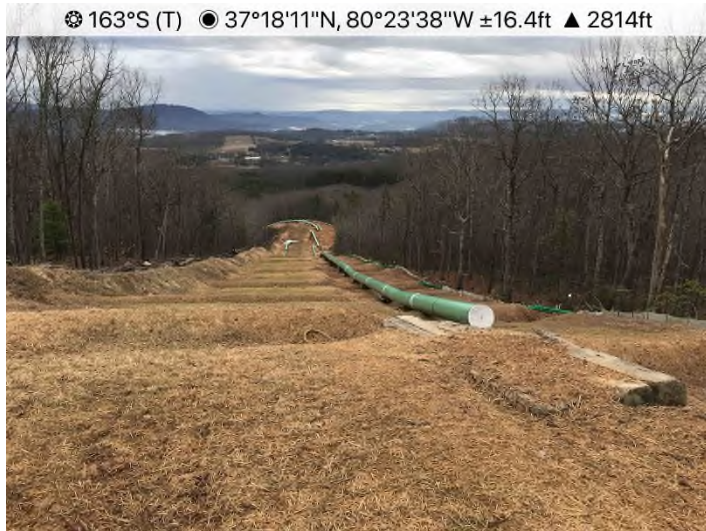
Fig. 1: **STA 11670+00** – Controls in place and functioning properly. Area stabilized with straw.

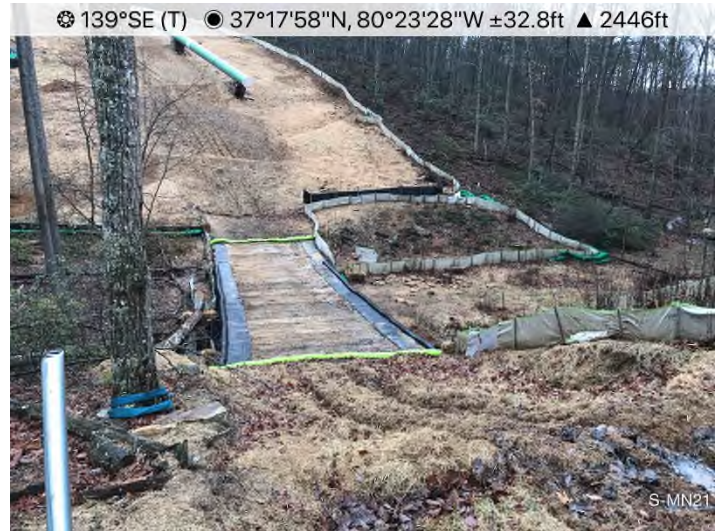
Fig. 2: **Stream S-MN21** – Controls in place and functioning properly.

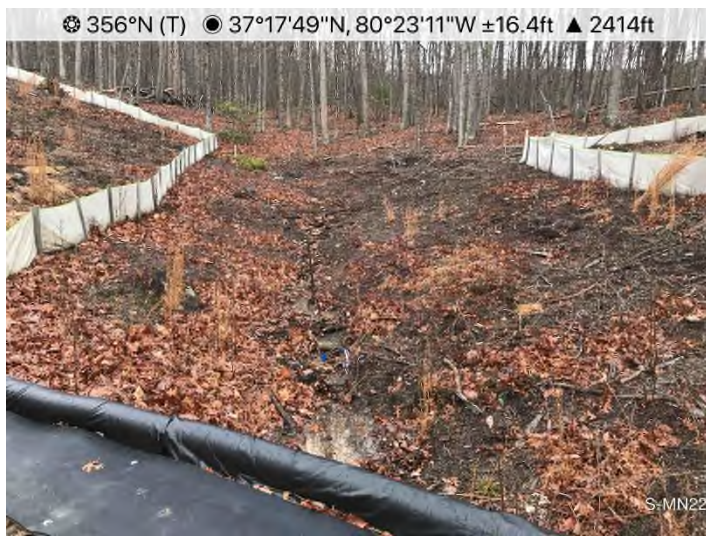
Fig. 3: **Stream S-MN22** – Controls in place and functioning properly.

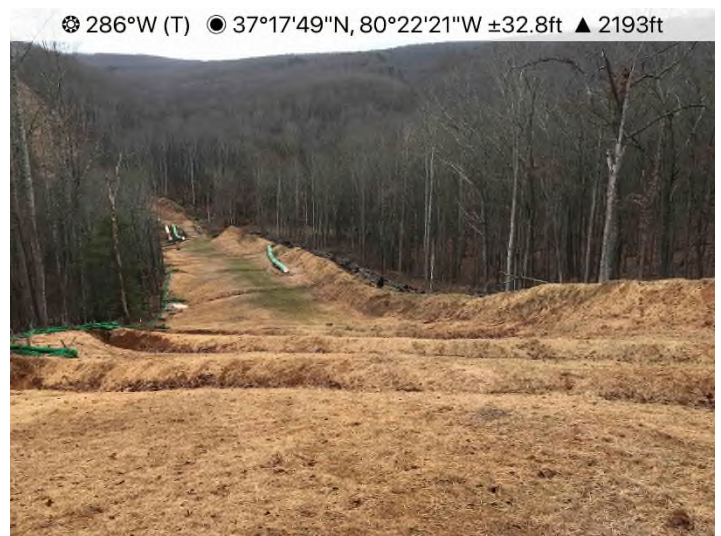
Fig. 4: **STA 11755+00** – Controls in place and functioning properly. Areas stabilized with straw.
