FIELD INSPECTION

Project Name:	Mountain Valley Pipeline	Inspector:	Matthew Grant
Inspection Date:	Wednesday, January 15, 2020	Project Contact:	Brian Clauto
Spread: Montgomery County MP 221- 222.6 AR MLV 26	Spread G	Weather (Wet/Dry/Rain):	Wet
STAGE OF CONSTRUCTION: (Check all that apply)			
Clearing	Rough Grading	Trench Excavation	Pipe Assembly, Testing & Installation
Backfilling and Grade	e Restoration	& Stabilization	Other: <u>Dormant</u>
		Yes No N/A	
Are controls installed and implemented in accordance with the approved □□□ crosion and sediment control plan and stormwater management plans?			
Are all control measures properly maintained in effective operating condition in accordance with good engineering practices and, where applicable, manufacturer specifications?			
3 Areas of offsite sedi	iment deposition were observed?		
Comments: Inspected designated streams and wetlands included: S-MN 21, S-MN 22, S- EF 65, S-EF62, S-IJ 52 ECD's were in place and functioning at the designated crossings. St 11703+79 waterbar end treatment is showing signs of being bypassed Deadline: 24 hrs. from notification St11703+79 silt fence in 2 locations has been undermined Deadline: Routine Mainte

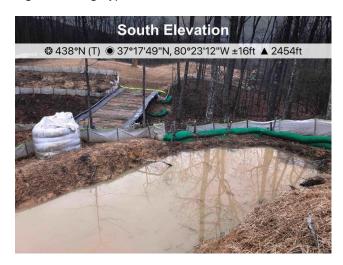
Fig. 1. St11703+79 waterbar end treatment is showing signs of being bypassed

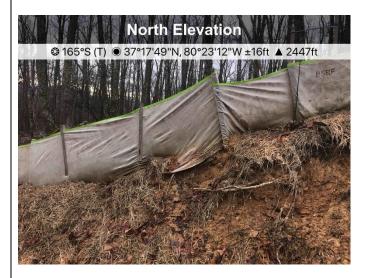
• Fig. 3. St 11703+79 silt fence in has been undermined

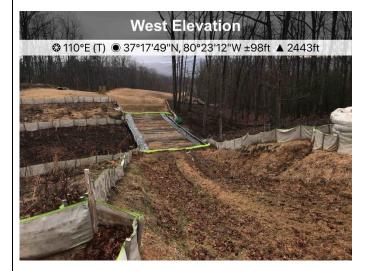
Fig. 4. Designated crossing S-MN22, ECD waddles in place
