Inspection Report

Project Name:	Mountain Valley Pipeline	Inspector:	Matthew Grant
Inspection Date:	Wednesday, January 8, 2020	Project Contact:	Brian Clauto
Spread: Montgomery Co. AR MLV 26 MP 222.7-223.1	Spread G	Weather (Wet/Dry/Rain):	Wet

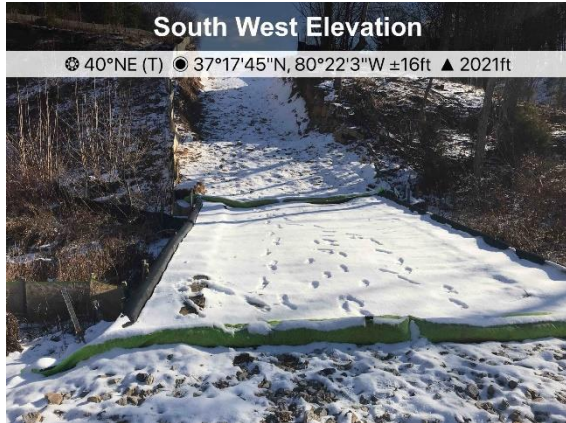
- Fig. 1 Designated stream crossing S-NN11 ECD's in place and functioning.

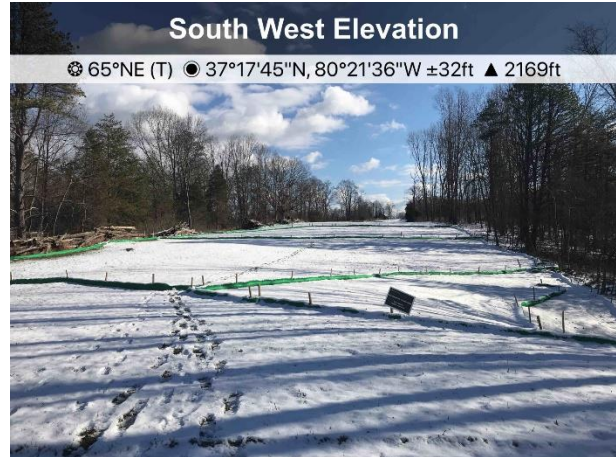
- Fig. 2 Near MP 223.2 ECD's were in place.

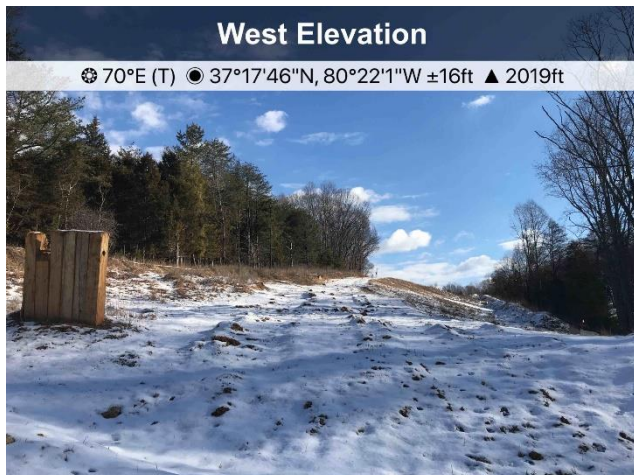
- Fig. 3 Near St 11770+00 area was snow covered, ECD's were in place at the time of the inspection

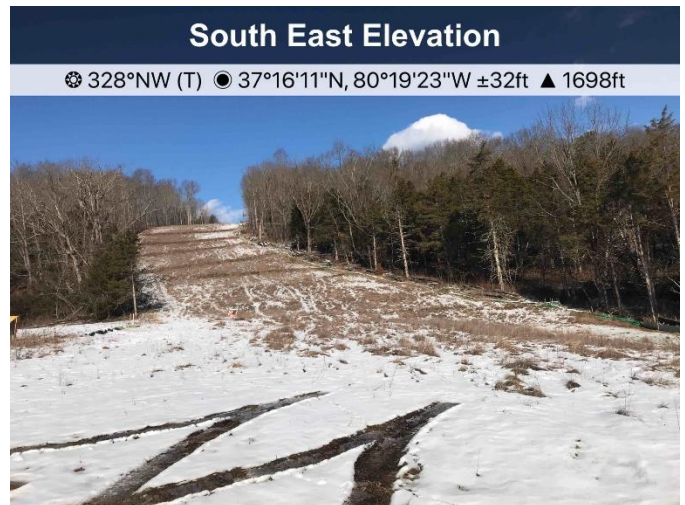
- Fig. 4 Facing MP 222.6 ECD's were in place.
