FIELD INSPECTION REPORT

Project Name:	Mountain Valley Pipeline	Inspector:	Matthew Grant
Inspection Date:	Tuesday, February 4, 2020	Project Contact:	Brian Clauto
Spread G: Craig Giles	AR GI 244 ATWS 1144, 1143, 1146, 1145 MP 208.4- 209.1 AR- 258.02 MP 218.5-218.5 AR-258.03 ATWS 1057, 1373 MP 219.5-219.8	Weather:	Dry
ACTIVE STAGE OF CONSTRUCTION: (Check all that apply)			
☐ Tree Felling	☐ Clearing/Grubbing ☐ Gra	ding	ning Stringing/Welding
☐ Lowering/Backfilling	☐ Final Grading ☐ Ten	np. Stabilization Perm.	Stabilization Dormant
			Yes No N/A
	rols installed and implemented in accorda t control plan and stormwater manageme		and 🖂 🗆
	ontrol measures properly maintained in ef d engineering practices and, where applic

FIELD INSPECTION PHOTO LOG

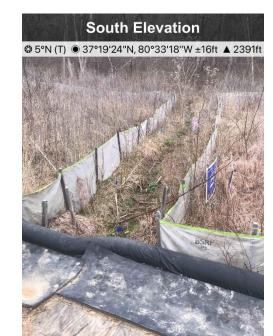
3. Areas of	offsite sediment deposition observed?		
 Comments: Inspected the following resources: S-IJ 8, S-IJ9, S-RR5, S-QQ2, S-RR13, S-RR14, S-006 Routine Maintenance: (72-Hour Deadline from Notification) N/A Ineffective Controls: (24-Hour Deadline from Notification) - On AR 258.02, the ECD waddle required repair on the bridge Recommended Corrective Action: Maintain and install all controls per the approved PSS&S.

Figure 3: At designated crossing S-QQ2 on AR 258.02 the ECD required maintenance.
