## FIELD INSPECTION REPORT

<b>Project Name:</b>	Mountain Valley Pipeline	<b>Inspector:</b>	Marshall Willis
<b>Inspection Date:</b>	Thursday, January 30, 2020	<b>Project Contact:</b>	Brian Clauto, Cory Chalmers
<b>Spread G: Giles County</b>	STA 11236+21 – 11159+86 STA 10929+71 – 10971+74 MVP-GI-249.01/249.02/242.01	<b>Weather:</b>	Dry

## FIELD INSPECTION PHOTO LOG

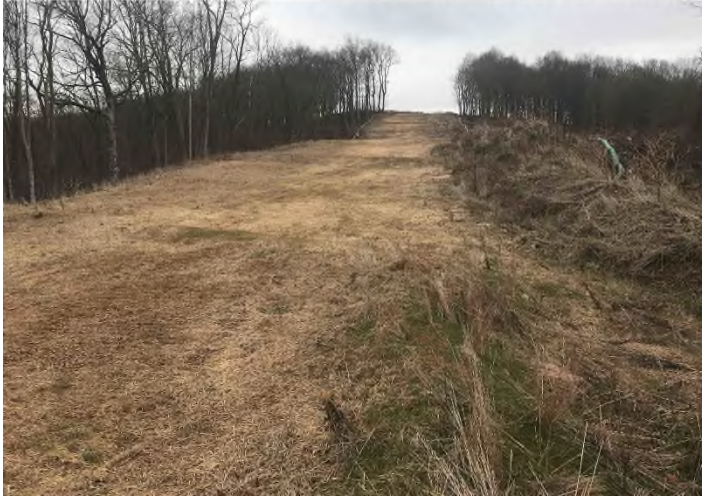
**Figure 1: STA 11227+00** – Controls in place and functioning properly. Area stabilized with straw.

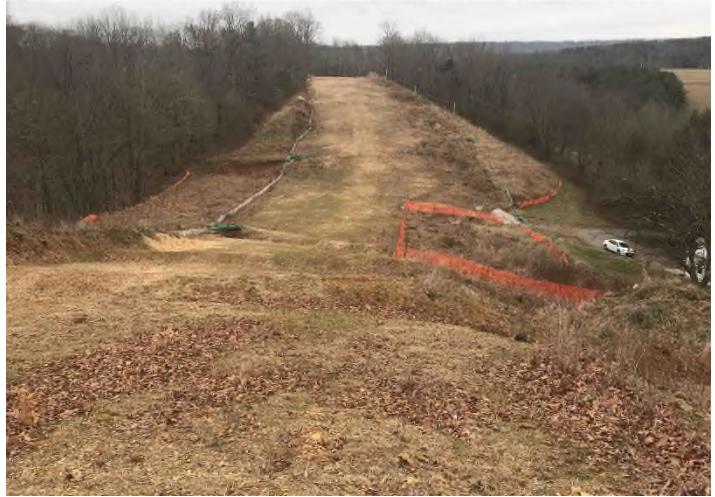
**Figure 2: STA 11203+00** – Controls in place and functioning properly. Area stabilized with straw.

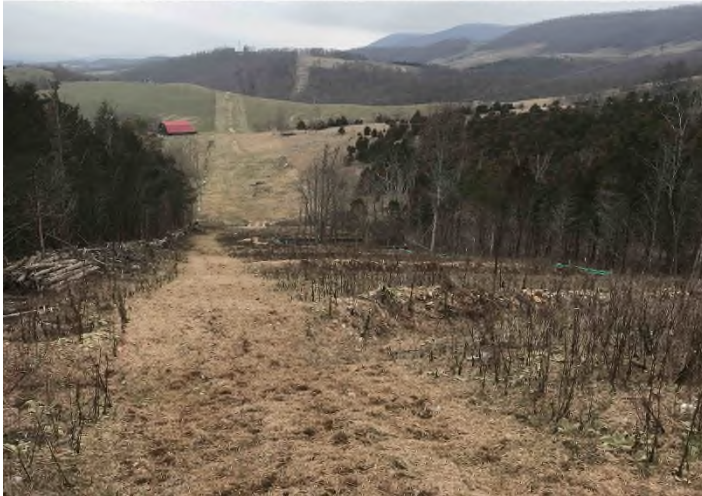
**Figure 3: STA 10970+00** – Controls in place and functioning properly. Area with straw.

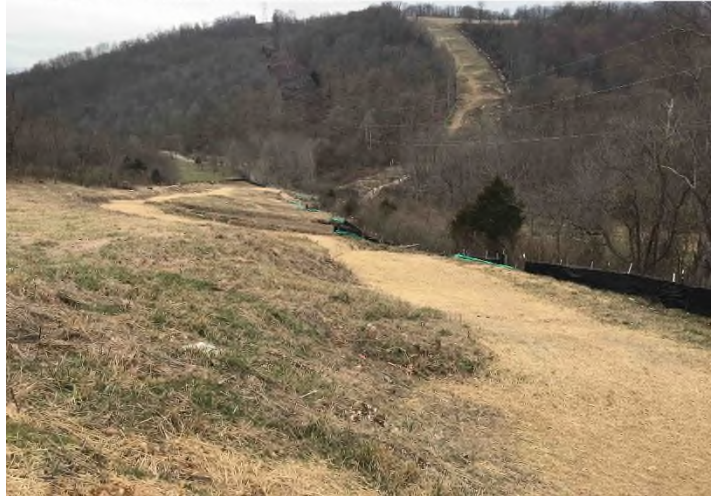
**Figure 4: STA 10932+00** – Controls in place and functioning properly. Area stabilized with straw.
