COMPLAINT INVESTIGATION REPORT

Project Name:	Mountain Valley Pipeline	Inspector:	Marshall Willis
Inspection Date:	Wednesday, March 25, 2020	Project Contact:	Brian Clauto, Cory Chalmers
Spread G: Craig County Giles County	STA 11471+52 – 11353+67 MVP-CR-258.01 MVP-GI-256.02	Weather:	Rainy

FIELD INSPECTION PHOTO LOG

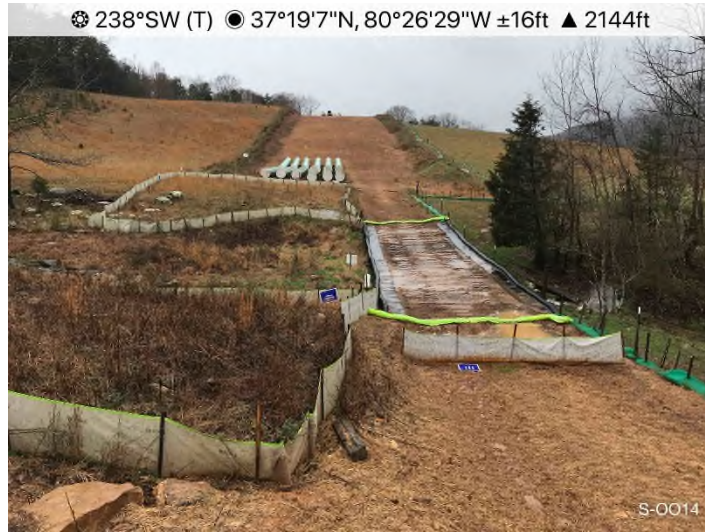
Figure 1: Stream S-0014 – Controls in place and functioning properly around stream S-0014. Area stabilized with straw.

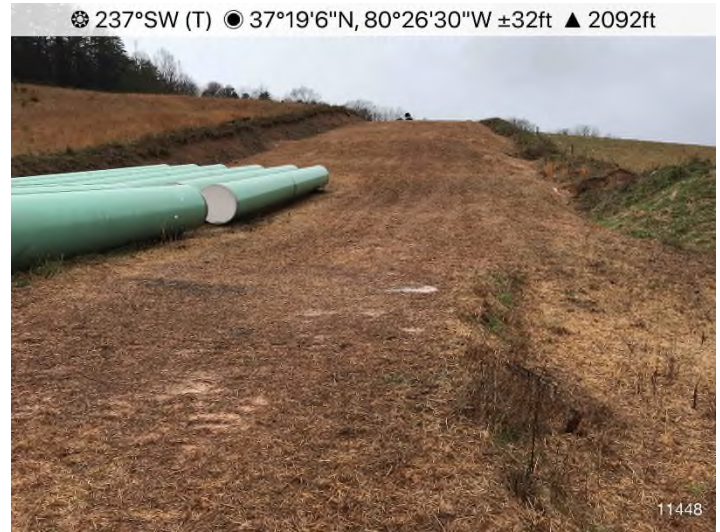
Figure 2: STA 11448+00 – Controls in place and functioning properly. Area stabilized with straw. No erosion evident.

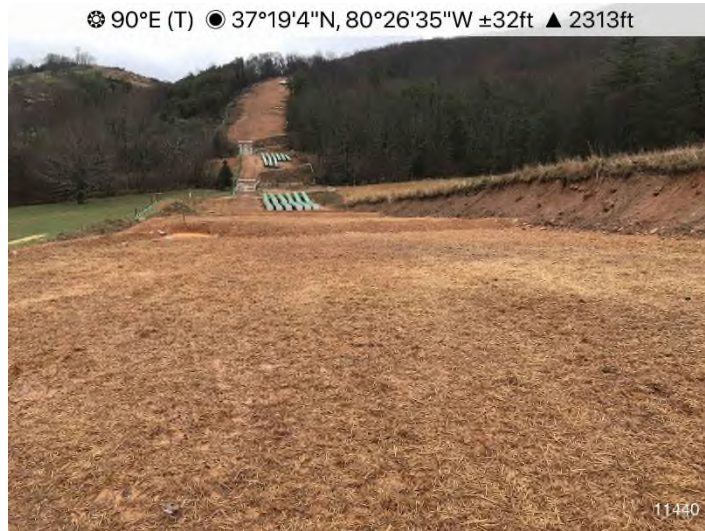
Figure 3: STA 11440+00 – Controls in place and functioning properly. Area stabilized with straw. No erosion evident.

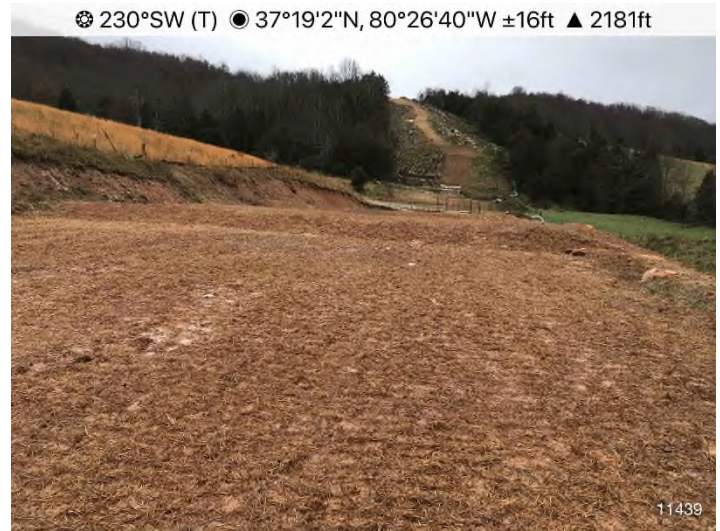
Figure 4: STA 11439+00 – Controls in place and functioning properly. Area stabilized with straw. No erosion evident.

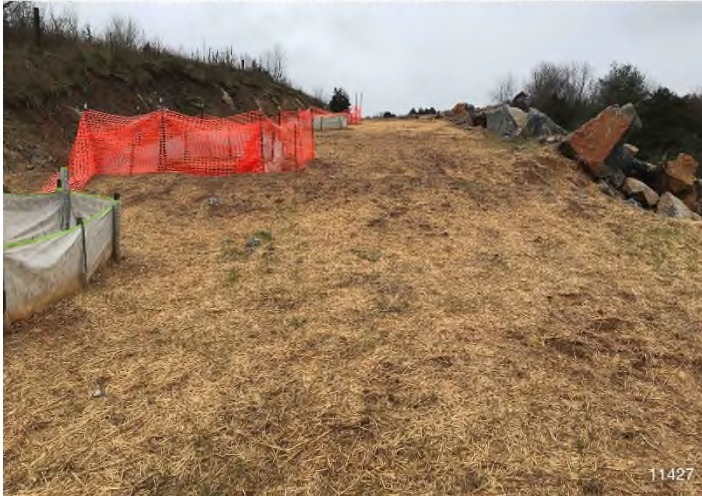
11427

Figure 5: STA 11427+00 – Controls in place and functioning properly. Area stabilized with straw. No erosion evident.

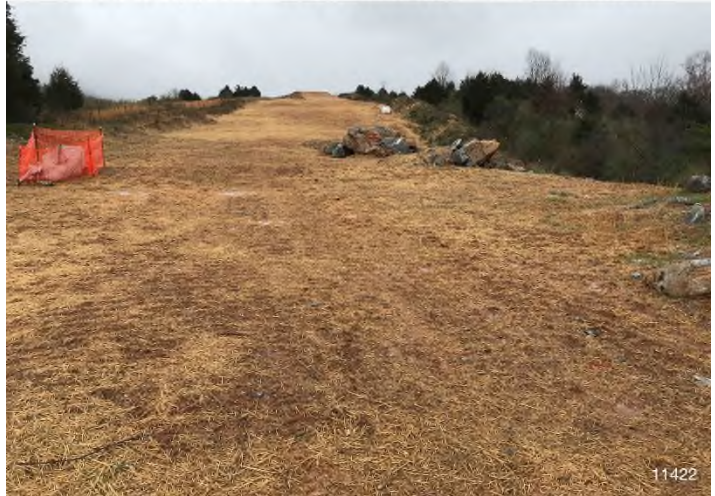
11422

Figure 6: STA 11422+00 – Controls in place and functioning properly. Area stabilized with straw. No erosion evident.

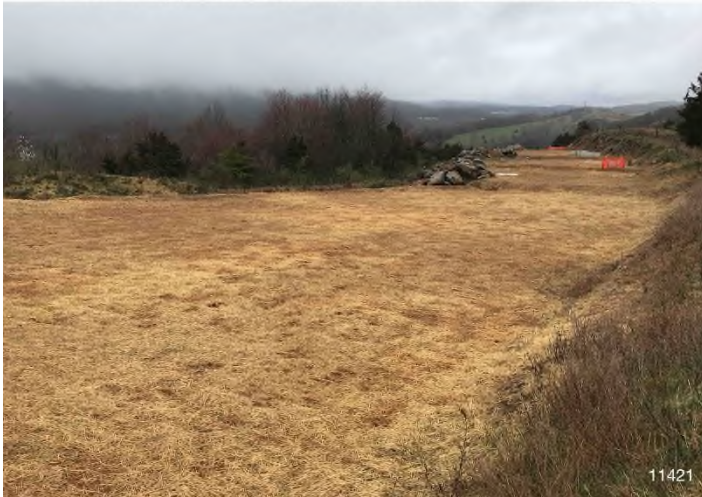
11421

Figure 7: STA 11421+00 – Controls in place and functioning properly. Area stabilized with straw. No erosion evident.

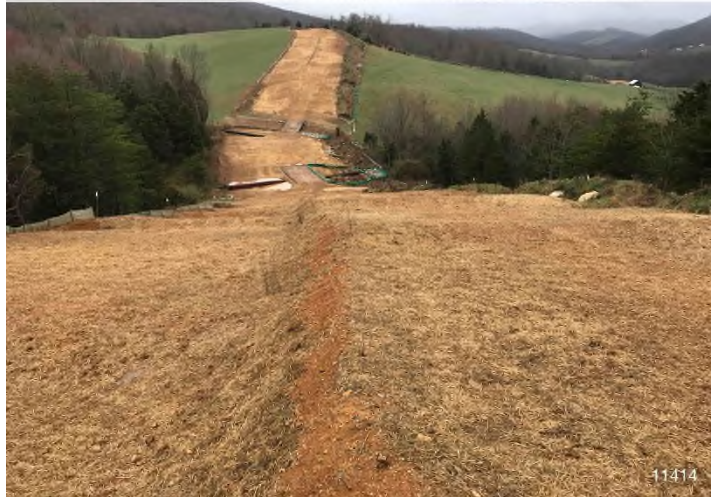
11414

Figure 8: STA 11414+00 – Controls in place and functioning properly. Area stabilized with straw. No erosion evident.
