FIELD INSPECTION REPORT

Project Name:	Mountain Valley Pipeline	Inspector:	Marshall Willis
Inspection Date:	Thursday, March 12, 2020	Project Contact:	Brian Clauto, Cory Chalmers
Spread G: Montgomery County	STA 11669+00 – 11766+80 MVP-MLV-AR-26	Weather:	Dry

FIELD INSPECTION PHOTO LOG

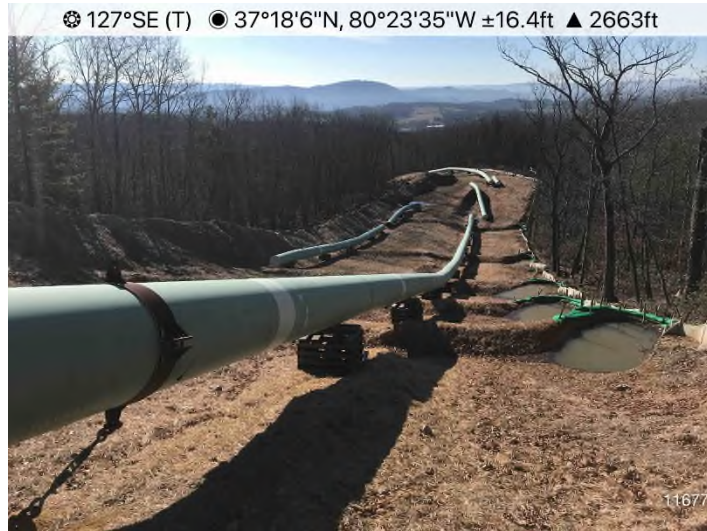
Figure 1: STA 11677+00 – Controls in place and functioning properly. Area stabilized with straw.

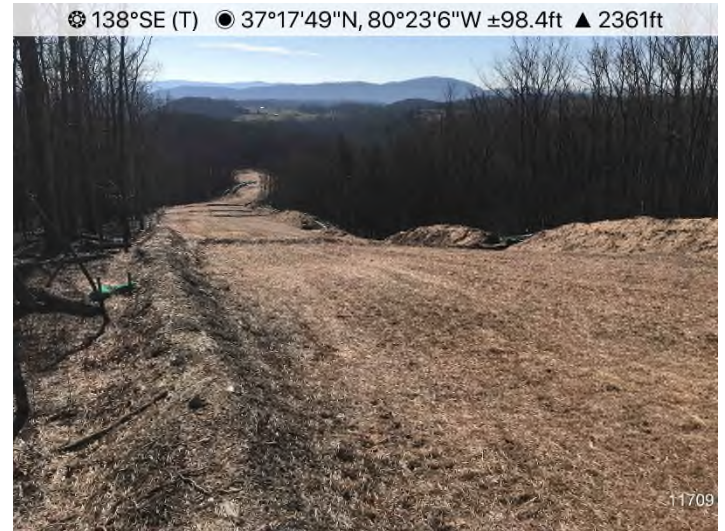
Figure 2: STA 11709+00 – Controls in place and functioning properly. Area stabilized with straw.

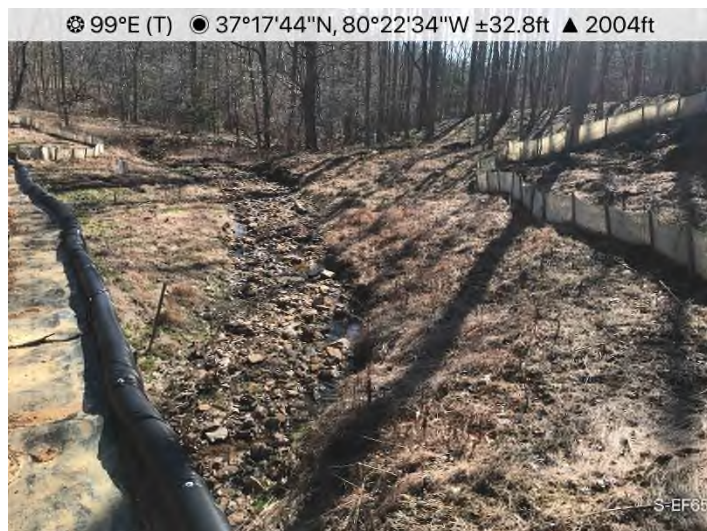
Figure 3: Stream S-EF65 – Controls in place and functioning properly around stream S-EF65.

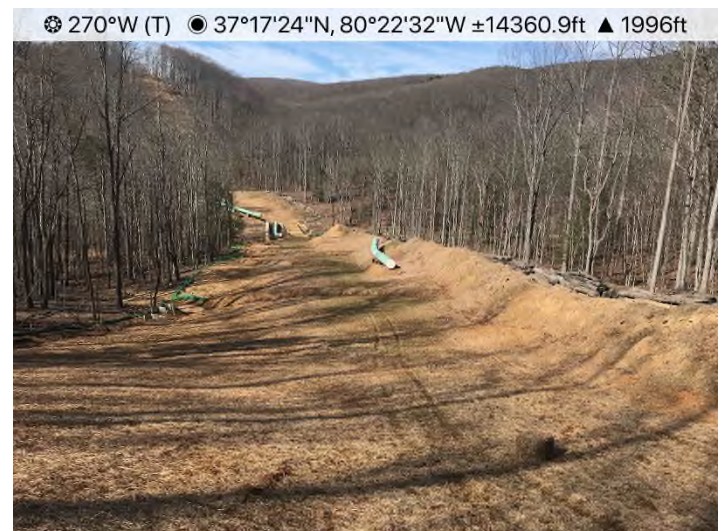
Figure 4: STA 11750+00 – Controls in place and functioning properly. Area stabilized with straw.
