FIELD INSPECTION REPORT

Project Name:	Mountain Valley Pipeline	Inspector:	Marshall Willis
Inspection Date:	Friday, March 6, 2020	Project Contact:	Brian Clauto, Cory Chalmers
Spread G: Montgomery County	STA 11788+43 – 11930+00 MVP-MN-266.03/266 ATWS 1487/1456/1457	Weather:	Snow

FIELD INSPECTION PHOTO LOG

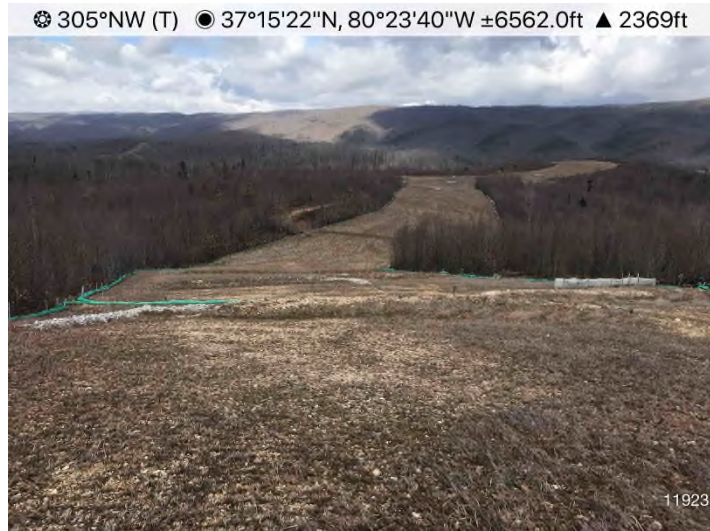
Figure 1: STA 11923+00 – Controls in place and functioning properly.

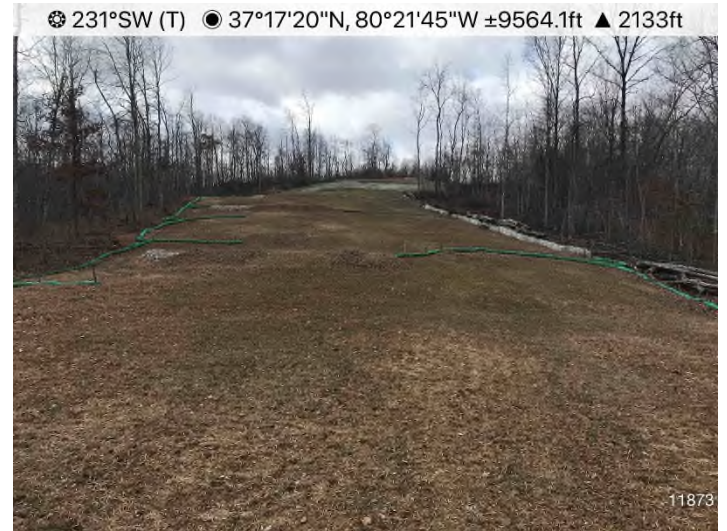
Figure 2: STA 11873+00 – Controls in place and functioning properly.

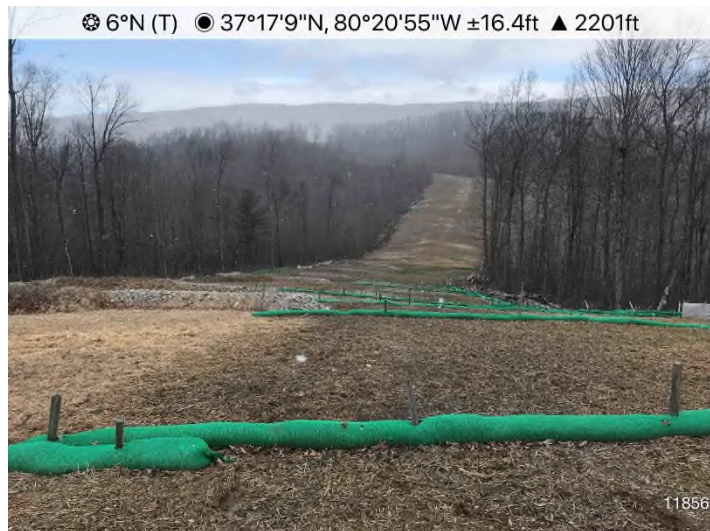
Figure 3: STA 11856+00 – Controls in place and functioning properly.

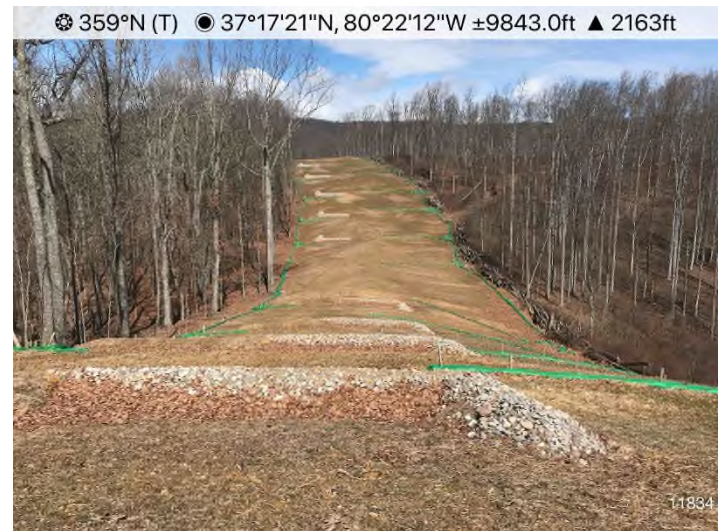
Figure 4: STA 11834+00 – Controls in place and functioning properly.
