FIELD INSPECTION REPORT

Project Name:	Mountain Valley Pipeline	Inspector:	Matthew Grant
Inspection Date:	Tuesday, February 25, 2020	Project Contact:	Brian Clauto,
Spread G: Montgomery	MP 225.9-222.8 MN 266 ATWS 1487 MLV 26	Weather:	Wet

FIELD INSPECTION PHOTO LOG

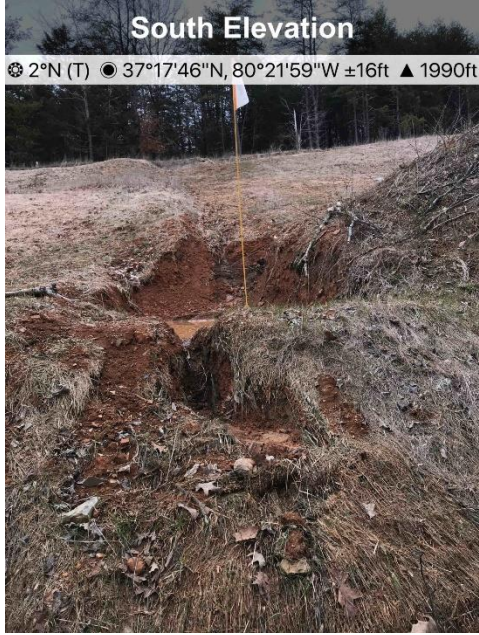
- St11770+00 sump outfall has eroded and requires maintenance

<p>▪ <u>Figure 1:</u> St11770+00 sump outfall has eroded and requires maintenance.</p> <div style="text-align: center; margin-top: 10px;"> <p>South Elevation</p> <p>☉ 2°N (T) ☉ 37°17'46"N, 80°21'59"W ±16ft ▲ 1990ft</p>

Recommended Corrective Action: Maintain and install all controls per the approved PSS&S.

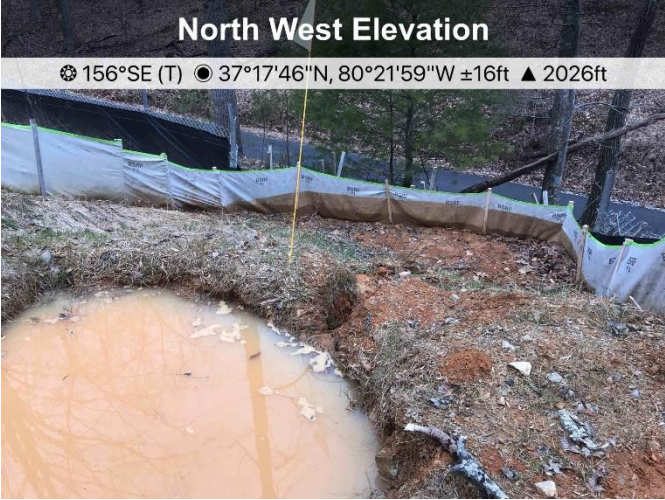
</div>	<p>▪ <u>Figure 2:</u> St11770+00 sump outfall has eroded and requires maintenance.</p> <div style="text-align: center; margin-top: 10px;"> <p>North West Elevation</p> <p>☉ 156°SE (T) ☉ 37°17'46"N, 80°21'59"W ±16ft ▲ 2026ft</p>

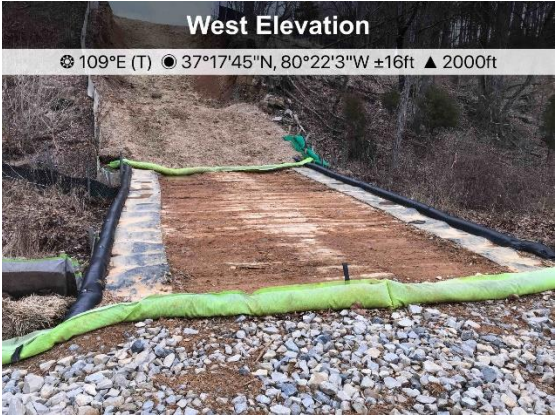
- **Comments:** Inspected the following resources: S-IJ52
- ECD's were in place at the designated crossing.

</div>
<p>▪ <u>Figure 3:</u> Designated crossing S-IJ52, ECD's are in place</p> <div style="text-align: center; margin-top: 10px;"> <p>West Elevation</p> <p>☉ 109°E (T) ☉ 37°17'45"N, 80°22'3"W ±16ft ▲ 2000ft</p>

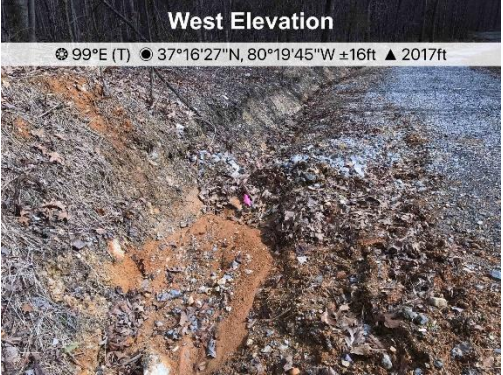
- On AR MN 266 check dam requires maintenance/ clean out.

</div>	<p>- <u>Figure 4:</u> On AR MN266, check dam requires maintenance/ clean out.</p> <div style="text-align: center; margin-top: 10px;"> <p>West Elevation</p> <p>☉ 99°E (T) ☉ 37°16'27"N, 80°19'45"W ±16ft ▲ 2017ft</p>
