FIELD INSPECTION REPORT

Project Name:	Mountain Valley Pipeline	Inspector:	Marshall Willis
Inspection Date:	Friday, June 5, 2020	Project Contact:	Brian Clauto, Cory Chalmers
Spread G: Montgomery County	STA 11471+50 – 11525+00 STA 11600+00 – 11620+00 MVP-CR-258.02/258.01 MVP-MN-258.03	Weather:	Dry

FIELD INSPECTION PHOTO LOG

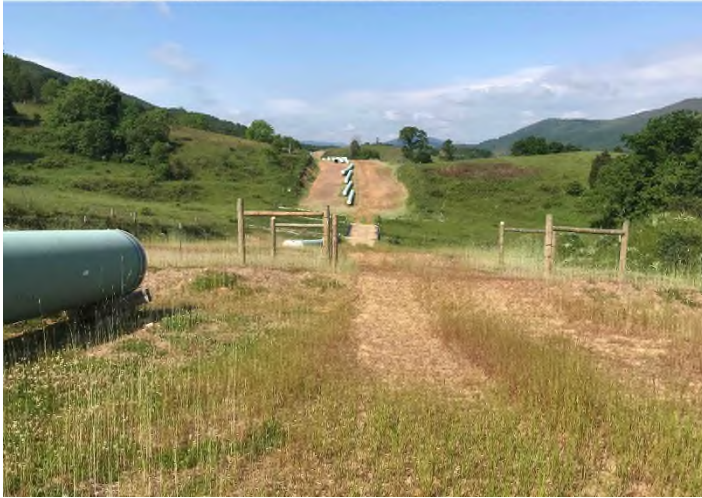
Figure 1: STA 11525+00 – Controls in place and functioning properly. Area stabilized with straw and vegetation.

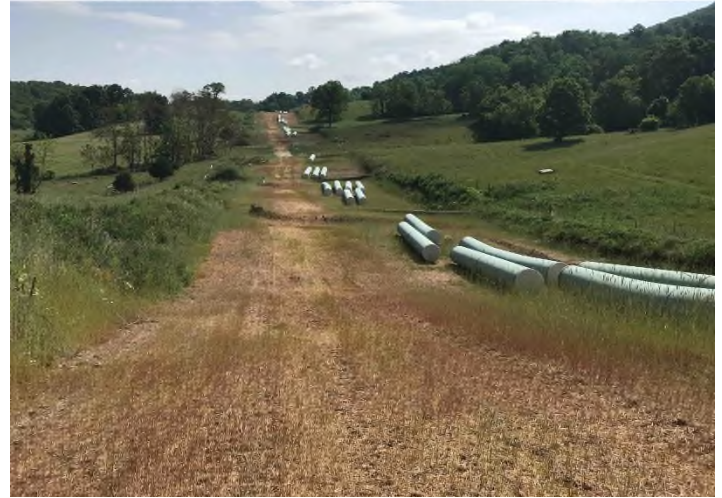
Figure 2: STA 11498+00 – Controls in place and functioning properly. Area stabilized with straw and vegetation.

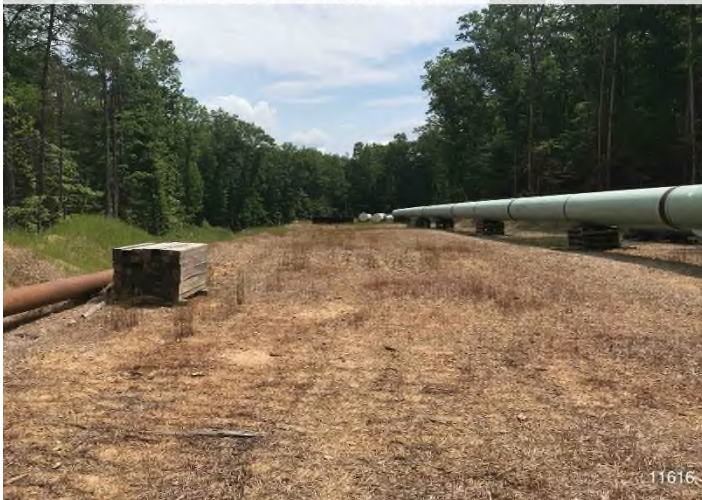
Figure 3: STA 11616+00 – Controls in place and functioning properly. Area stabilized with straw.

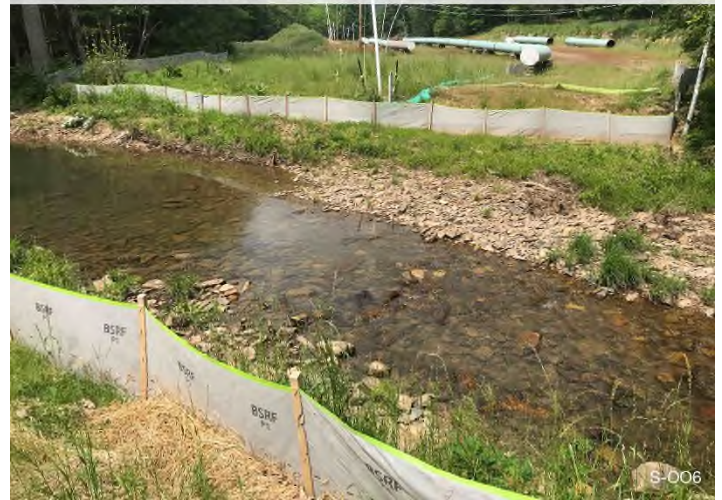
Figure 4: Stream S-006 – Controls in place and functioning properly around Craig Creek crossing.
