FIELD INSPECTION REPORT

Project Name:	Mountain Valley Pipeline	Inspector:	Marshall Willis
Inspection Date:	Thursday, May 28, 2020	Project Contact:	Brian Clauto, Cory Chalmers
Spread G: Giles County	STA 11159+86 – 11236+21 ATWS 1370/1370A/1347/1464 MVP-MLV-AR-25 MVP-GI-249.01	Weather:	Wet

FIELD INSPECTION PHOTO LOG

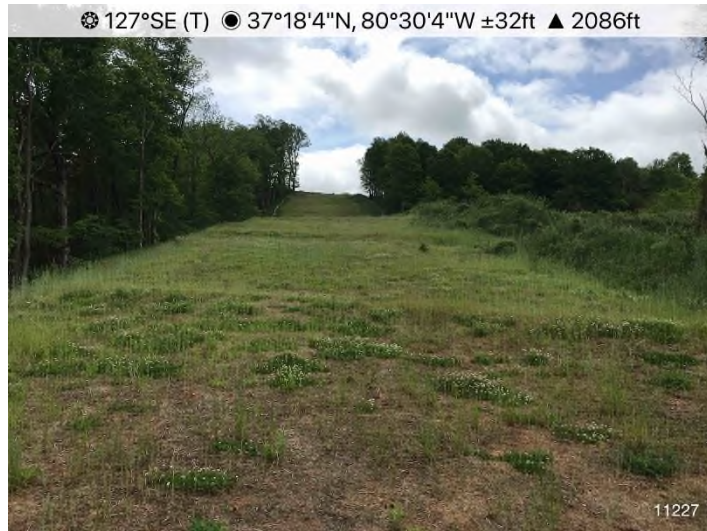
Figure 1: STA 11227+00 – Controls in place and functioning properly.

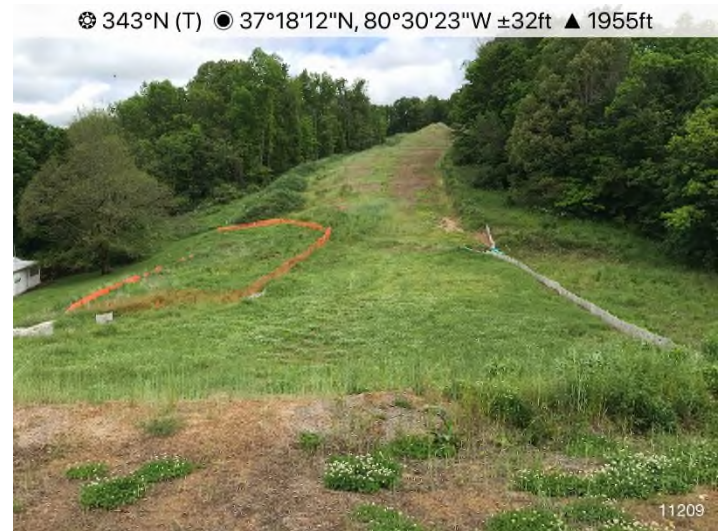
Figure 2: STA 11209+00 – Controls in place and functioning properly.

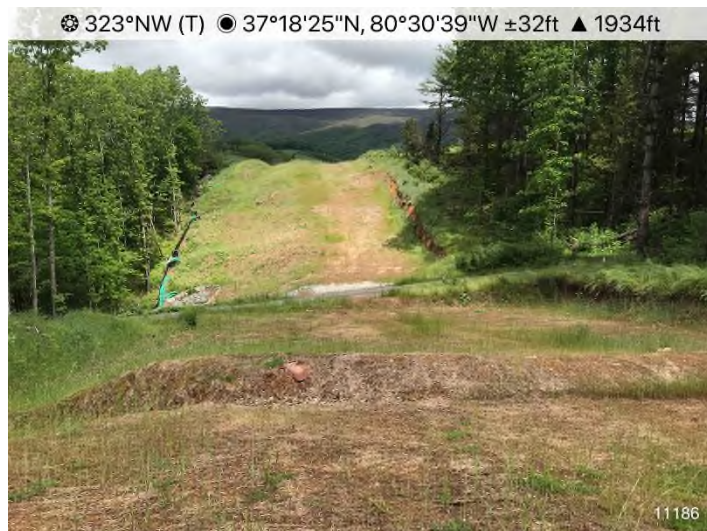
Figure 3: STA 11186+00 – Controls in place and functioning properly.

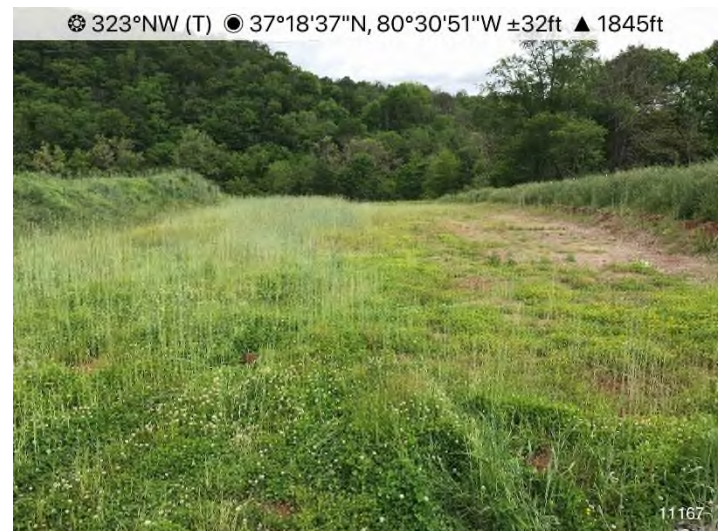
Figure 4: STA 11167+00 – Controls in place and functioning properly.
