FIELD INSPECTION REPORT

Project Name:	Mountain Valley Pipeline	Inspector:	Marshall Willis
Inspection Date:	Wednesday, May 13, 2020	Project Contact:	Brian Clauto, Cory Chalmers
Spread G: Montgomery County	STA 11765+50 – 11800+00 STA 11601+00 – 11620+00 MVP-MLV-AR-26 MVP-MN-258.04	Weather:	Dry

FIELD INSPECTION PHOTO LOG

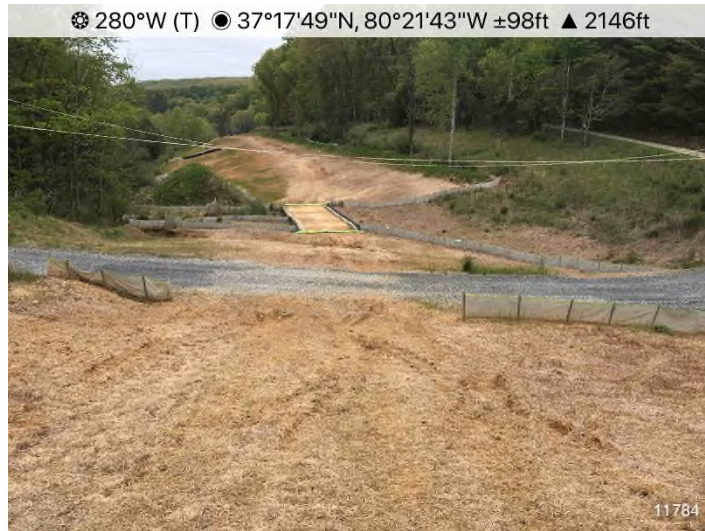
Figure 1: STA 11784+00 – Controls in place and functioning properly. Area stabilized with straw.

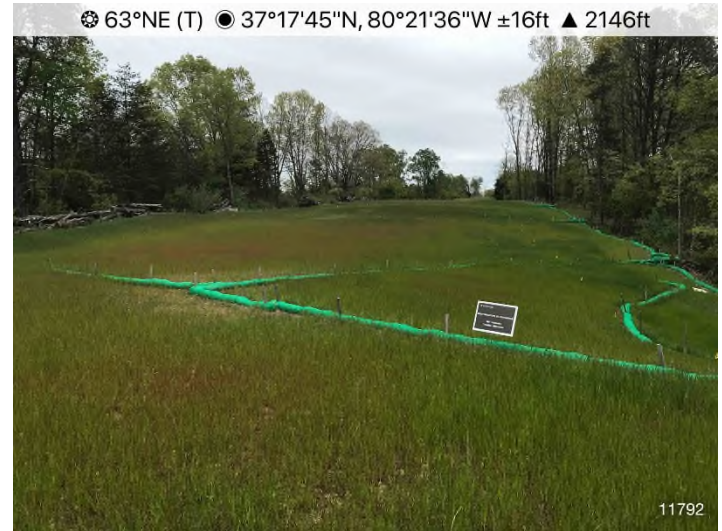
Figure 2: STA 11792+00 – Controls in place and functioning properly.

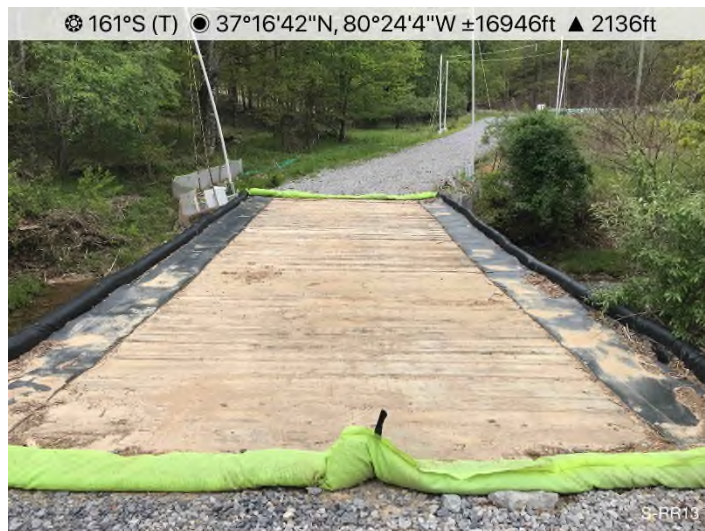
Figure 3: Stream S-RR13 – Controls in place and functioning properly along S-RR13.

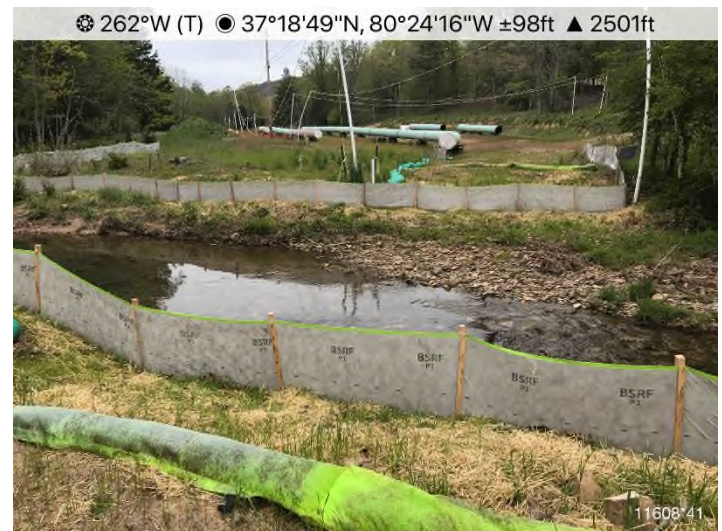
Figure 4: STA 11608+40 – Controls in place and functioning properly along Craig Creek.
