COMPLAINT INVESTIGATION REPORT

Project Name:	Mountain Valley Pipeline	Inspector:	Marshall Willis
Inspection Date:	Wednesday, April 22, 2020	Project Contact:	Brian Clauto, Cory Chalmers
Spread I: Franklin County	STA 13674+00 – 13690+00	Weather:	Dry

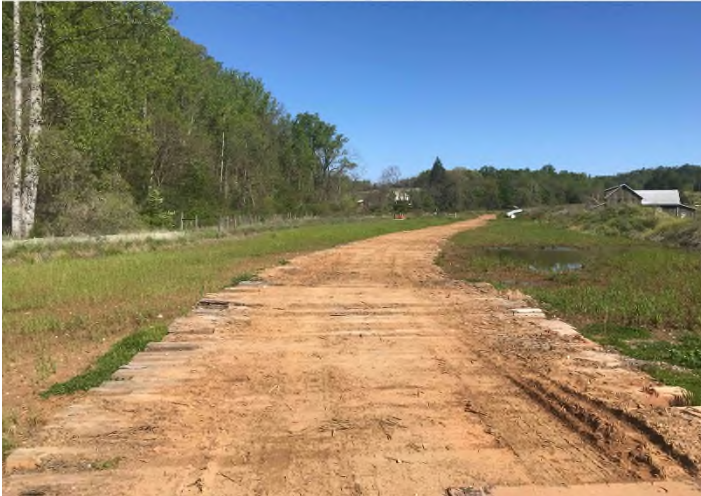
Figure 1: STA 13687+50 – Controls in place and functioning properly. ROW stabilized with temporary vegetation and timber matting in travel lane.

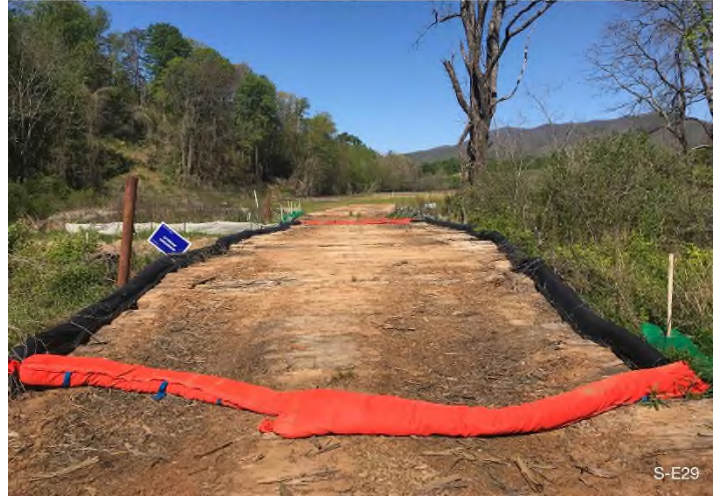
Figure 2: Stream S-E29 – Unnamed trib. to Teels Creek. Controls in place and functioning properly at crossing.

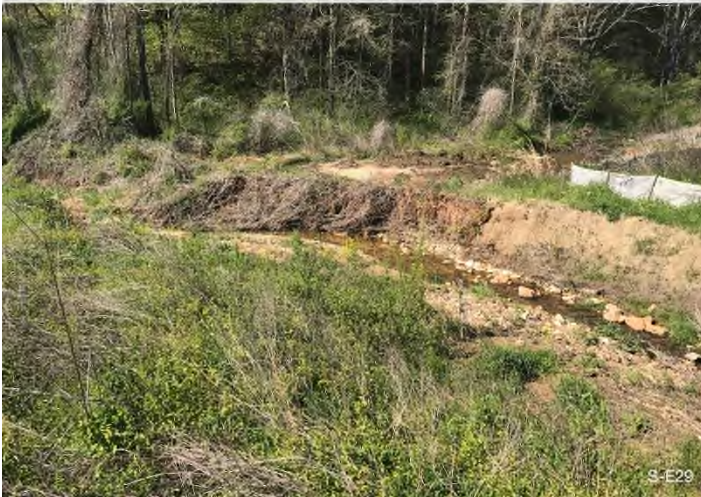
Figure 3: Stream S-E29 – Unnamed trib. to Teels Creek crossing looking downstream towards Teels Creek confluence. Incised stream banks covered in stabilization matting within ROW.

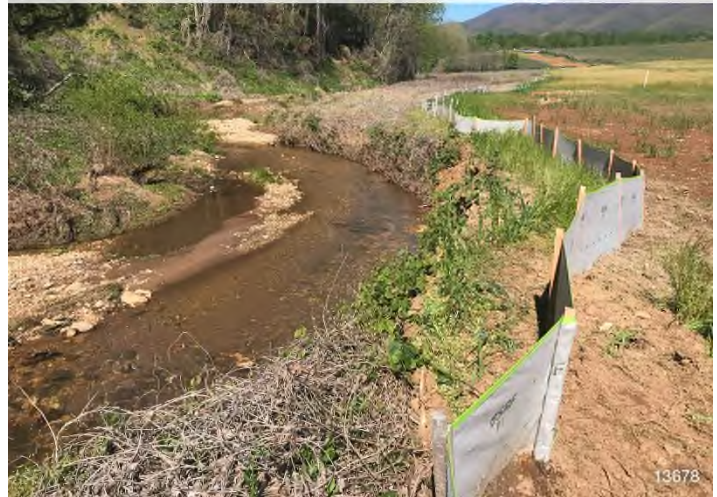
Figure 4: STA 13678+00 – Recent P1 repair along Teels Creek (S-E28). Note incised stream banks caused by stream meandering along inside bends.
