## VWP FIELD INSPECTION CHECKLIST

<b>Project Name</b>	Mountain Valley Pipeline Spread H, Franklin County	<b>VWP Permit #</b>	N/A	<b>Inspection Date</b>	5/31/2018
<b>Inspector Name</b>	Nathan Hughes; Jesse Roberts	<b>Phone # &amp; Email Address</b>	(804) 698-4026; <a href="mailto:Nathan.Hughes@deq.virginia.gov">Nathan.Hughes@deq.virginia.gov</a> (540) 562-6785; <a href="mailto:Jesse.Roberts@deq.virginia.gov">Jesse.Roberts@deq.virginia.gov</a>		
<b>Address or lat/long (if no permit no.)</b>	Cahas Mountain Road; near Mile Post 255.5	<b>Others Present During Inspection</b>	N/A		
<b>Project Phase</b>	Land Clearing; Grading	<b>Reason for Inspection</b>	Complaint		
<b>PERMIT / REGULATORY REQUIREMENT</b>		<b>Yes/ No/ NA</b>	<b>Location, Description and Other Notes</b>		
Unauthorized impacts to surface waters, including wetlands, or upland preservation areas <b>have occurred</b> .* <i>(This includes sedimentation impacts due to inadequate or failed erosion controls.)</i>		Yes	Approximately 2,800 linear feet (comprising 2 separate streams) have been impacted by sedimentation: ~1,110 linear feet of stream located south of project's Limits of Disturbance (LOD); ~1,690 linear feet of stream im

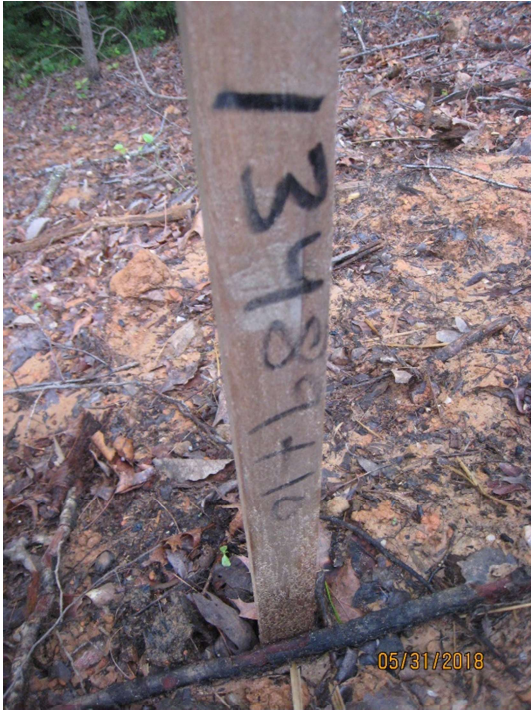
Close-up of number on survey stake

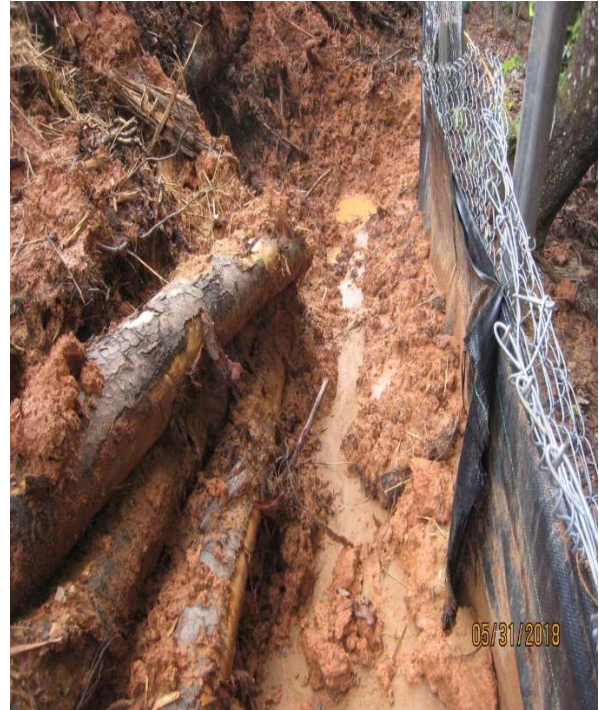
Sediment located on north side of SF

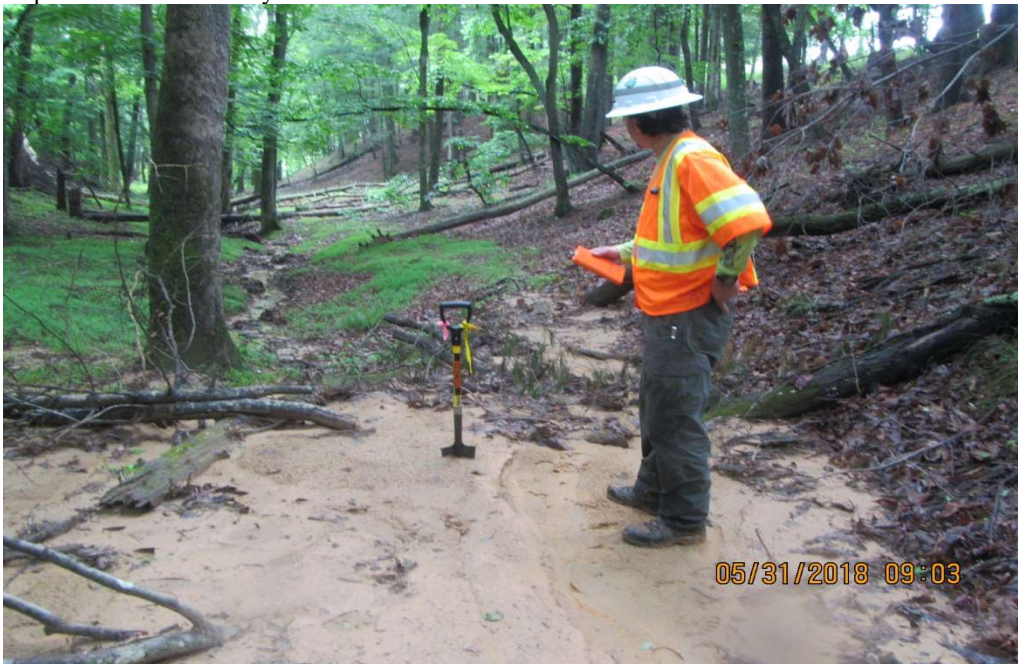
Sediment within channel at debris dam ~420-feet from MVP LOD  
Depth 3 to 8-inches (average), Maximum depth of 11-inches; Sediment deposit 12-feet wide

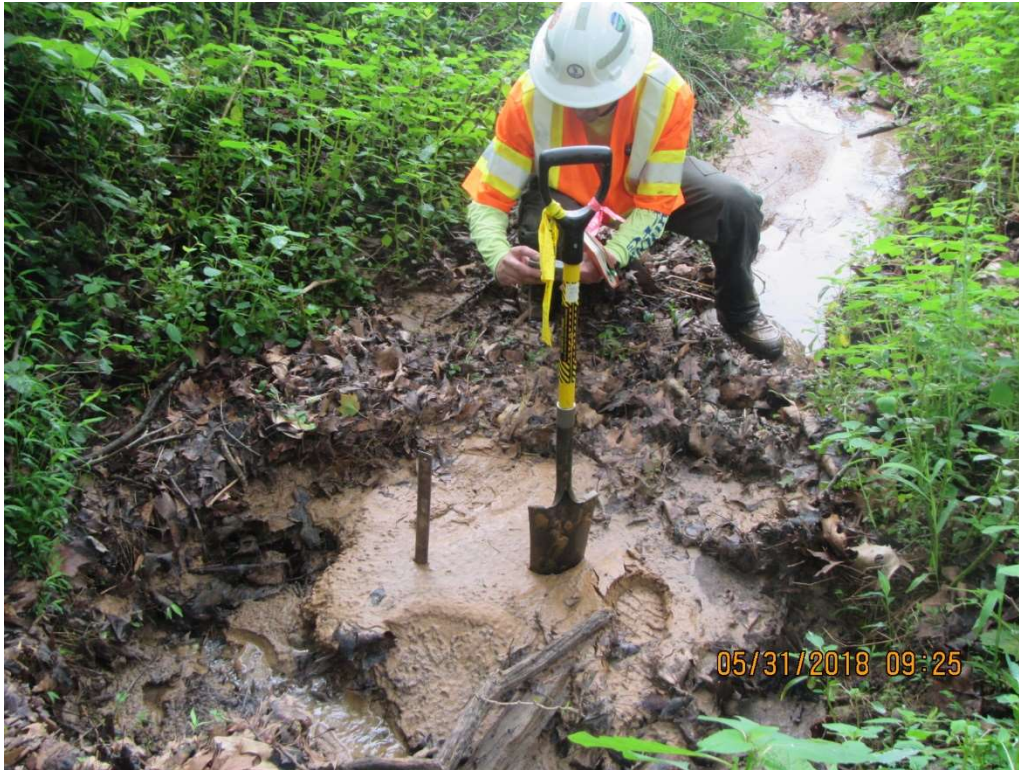
Sediment in channel near treeline ~1,000-feet from MVP LOD  
Channel 3-feet wide; Sediment depth 6.5-inches

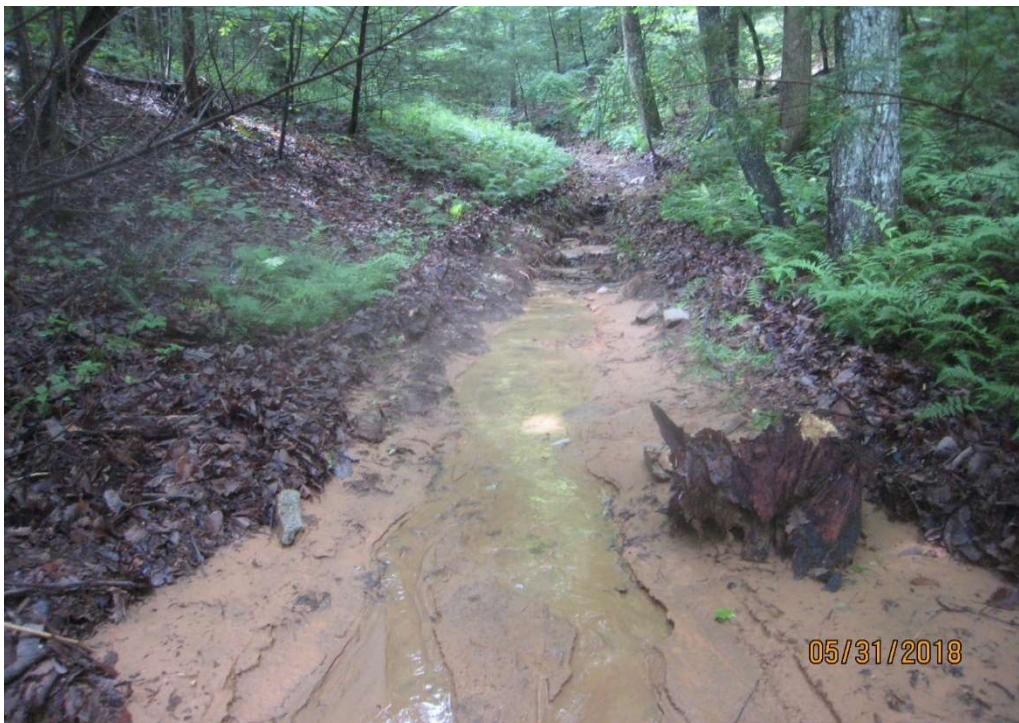
Sediment within channel ~685-feet from MVP LOD  
Channel 3 to 5-feet wide; Sediment depth 3-inches in thalweg, 3 to 6-inches on sediment bars
