VWP FIELD INSPECTION CHECKLIST

Project Name	Mountain Valley Pipeline Spread H, Montgomery County	VWP Permit #	N/A	Inspection Date	6/26/2018
Inspector Name	Nathan Hughes; Matt Grant	Phone # & Email Address	(804) 698-4026; Nathan.Hughes@deq.virginia.gov (804) 418-9874; Matthew.Grant@deq.virginia.gov		
Address or lat/long (if no permit no.)	Catawba Road; 37°15'53.6"N, 80°18'30.8"W Stream Crossing #39 and #40	Others Present During Inspection	N/A		
Project Phase	Land Clearing; Grading	Reason for Inspection	Complaint		
PERMIT / REGULATORY REQUIREMENT		Yes/ No/ NA	Location, Description and Other Notes		
Unauthorized impacts to surface waters, including wetlands, or upland preservation areas have occurred . <i>(This includes sedimentation impacts due to inadequate or failed erosion controls.)</i>		Yes	Approximately 2,200 linear feet (comprising 2 separate streams) have been impacted by sedimentation		
Non-impacted wetlands, streams and preservation areas within 50 feet of construction are clearly marked to prevent unpermitted impacts.		N/A	Impacted streams are located greater than 50 feet from project's LOD

Site Name: Mountain Valley Pipeline_Spread H south of Catawba Road

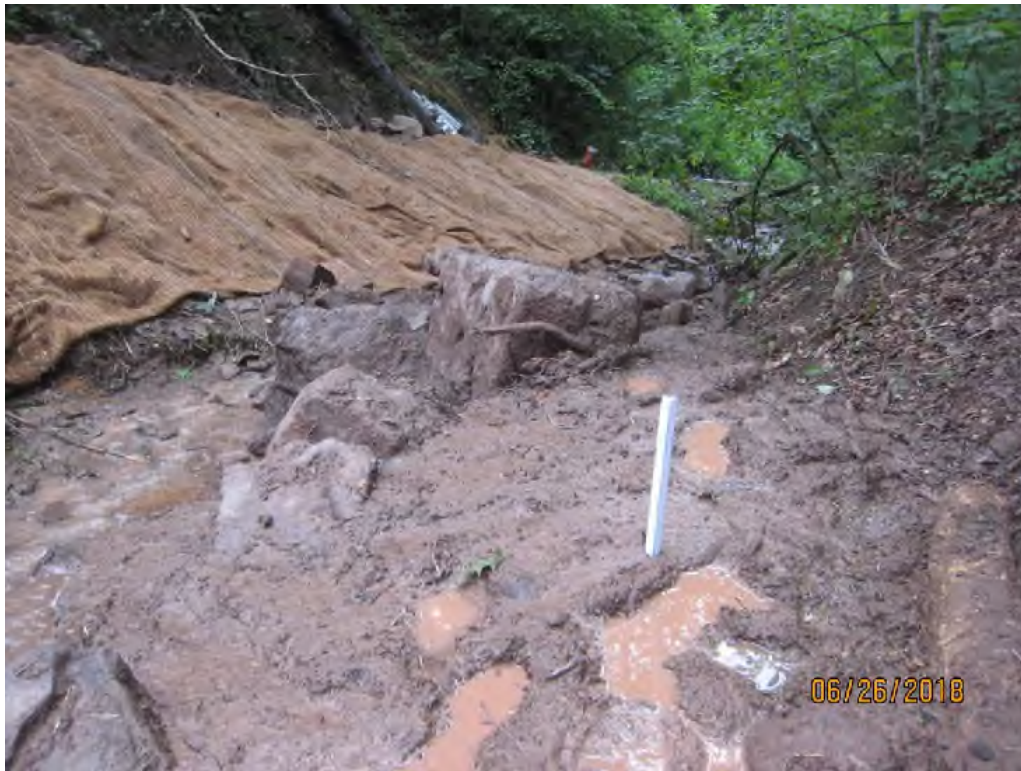
Photo 1: Sedimentation within "Stream 39" ~25' downstream of LOD

Orientation: Downstream

1. Repair erosion and sediment controls in areas where needed;
2. Stabilize all slopes above and below perimeter controls;
3. Remove sediment from impacted stream channels using hand removal methods (buckets and shovels) and stabilize with appropriate seed mix where applicable.

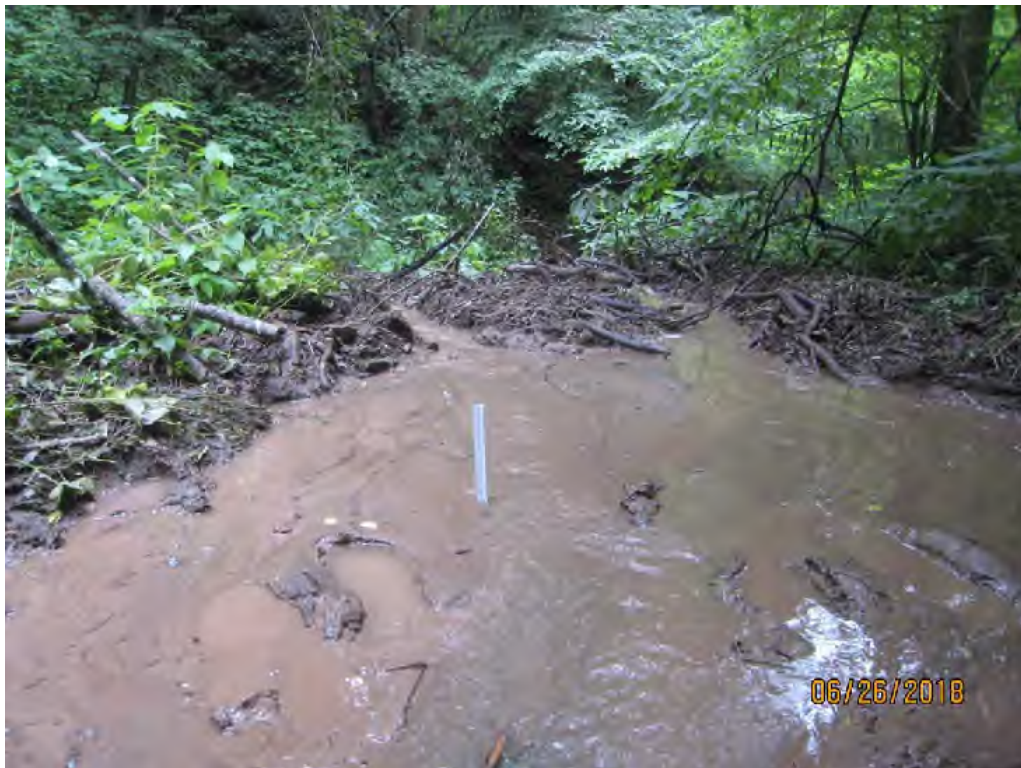
Photo 2: 4.5' of sediment at debris dam ~210' from Photo 1

Orientation: Downstream

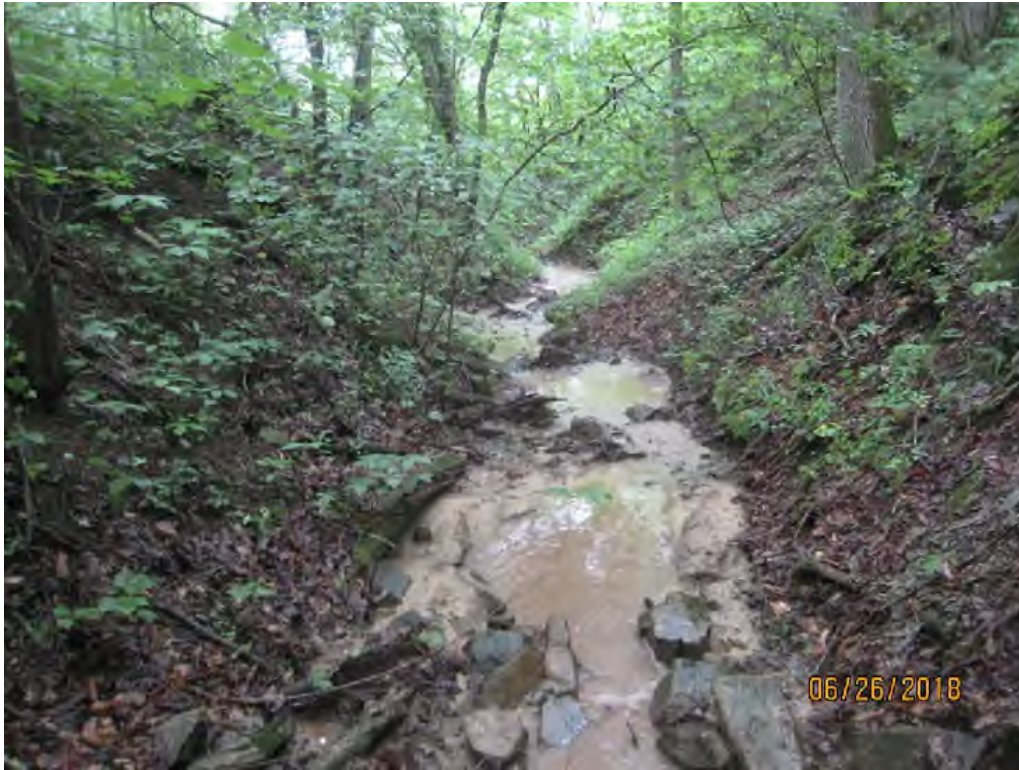
Photo 3: Sediment in stream at confluence with "Stream 40" ~265' downstream of Photo 1
Orientation: Downstream

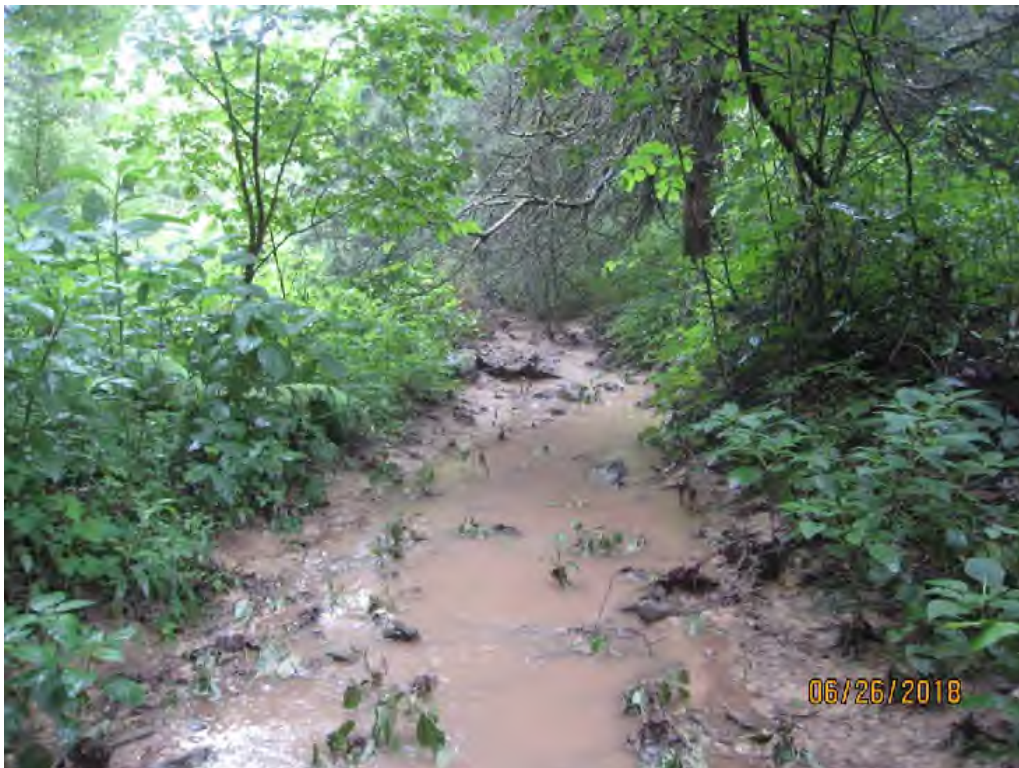
Photo 4: Sediment in stream ~1,325' from Photo 1
Orientation: Upstream
