VWP FIELD INSPECTION CHECKLIST

Project Name	Mountain Valley Pipeline Spread H, Montgomery County	VWP Permit #	N/A	Inspection Date	6/26/2018
Inspector Name	Nathan Hughes; Matt Grant	Phone # & Email Address	(804) 698-4026; Nathan.Hughes@deq.virginia.gov (804) 418-9874; Matthew.Grant@deq.virginia.gov		
Address or lat/long (if no permit no.)	Bacchus Road; 37°15'30.5"N, 80°17'46.8"W Stream Crossing SMM-15	Others Present During Inspection	N/A		
Project Phase	Land Clearing; Grading	Reason for Inspection	Complaint		
PERMIT / REGULATORY REQUIREMENT		Yes/ No/ NA	Location, Description and Other Notes		
Unauthorized impacts to surface waters, including wetlands, or upland preservation areas have occurred .* <i>(This includes sedimentation impacts due to inadequate or failed erosion controls.)</i>		Yes	Approximately 3,600 linear feet of stream channel have been impacted by sedimentation		
Non-impacted wetlands, streams and preservation areas within 50 feet of construction are clearly marked to prevent unpermitted impacts.		N/A	Impacted streams are located greater than 50 feet from project's LOD

Site Inspection

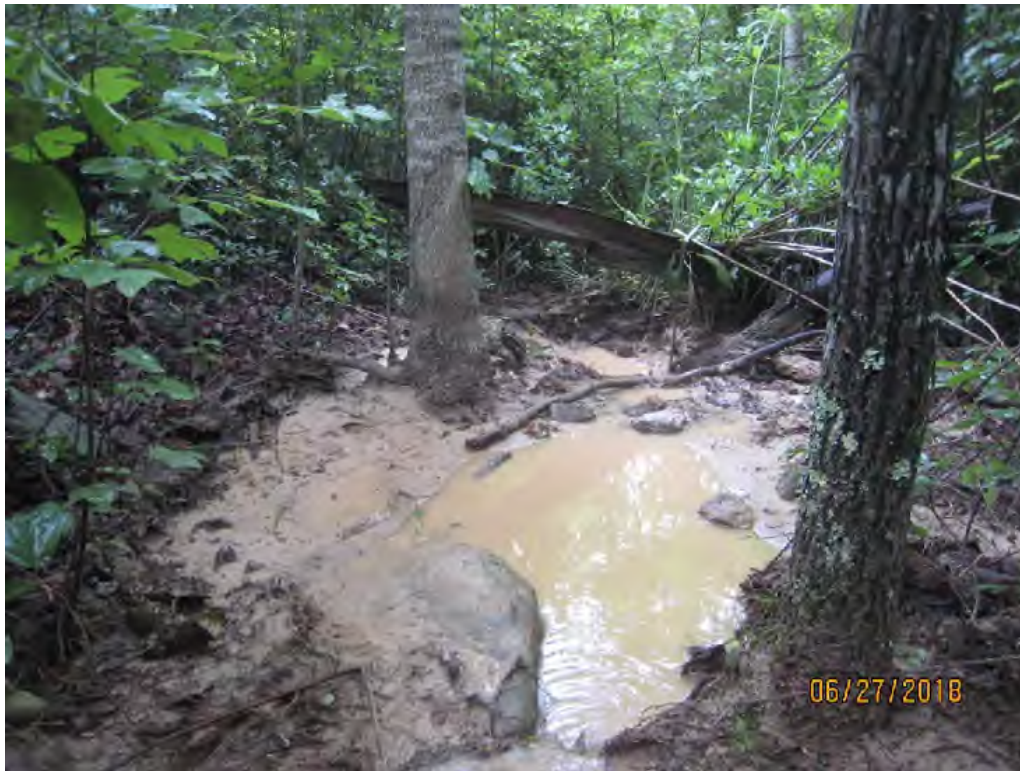
Photo 1: Sedimentation within "SMM-15" ~160' downstream of LOD; Depth = 3"
Orientation: Downstream

1. Repair erosion and sediment controls in areas where needed;
2. Stabilize all slopes above and below perimeter controls;
3. Remove sediment from impacted stream channels using hand removal methods (buckets and shovels) and stabilize with appropriate seed mix where applicable.

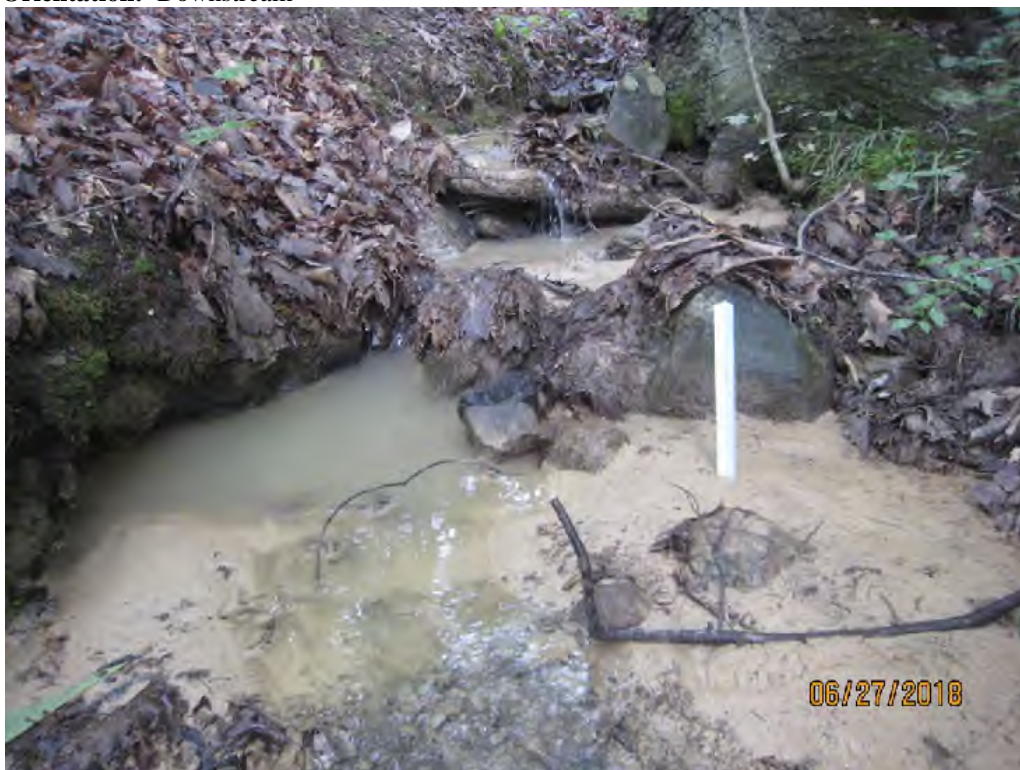
Photo 2: Sediment in stream ~685' from LOD; Depth = 3"
Orientation: Upstream

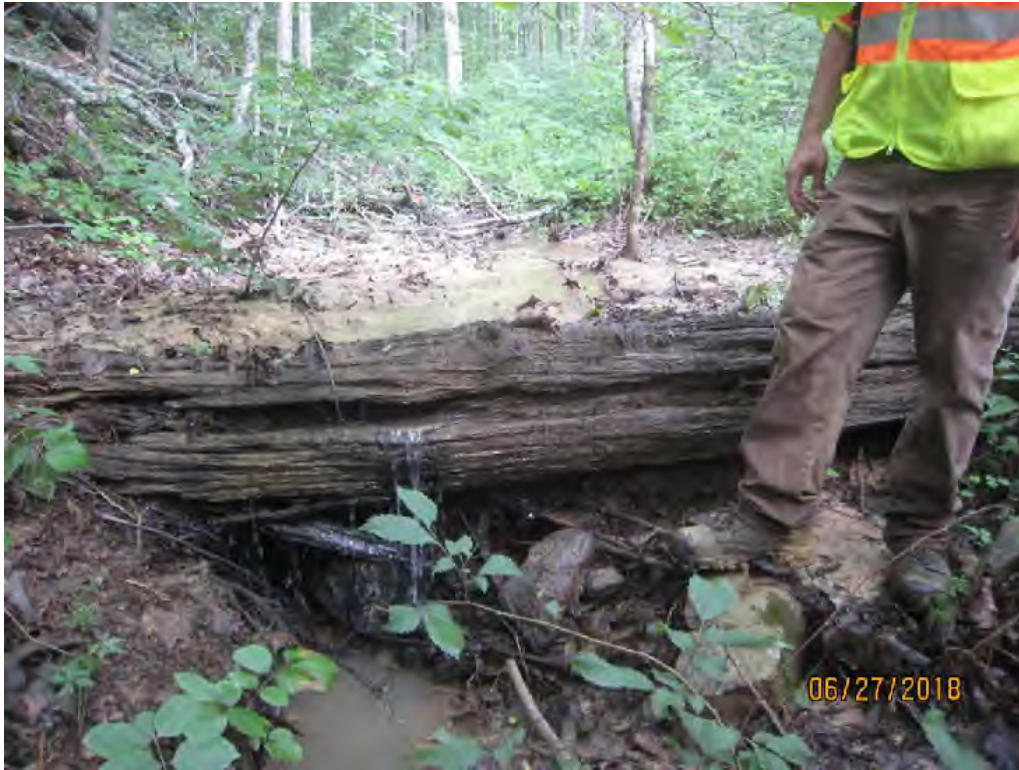
Photo 3: Sediment in stream at debris dam ~1,690' downstream of LOD; Depth = 2-7"
Orientation: Upstream

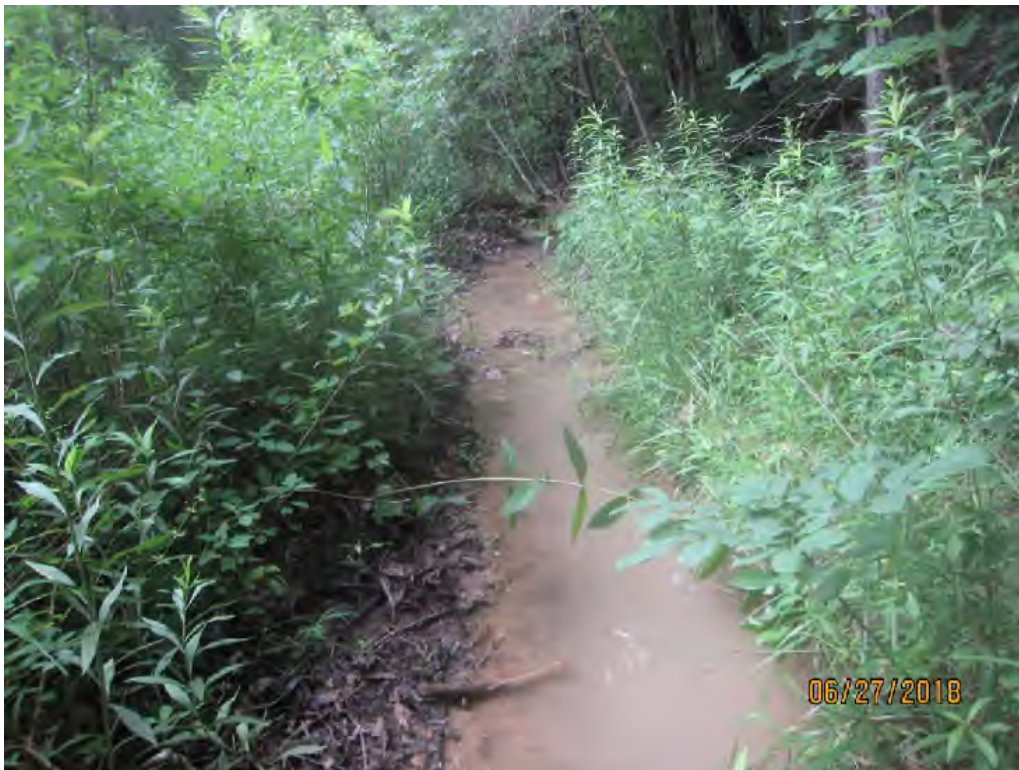
Photo 4: Sediment in stream ~3,485' from LOD near access road; Depth = 2"
Orientation: Downstream
