COMPLAINT INSPECTION REPORT

Project Name:	Mountain Valley Pipeline	Inspector:	John McCutcheon
Inspection Date:	Thursday, July 26, 2018	Project Contact:	Brian Clauto, Tim Bowen
Spread:	Spread G	Weather (Wet/Dry/Rain):	Dry

Comments: This report is for an inspection at the Doe Creek Road crossing near MP 207 in Giles County, in response to a complaint of sediment in Doe Creek.

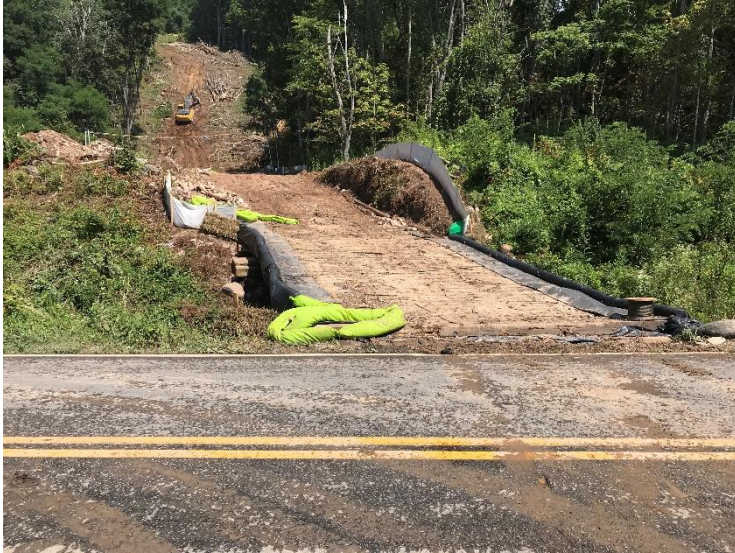
Comment 1.

Doe Creek bridge crossing, E&S controls in good repair.

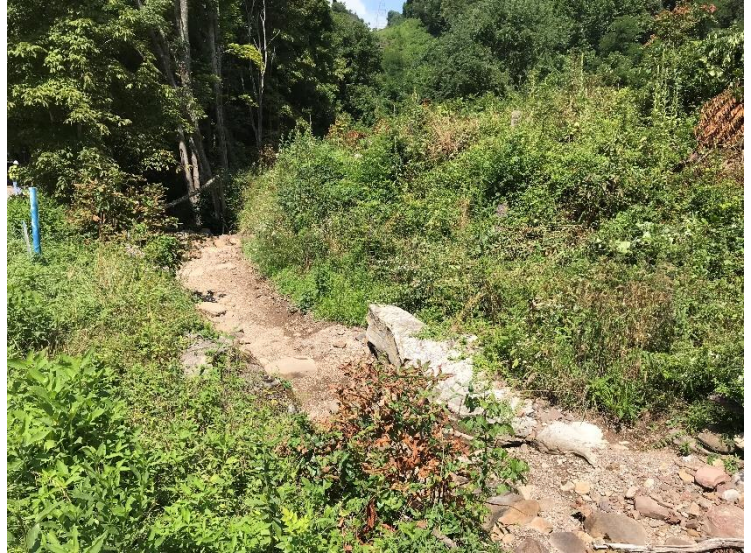
Comment 2.

Channel downstream of crossing.

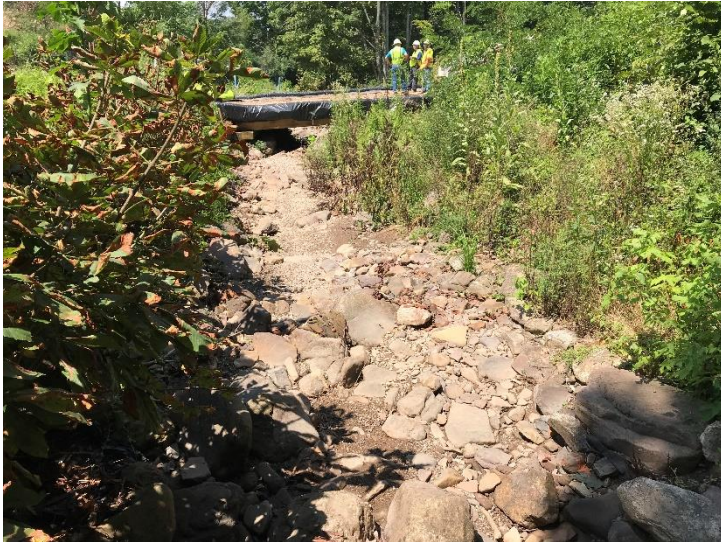
Comment 3

Channel downstream of crossing.

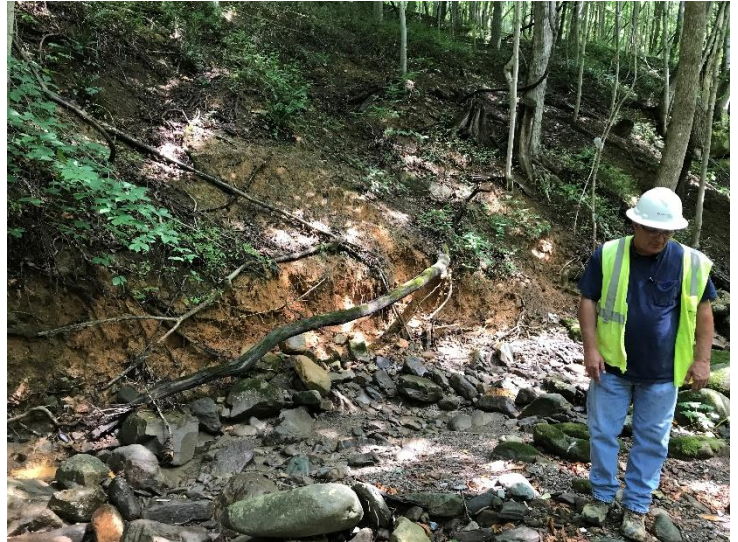
Comment 4.

Existing eroding streambank upstream of creek crossing.
