## **COMPLAINT INSPECTION REPORT**

Project Name:	Mountain Valley Pipeline	Inspector:	John McCutcheon
Inspection Date:	Wednesday, July 25, 2018	Project Contact:	Brian Clauto, Tracy Hilbun
Spread:	Spread I	Weather (Wet/Dry/Rain):	Dry

## FIELD INSPECTION PHOTO LOG

Project Name: Mountain Valley Pipeline Date: Wednesday, July 25, 2018

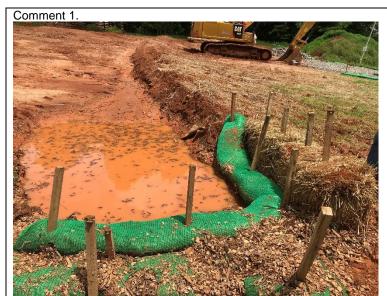
End of waterbar eroded, discharging downhill instead of off ROW. Repaired with straw bale.

Comment #	Regulatory Citation/Legal requirement <sup>1</sup>	Observation/Recommended Corrective Action					
1	(Va. Code §62.1- 44.15:31) (MVP Standards & Specifications for VA, p. 1) (9VAC 25-840- 60.A).	Observation: Waterbar eroded and discharging back onto ROW.  Recommended Corrective Action: Clean out and repair waterbar.					
2	(Va. Code §62.1- 44.15:31) (MVP Standards & Specifications for VA, p. 1) (9VAC 25-840- 60.A).	Observation: Compost filter socks silt fence and check dams need maintenance  Recommended Corrective Action: Clean out accumulated sediment in silt fence and check dams. Re-level sagging compost filter socks.					
3	(Va. Code §62.1- 44.15:31) (MVP Standards & Specifications for VA, p. 1) (9VAC 25-840- 40.2	Observation: Stabilization on stockpiles is thin or absent.  Recommended Corrective Action: Stabilize stockpiles.					
4	(Va. Code §62.1- 44.15:31) (MVP Standards & Specifications for VA, p. 1) (9VAC 25-880- 70.II.G.2.)	Observation: Sediment has been deposited in ditch and grass on either side of Bonbrook Mill Drive.  Recommended Corrective Action: Remove sediment and stabilize disturbed areas.

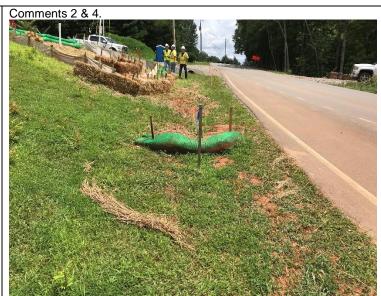
Filter sock check dam loaded with sediment. Sediment in roadside ditch.

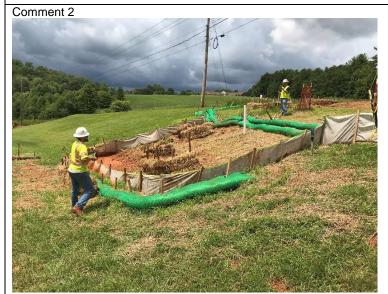
Silt fence loaded with sediment. Compost filter socks have sagged.

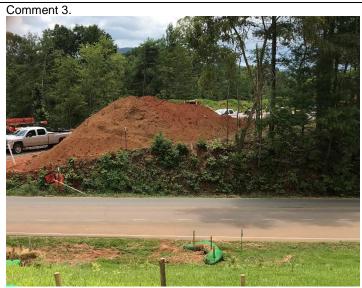
Stockpiles unstabilized.

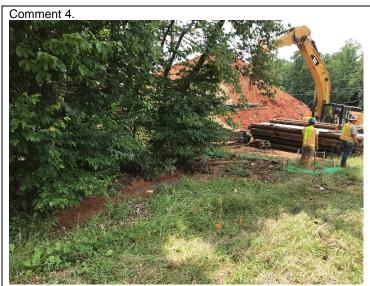
Sediment in roadside ditch.
