## INSPECTION REPORT

<b>Project Name:</b>	Mountain Valley Pipeline	<b>Inspector:</b>	John McCutcheon
<b>Inspection Date:</b>	Wednesday, July 18, 2018	<b>Project Contact:</b>	Brian Clauto
<b>Spread:</b>	Spread G	<b>Weather (Wet/Dry/Rain):</b>	Dry

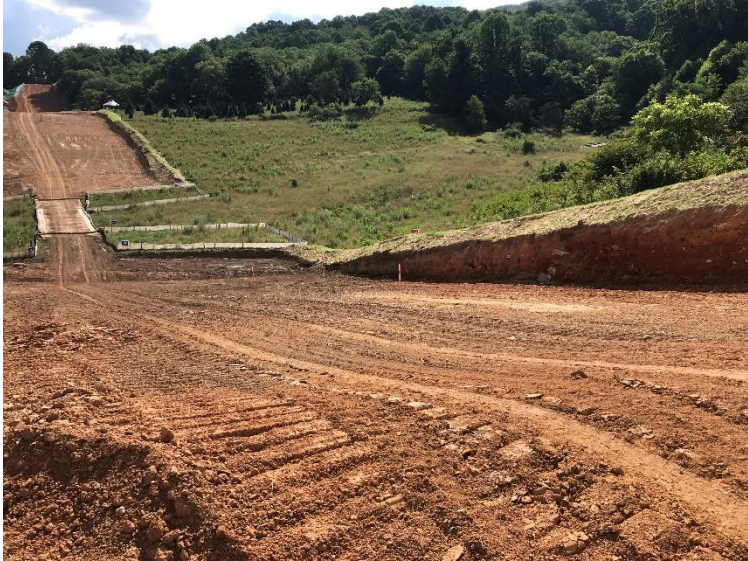
Comment 1

1. Water bar missing at STA 11515+85 according to slope and table MVP 17.2. Provide additional water bar. (9VAC 25-840-40.4)
2. Supplement existing stabilization. (9VAC 25-840-40.2)

Waterbar missing.

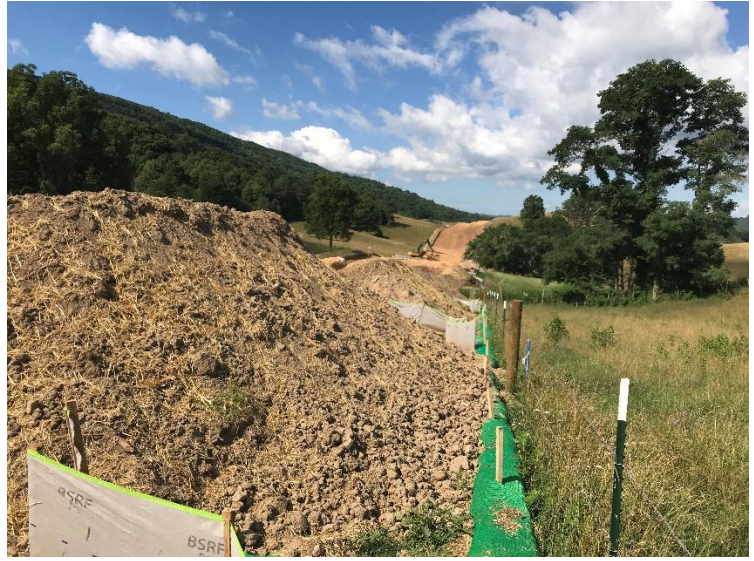
Comments 2&3

3. At STA 11519+60, stockpile soil has filled and spilled over compost filter socks. Remove soil from contact with filter sock and material spilled over. (9VAC 25-840-60.A)

Stockpile needs stabilization, Filter sock needs cleaning out.

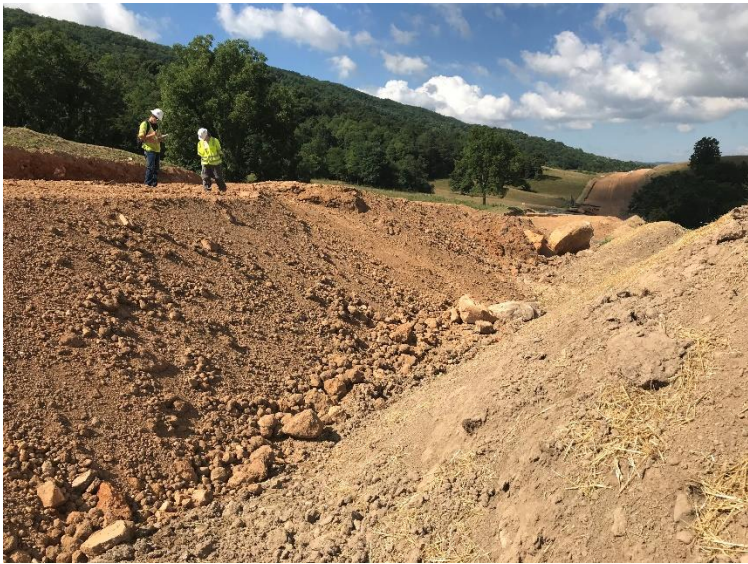
Comment 4

4. Slope on sides of graded ROW in vicinity of STA 11516+00 is bare. Stabilize denuded areas that will remain undisturbed within 7 days. (9VAC 25-840-40.1)

Side slope needs stabilization.

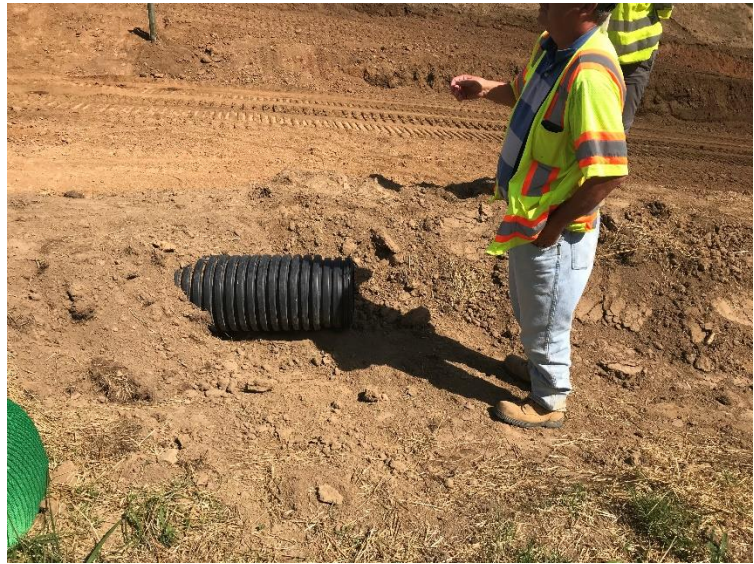
Comment 5

5. Pipe bypassing fence at STA 11501+20 lacks outlet protection. Provide outlet protection. (9VAC 25-840-40.11)
6. Waterbars discharging concentrated flow down graded slopes on two-tone ROW in vicinity of STA 11498+91. Provide stable conveyance for concentrated flows down slopes. (9VAC 25-840-40.8.)

Pipe needs outlet protection

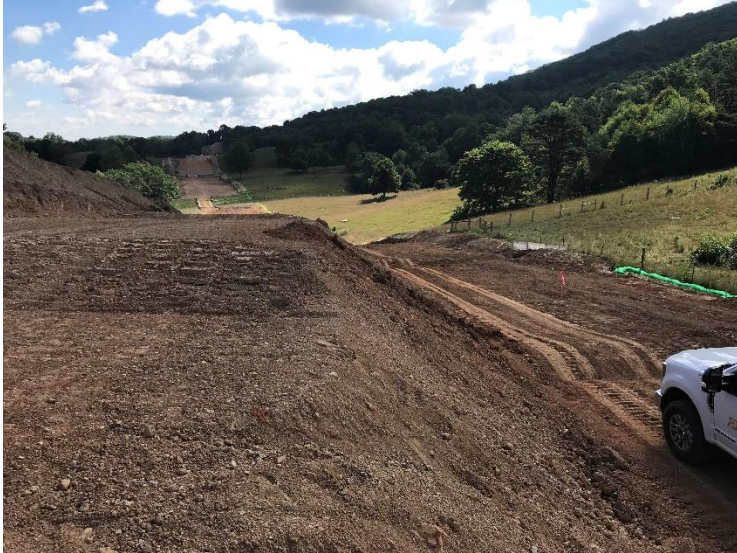
Comment 6

Stable conveyance needed for concentrated flow from waterbar directed down face of slope.

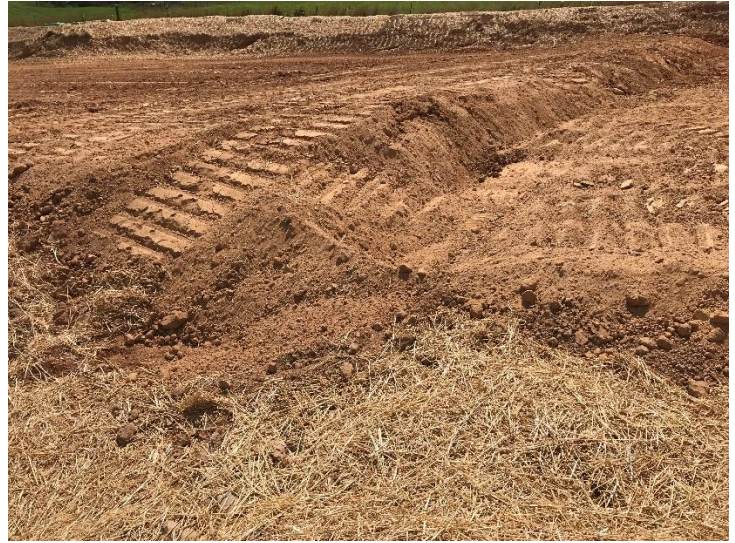
Comment 7

7. Discharge end of waterbar at STA 11483+00 blocked by small mound of soil. Remove soil and maintain clear flow line along channel of waterbars. (9VAC 25-840-60.A)

Soil pile needs to be removed from end of waterbar.

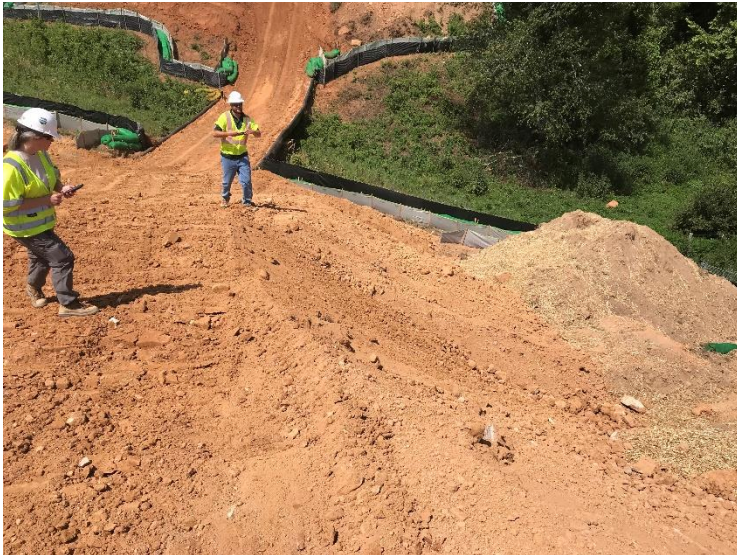
Comment 8

8. Concentrated flow from waterbar discharging down side slope in vicinity of 11481+00. Provide stable conveyance for concentrated flows down slopes. (9VAC 25-840-40.8.)

Stable conveyance needed for concentrated flow from waterbar directed down face of slope
